TECHNICAL ASSESSMENT
EXPLOSION AT TUZLA MAY 25th, 1995

MISSION DATED FEBRUARY 9th, 2016

Pierre LAURENT
Expert commissioned by Appeal Court of Paris, IPC
Arms, Ammunitions, Ballistics, Pyrotechnics
INPG engineer, Msc, DEA, DBA, Marines Troops Captain (R)

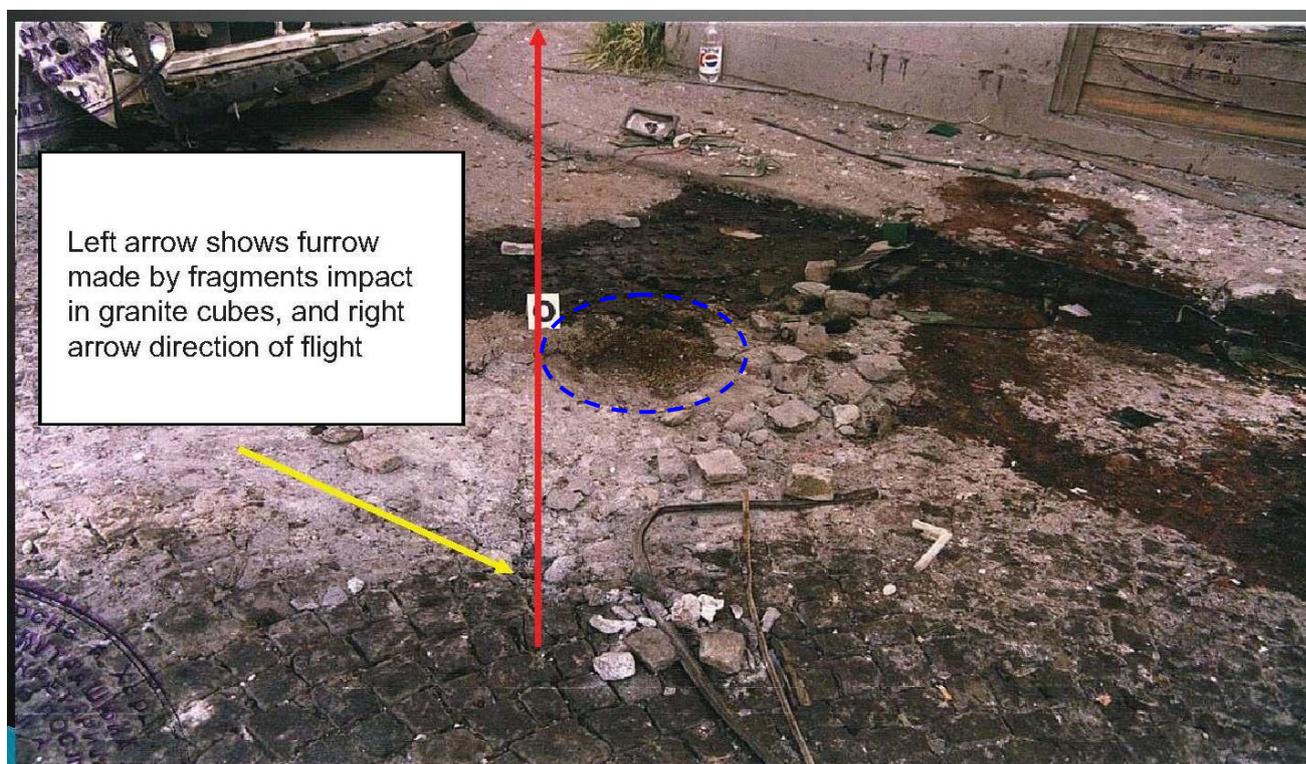
Position of furrow according to Prof. Berko ZECEVIC (in red), it is noted that the would be furrow is not aligned with the crater (in blue)

Comments in the white square and red line are from Prof. Berko ZECEVIC

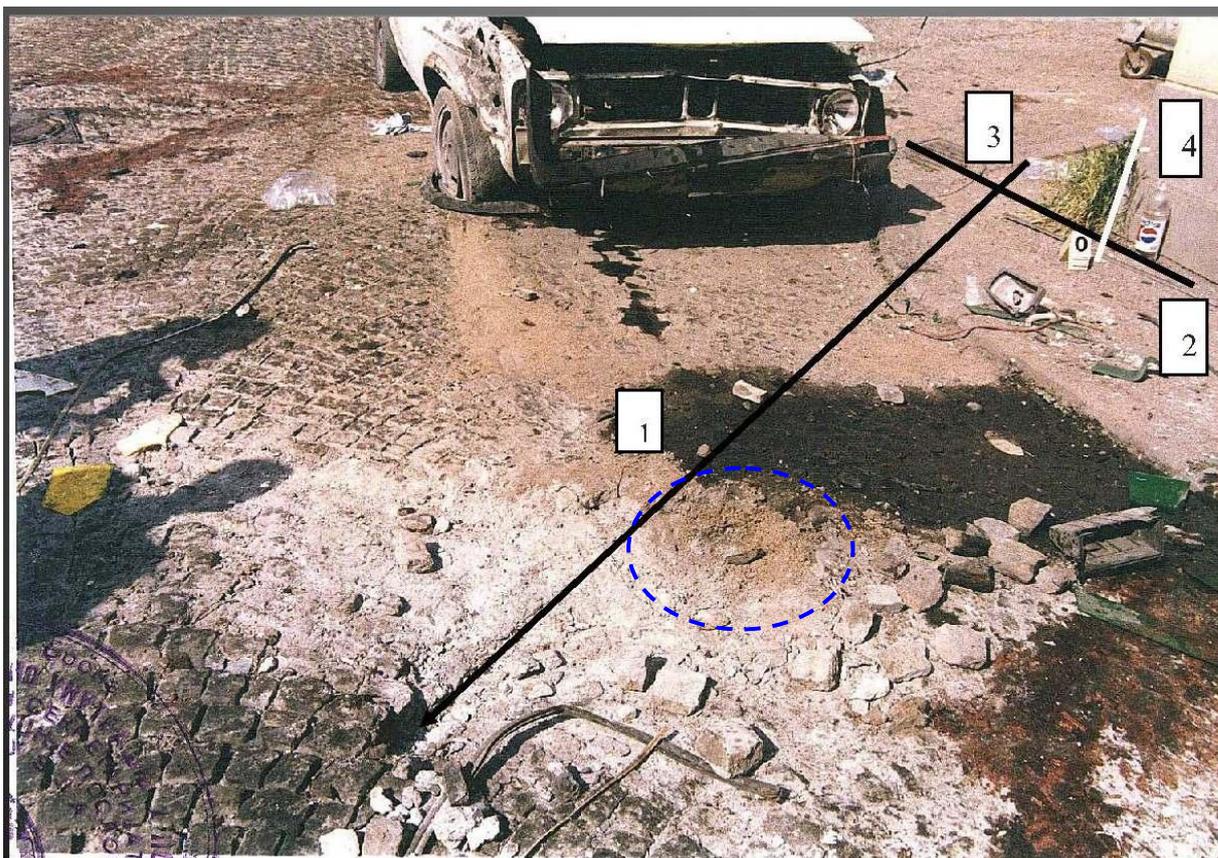
Position of furrow according to Prof. Berko ZECEVIC (in black),
Again, it is clear that the alleged furrow is not aligned with the crater (in blue)

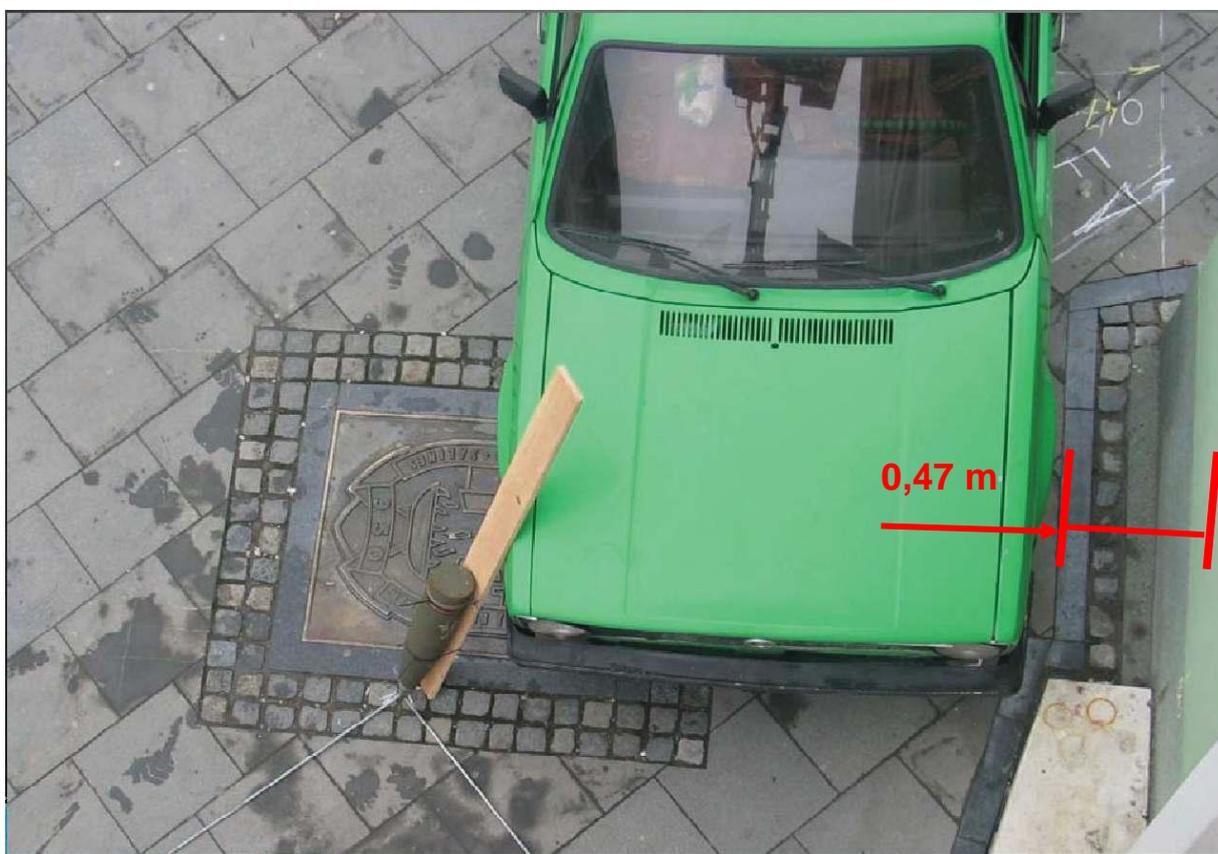
Reconstruction of a 130 mm incoming projectile arrival with AoF = 62°
(as positioned by Prof. Berko ZECEVIC)

It is noted that Prof. Berko ZECEVIC placed the car at 0,47 m from the NIK building. It is not known why Prof. Berko ZECEVIC places the car that near the wall. He considers himself that the sidewalk is 1,15 m wide. This point is important because there is graphic proofs in the next chapter that the car was alongside the sideway and not half onto the sideway as described by Prof. Berko ZECEVIC. We would not dispute that the width of the sideway may be a little bit less than 1,15 m, say 1,0 m for example, but in no case the side walk width was near 0,47 m.

This is a big issue because, to comply with the actual photos of the crime scene, we would be bound to move the car about 0,5 m sideway towards the square (to the left on the above photo). Then, the projectile would have to be set vertically in a way that it is simply not possible from a ballistic point of view unless the projectile is used as an IED.

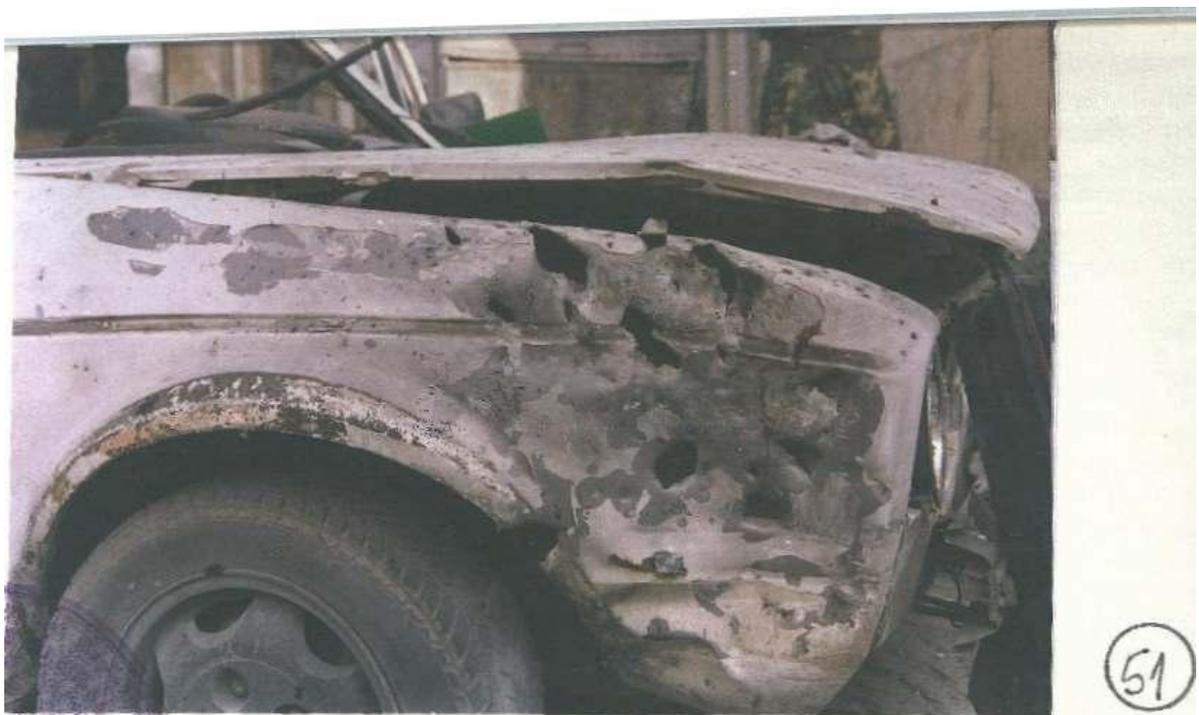
Furthermore, if we were to move the car sideways and back to insure a proper position of the crater in front of the right wheel, then it becomes impossible to account for the trajectories of fragments that are supposed to punch holes in the right aisle of the GOLF car as shown on the photos.

GOLF car right aisle (crime scene)

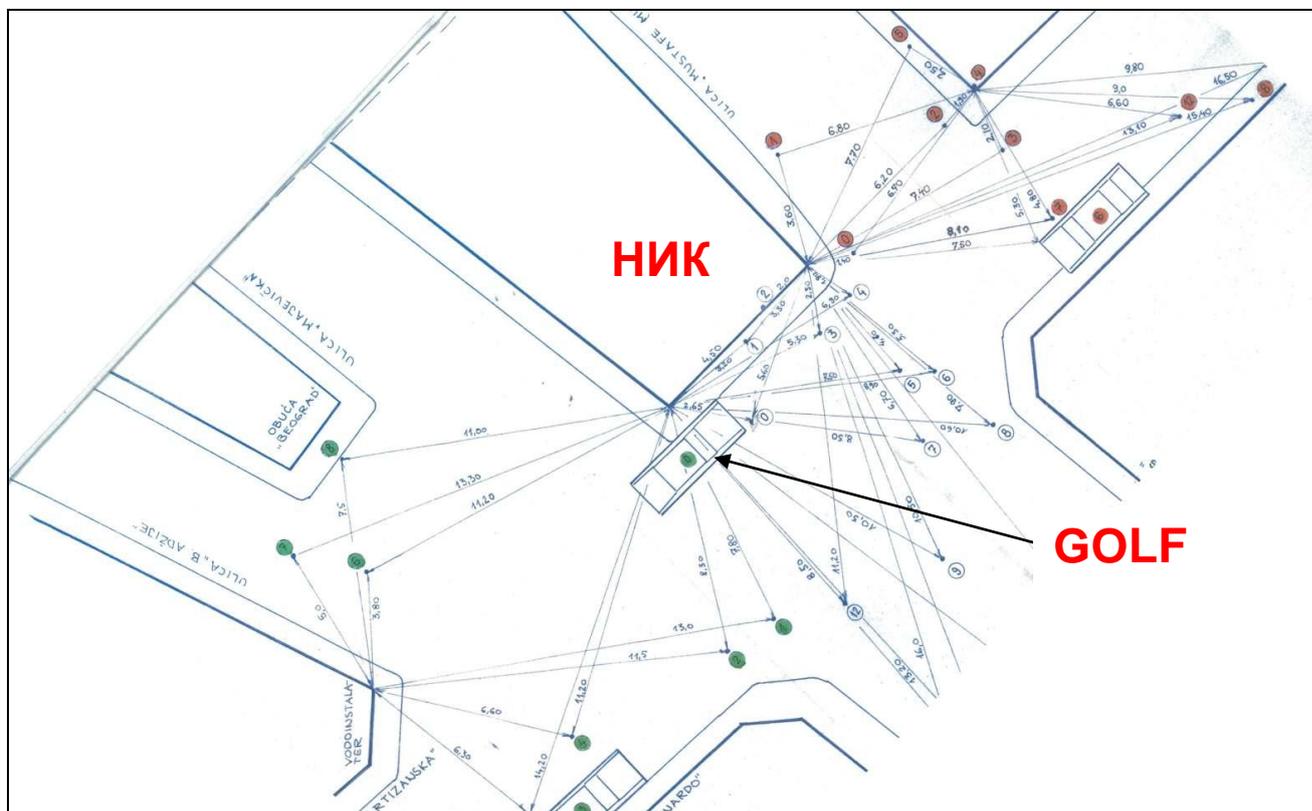
On a sketch here below, extracted from a sketch drawn by the local Police after the attack, the GOLF car is shown with its left side aligned with the curb.

**Position of the GOLF car alongside the sidewalk
according to crime scene investigations**

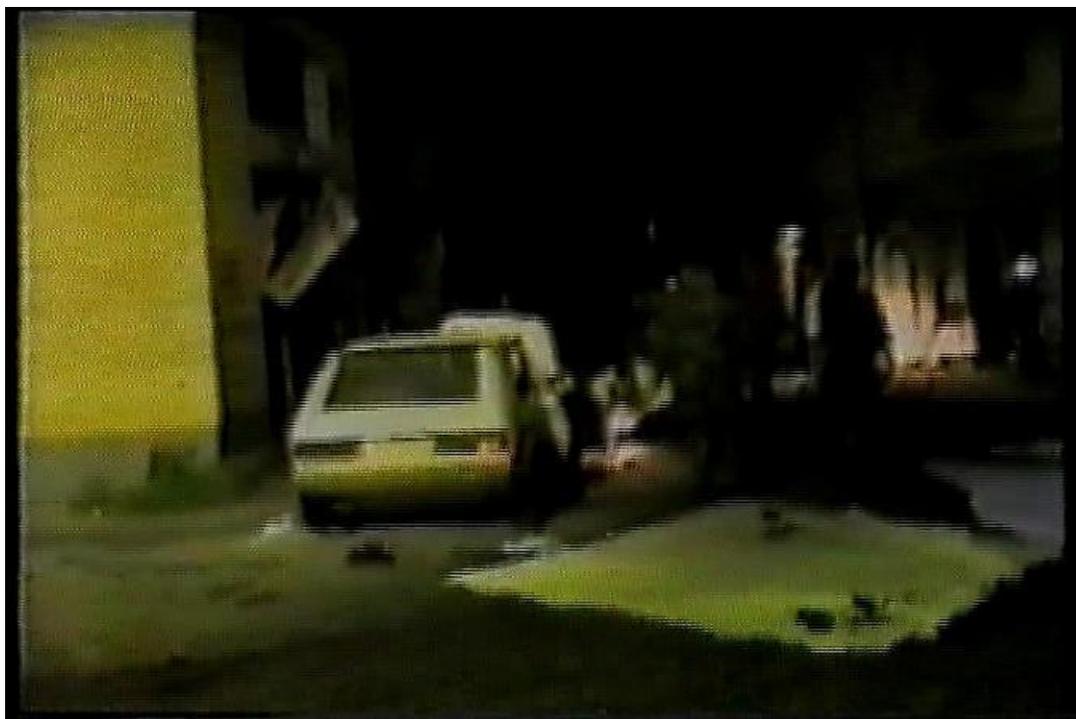
This position of the car alongside of the sidewalk is also confirmed by the extract of a video which was shot in the night of the event (here after) and also by a photo that was taken after the car was pulled back from the crater (trace left by the wheel in the dust, oil dipping in a straight line).

Extract of a video shot before the GOLF car was displaced

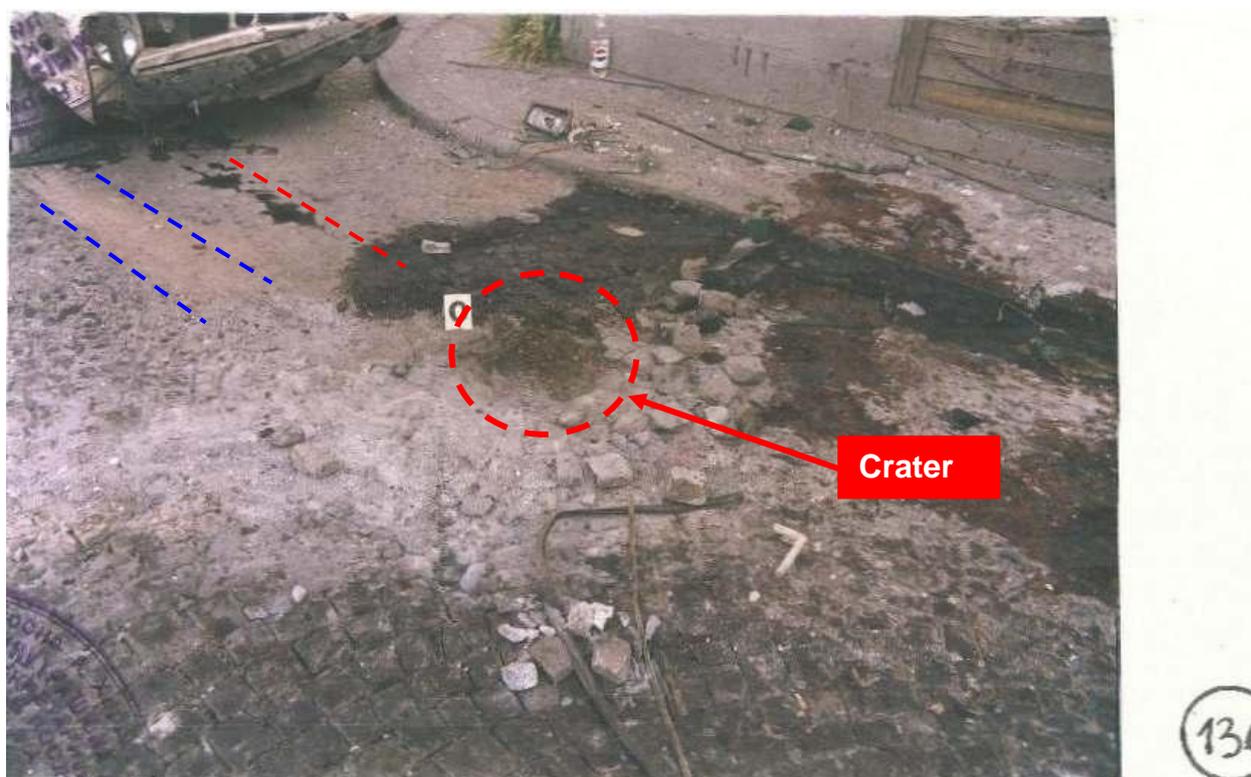
Traces that show that the car was alongside the curb

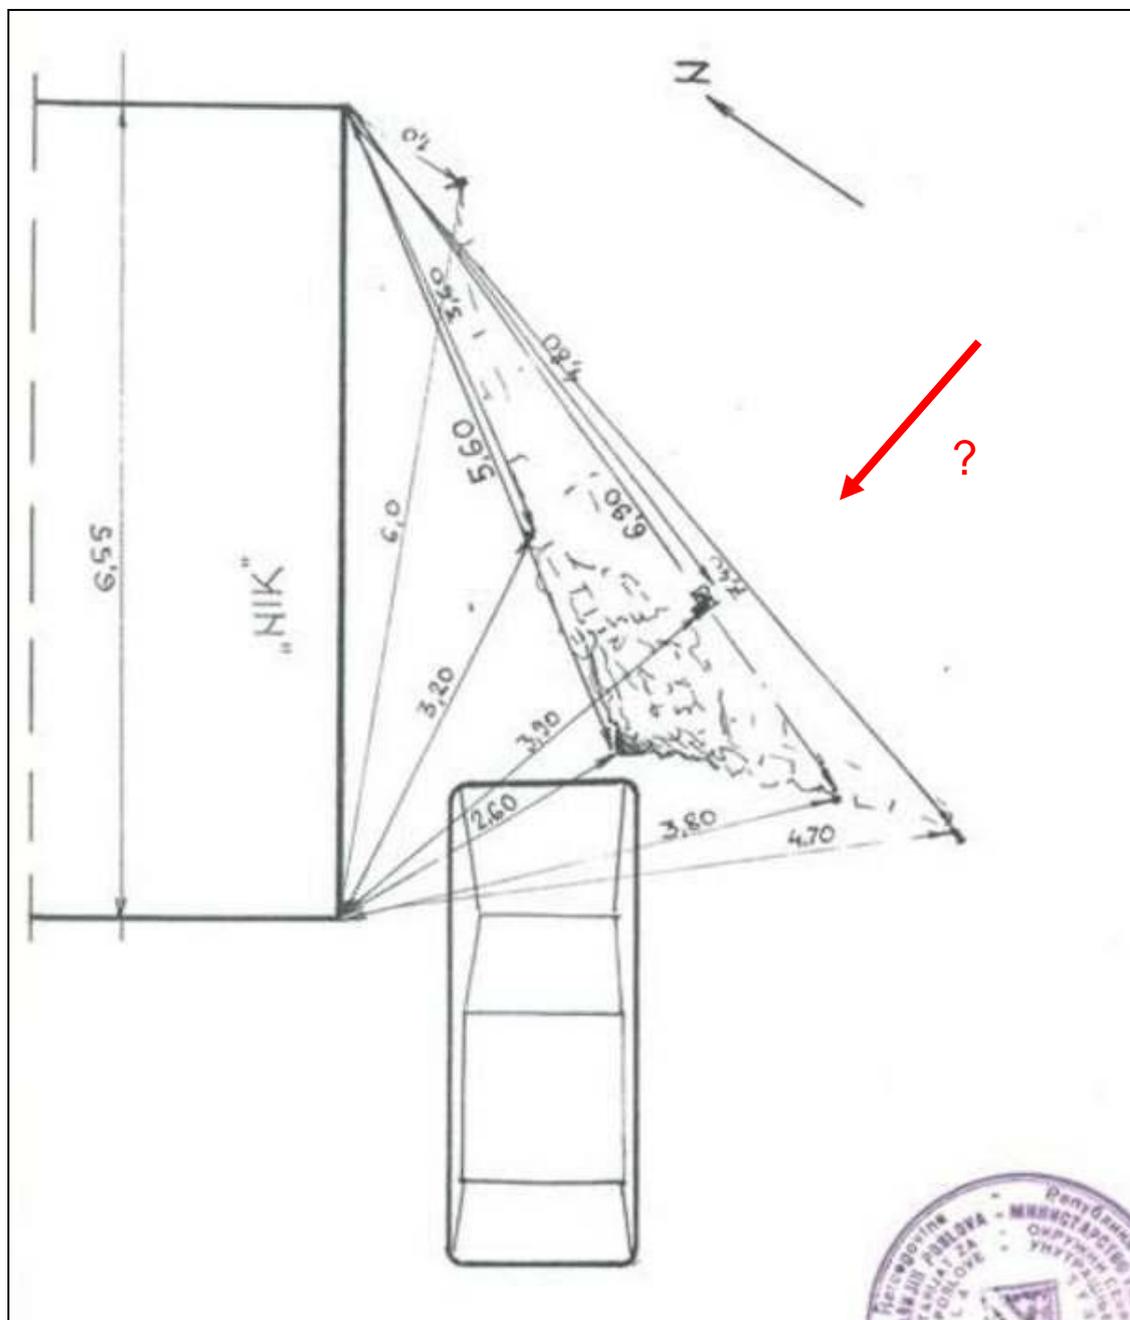
**Based only on sketch by the Police (crim. tech. Irfan Džinović),
we might be led to think a projectile came from the east**

But it would be very unwise to assert such a thing since the photos show a fairly round crater.

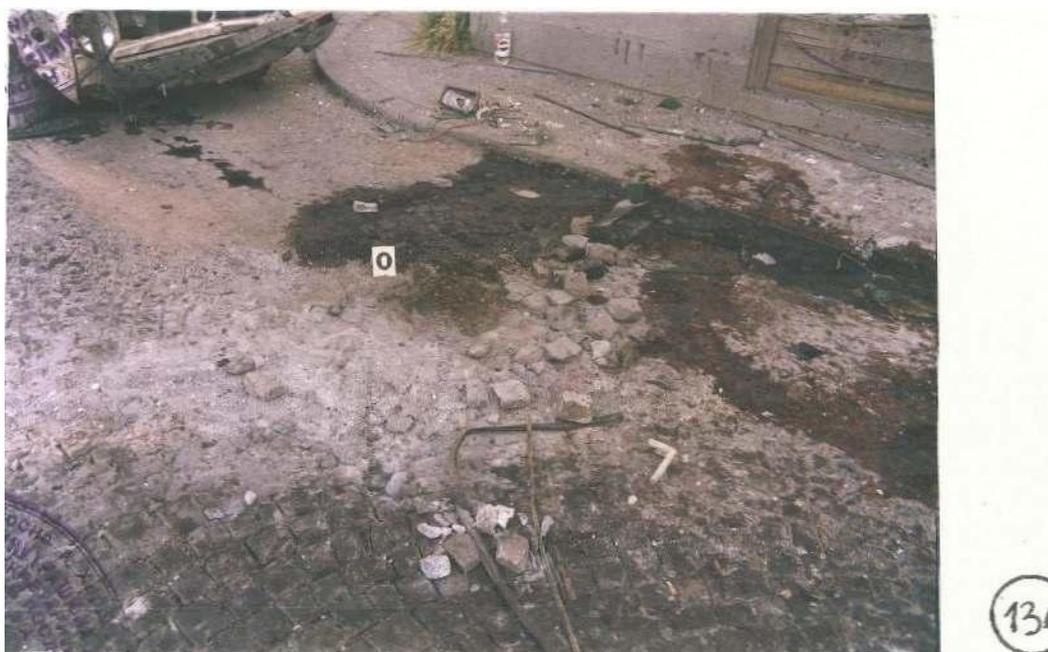
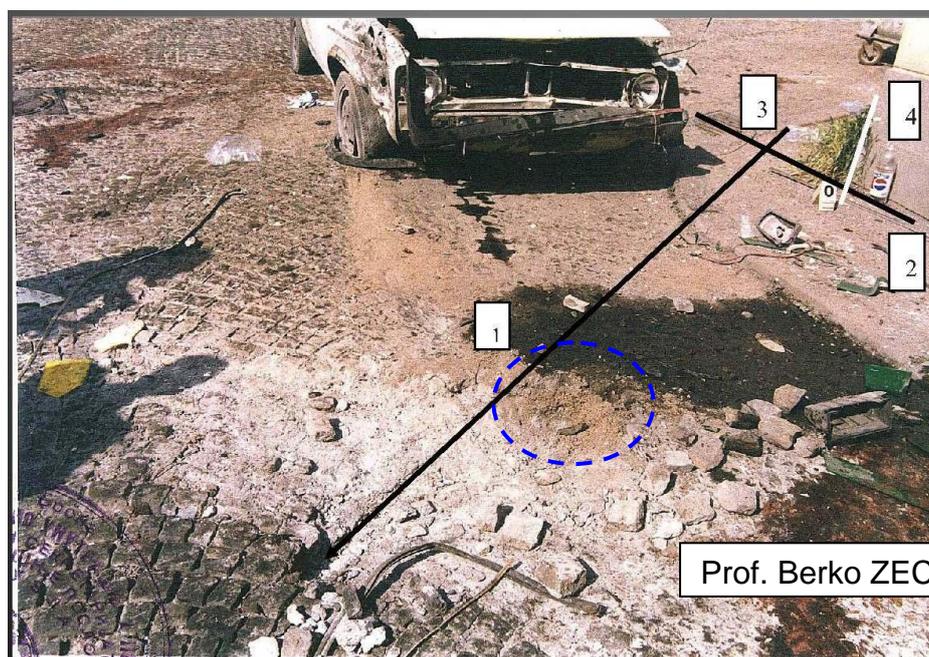
As for the identification of a "furrow" based on photos, comparing the two photos here after, it seems more related to the morning shade on granite block interstices than anything else. It is not aligned with the round crater and it is too far away to have been created by the explosion of a single projectile.

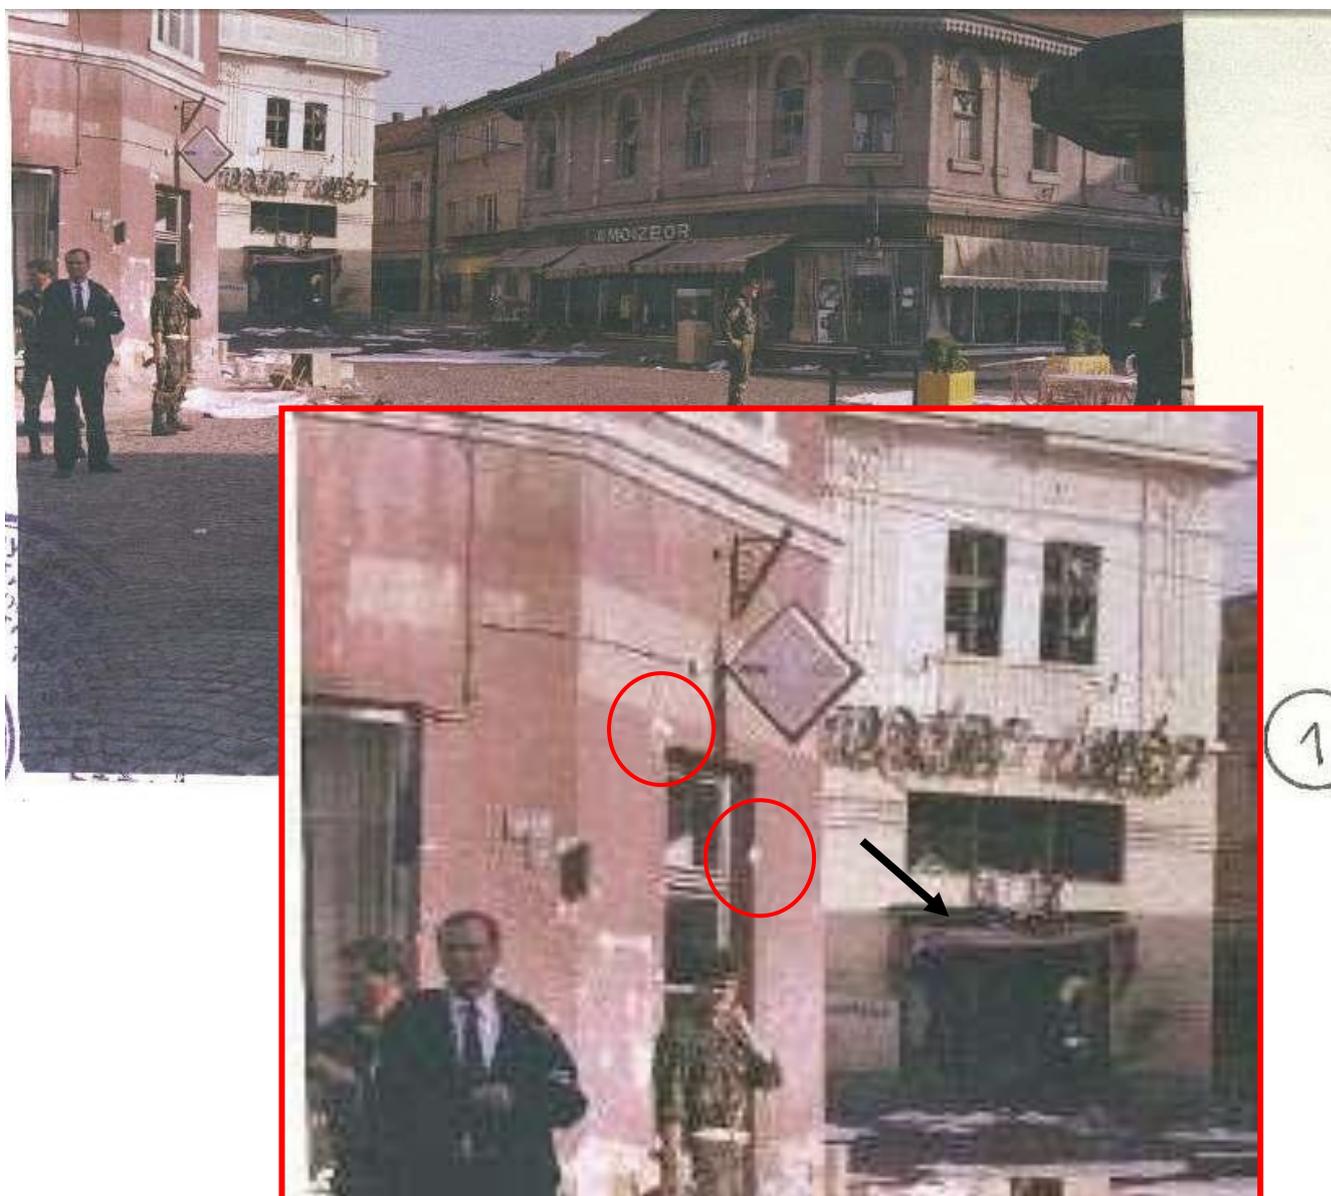
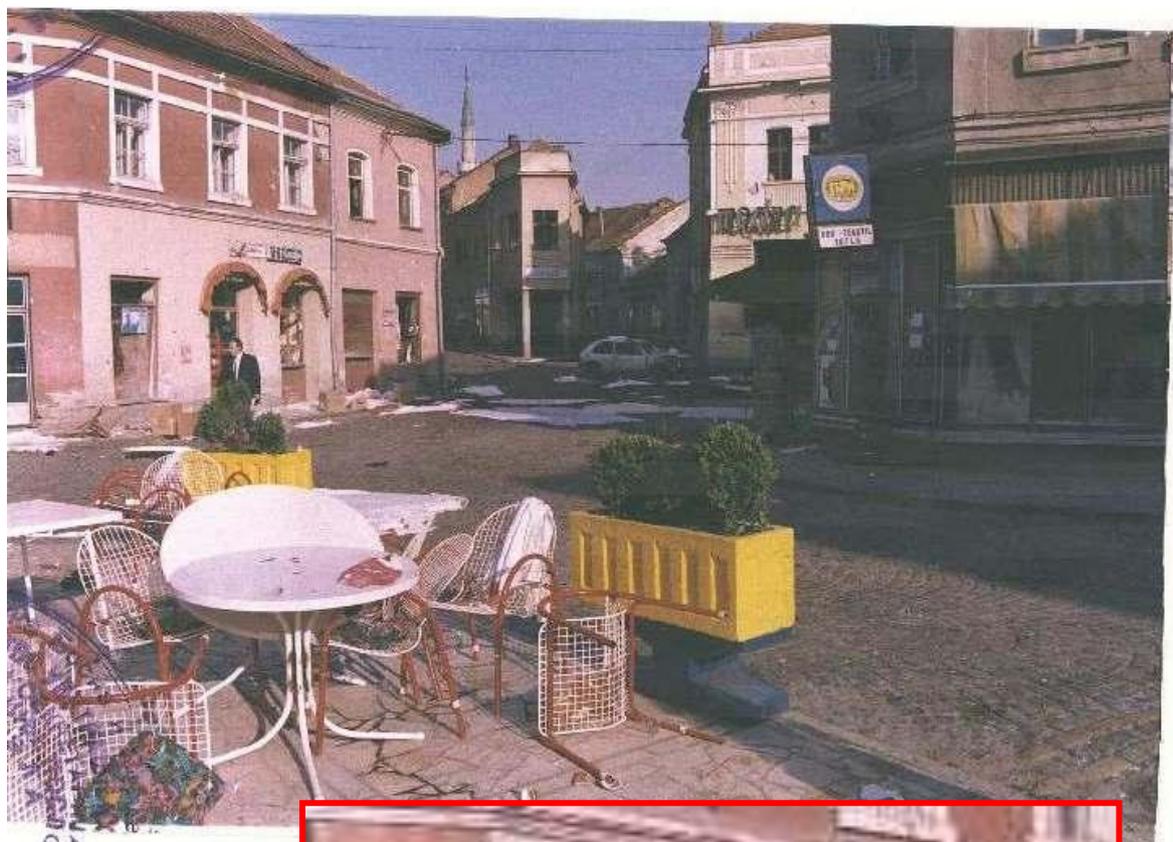
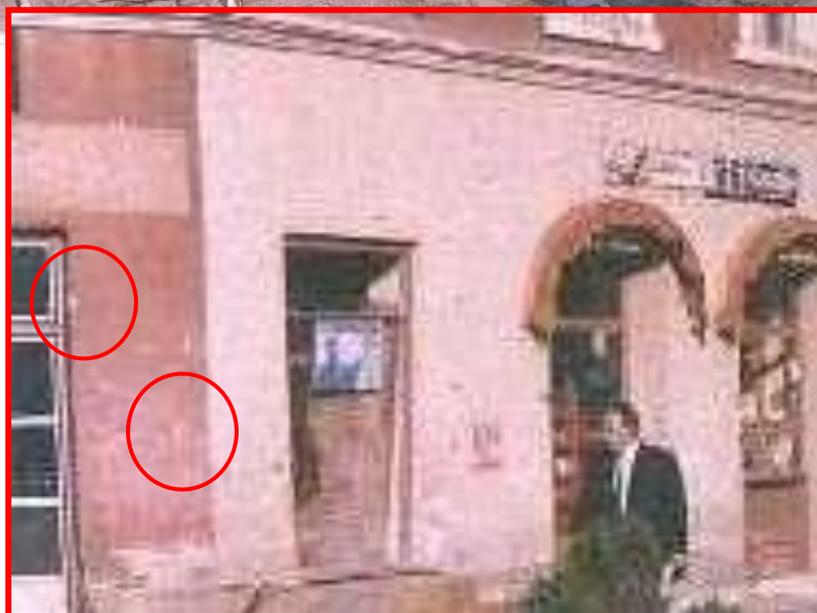
We have interrogation as regard two photos taken the day after the facts. Here after, we show what look like impacts which are seen on a corner. But, fragments coming from the NIK building cannot reach this corner.

The photos are of poor quality, but what is seen is not some kind of photo artefacts since the same details appear on both photos.

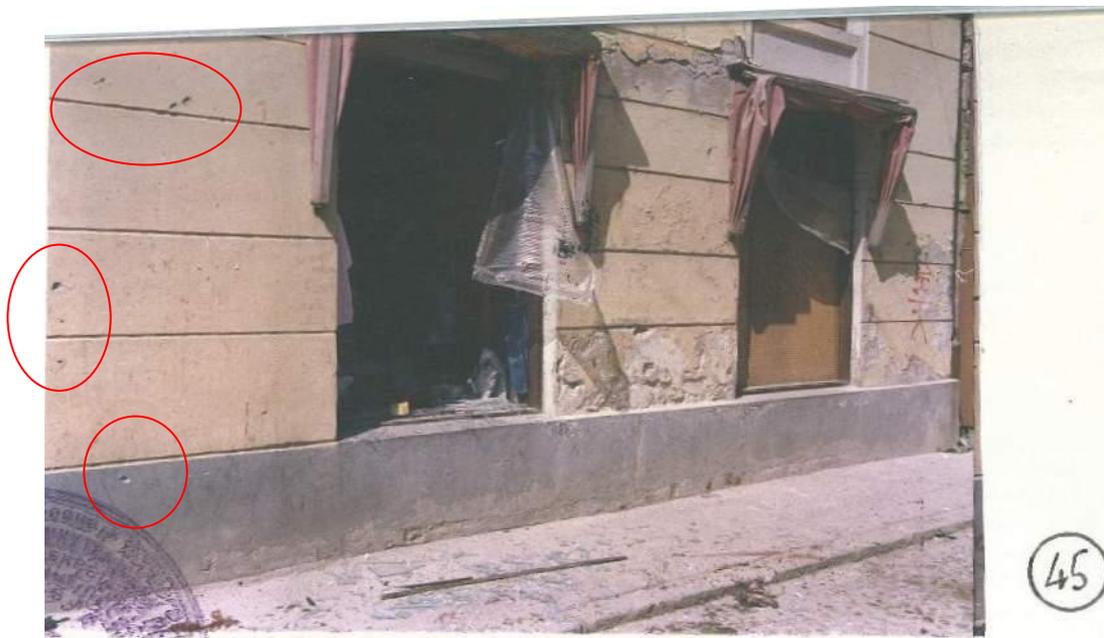
We have the same interrogation regarding the north-east side of the NIK building where there should not be any impact of fragments.

North-east side of actual NIK building after the event

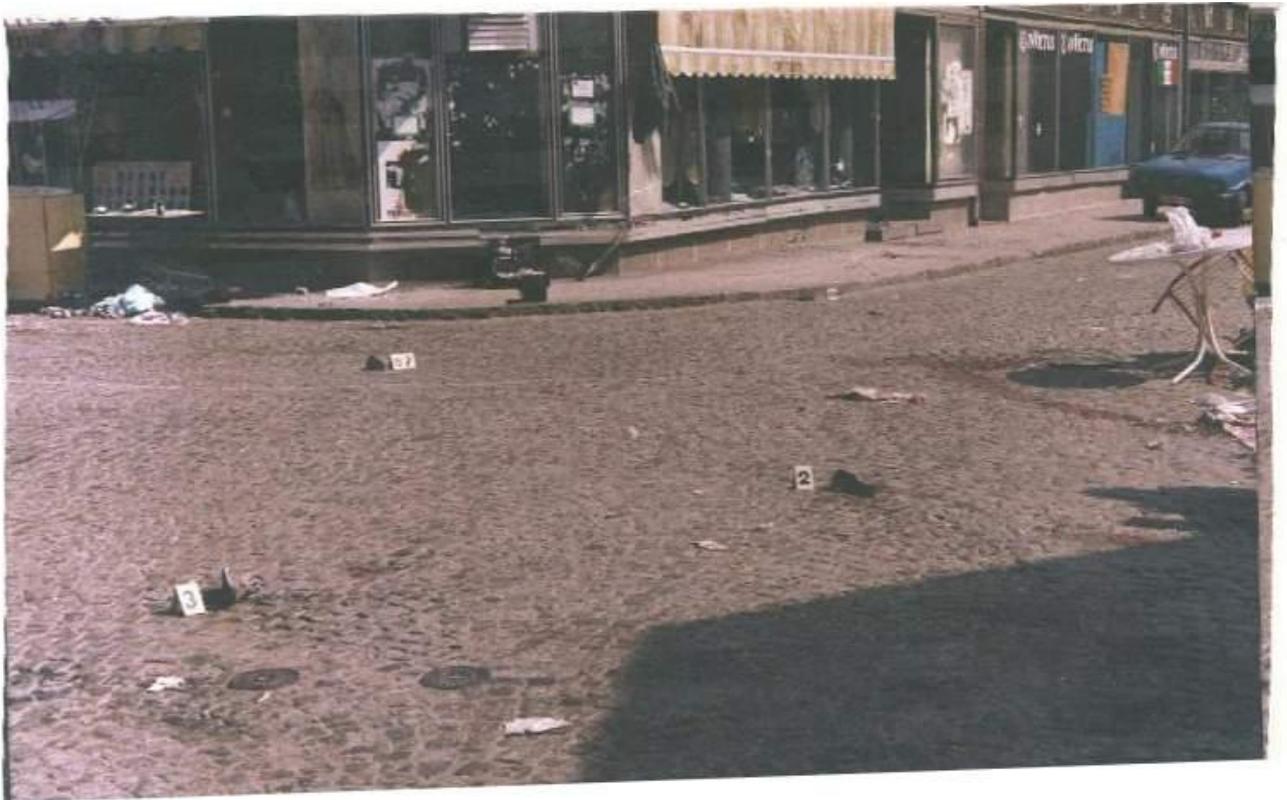
Depending on the internal structure of the building, we have interrogations regarding impacts and glazing damage at the south corner of the building samoizbor. This corner is definitely out of sight from the centre of explosion. "Ricochets" are not a sufficient explanation for a number of impacts still to be seen of the photo here after (photo 20 from the Police album).

Corner Kapija Square / Nicolas Tesla street (photo 20 of Police album)

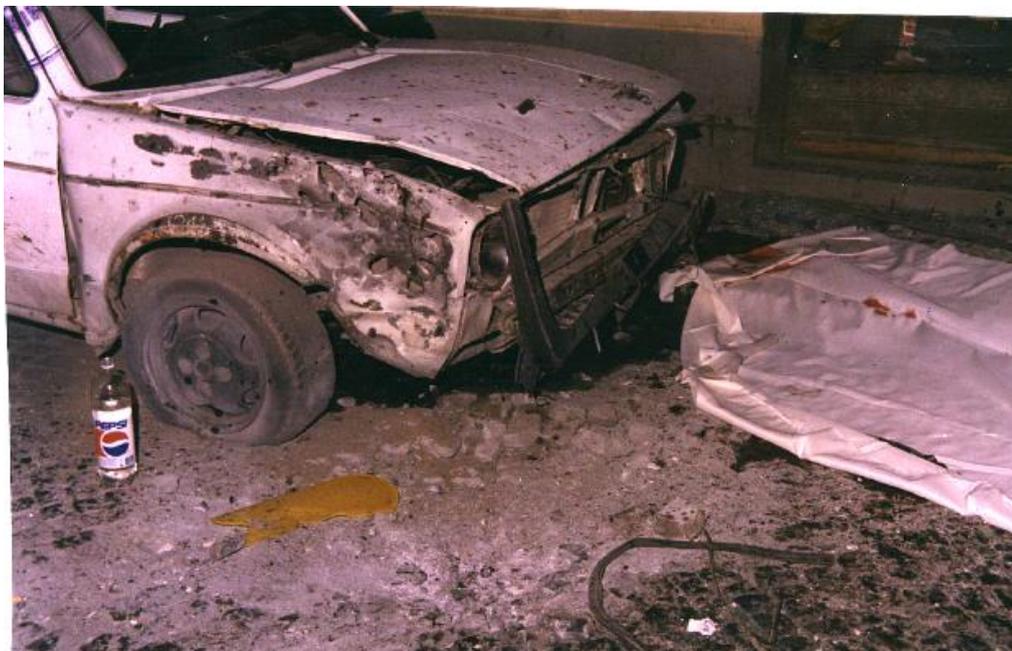
The front and the front right of the test vehicle suffered much more damages than in the event which took place May 25th, 1995.

The car in Kapija Square in 1995 just after the blast...

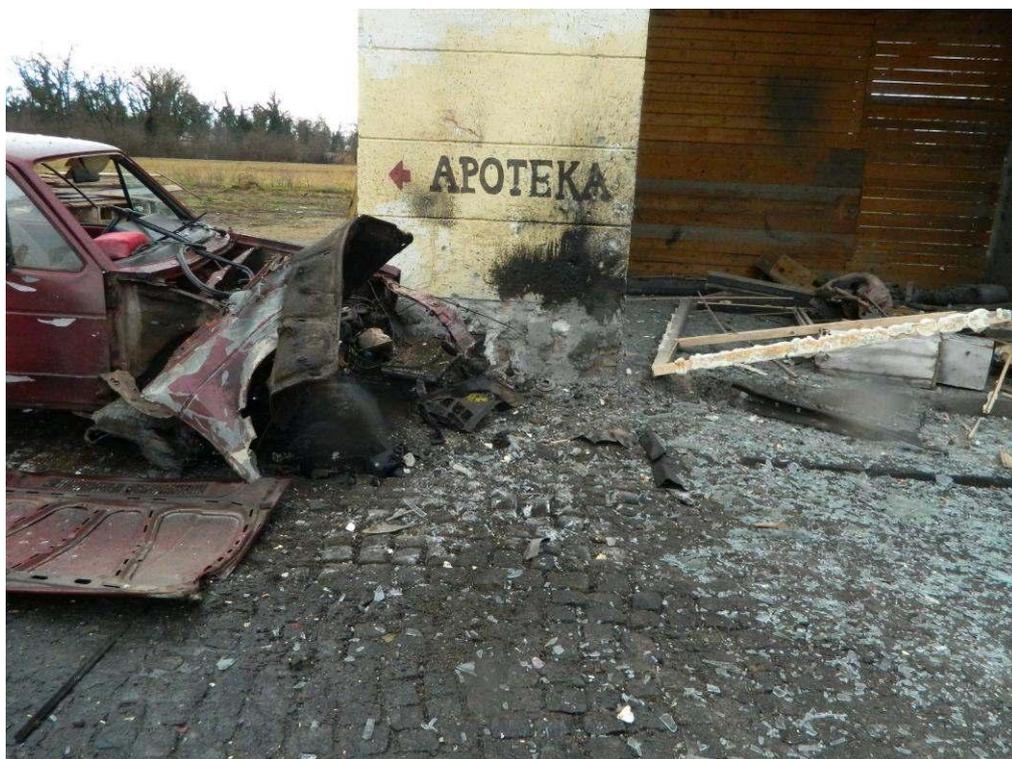
...compared with the GOLF car destroyed by the experiment on Feb. 10th, 2016

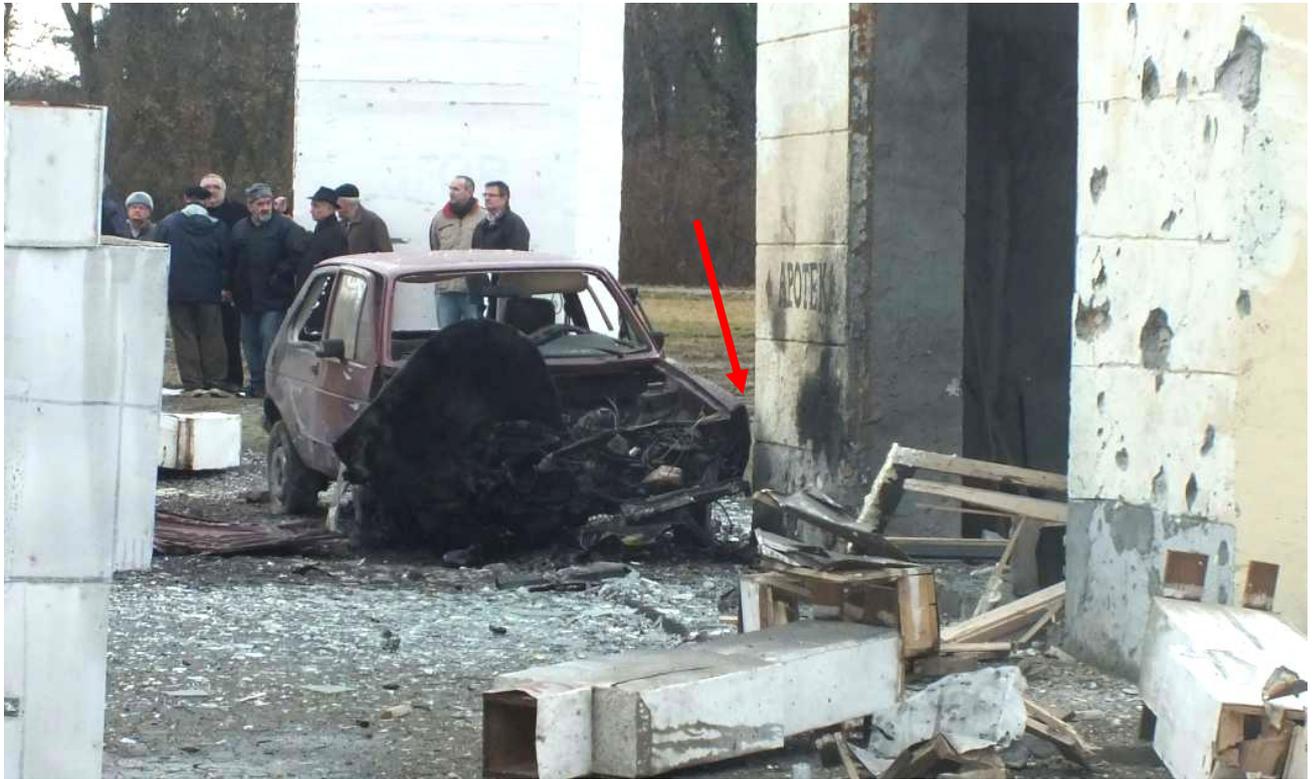
Furthermore, the car in our experiment moved back between 0,9 m and 1,20 m depending on where the measurement is taken. Also, the car in our experiment was pushed aside against the wall of NIK building (side movement of about 0,47 m). On the contrary, there is no sign that the car in Kapija had moved back or toward the wall due to the detonation.

Photo showing that the car was moved sideways by the blast

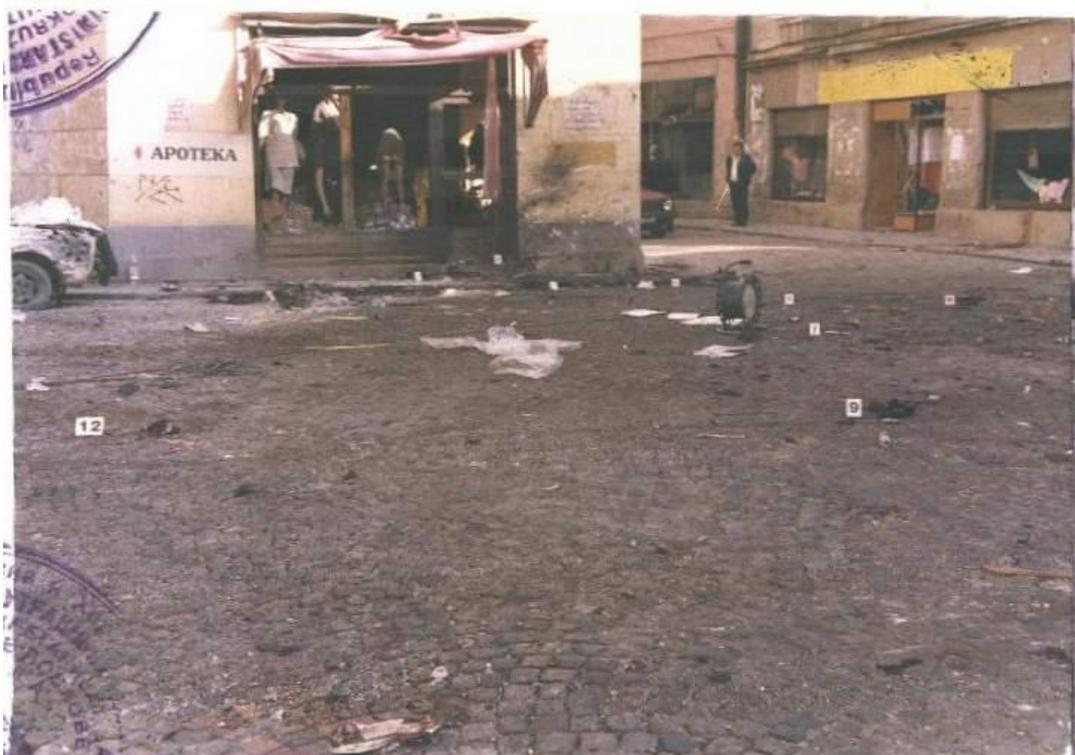
The front NIK store window in Kapija Square had its glazing broken. On the north side of the shop at least one of the two smaller windows had its glazing broken as well. The display dummies in the shop remained in their upright position. Windows frame were not displaced in the event in Kapija Square.

Store window of the actual NIK building after the event, note how the window frame is still in place, and also that the display dummies are still in their upright position

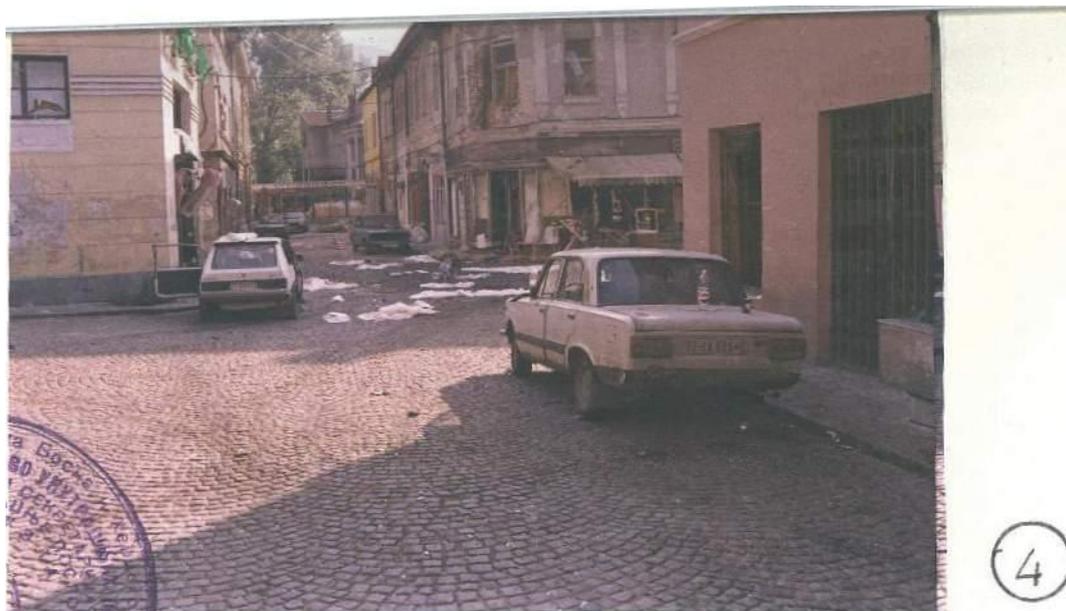
South-West side of the actual NIK building after the event

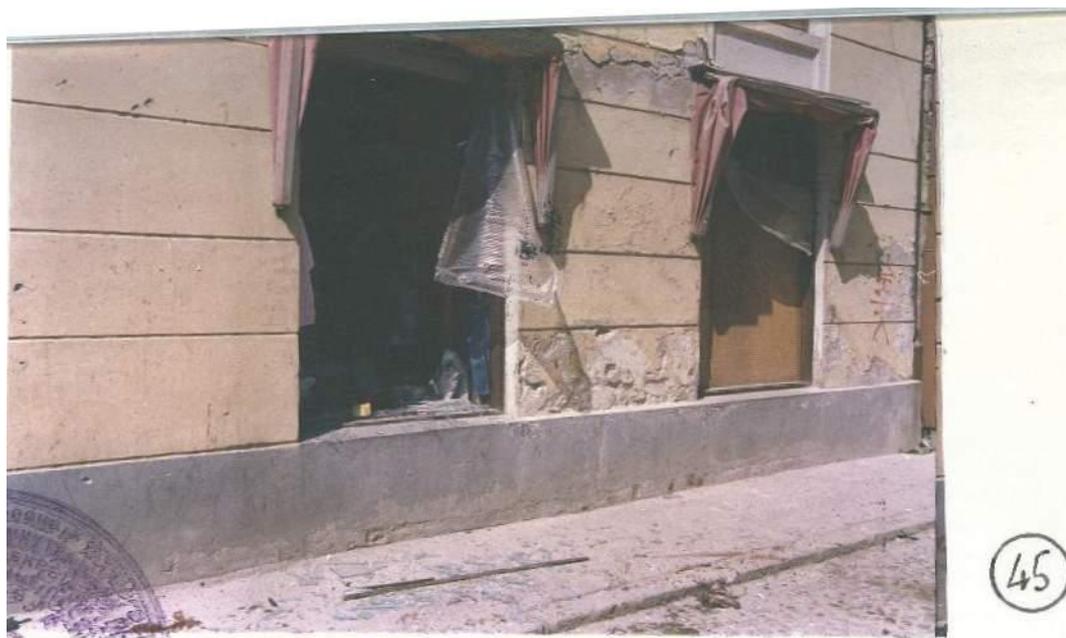
North-East side of actual NIK building after the event

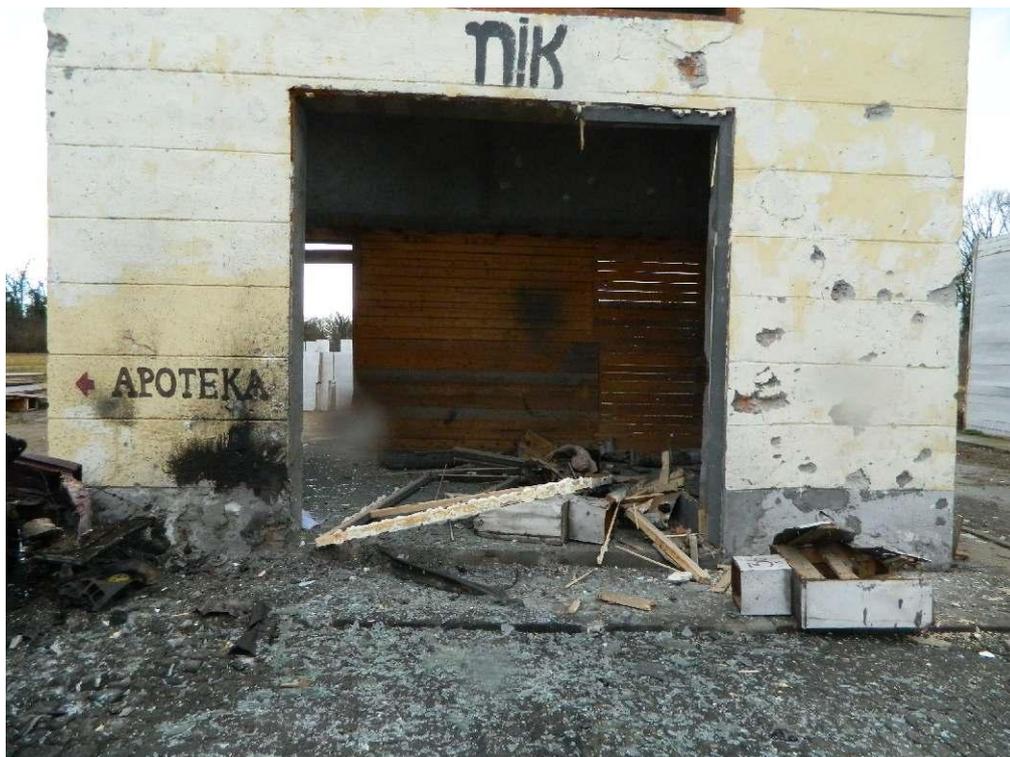
During the test on Feb. 10th, 2016, all glazing is gone but also the wooden frame of the store window. The display dummies have fallen.

We have no information about how strongly was constructed the frame of the windows in Kapija. Only based on visual comparison, the damages seems to have been much more important during the experiment dated Feb. 10th, 2016.

**Store window of NIK building :
results of explosion during experiment at NIKINCI Feb. 10th, 2016**

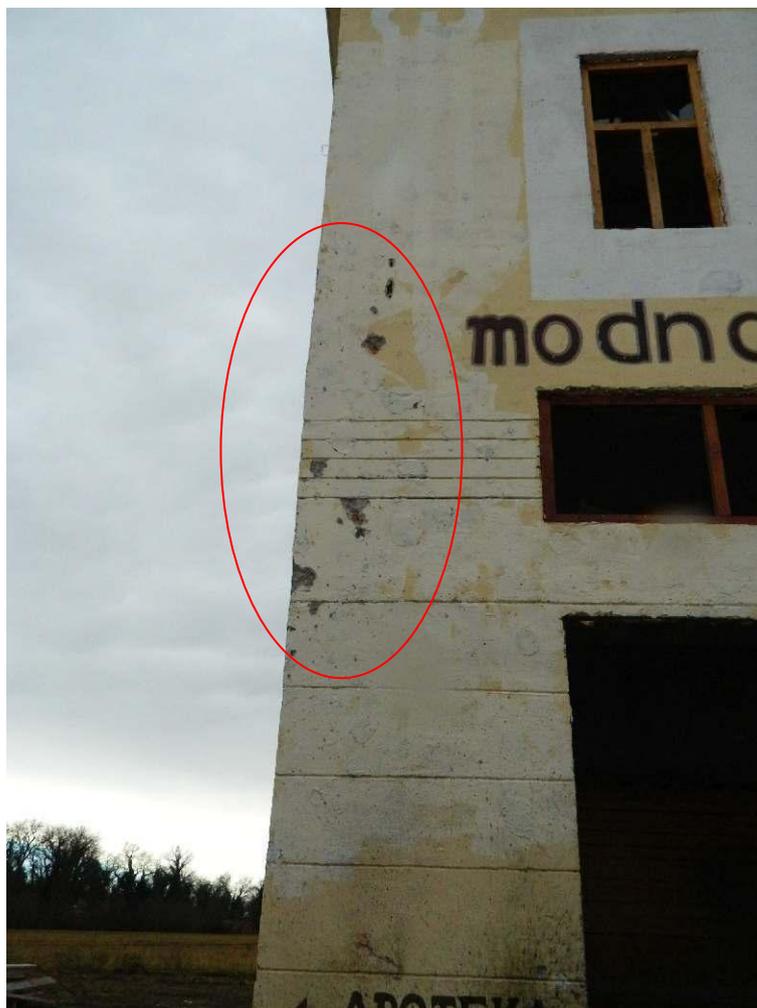
After the experimentation, fairly high up on the mock-up NIK building south corner, there are impacts that come from heavy fragments from the tail of the projectile. Such impacts were not to be seen in the actual case in Kapija.

Experiment dated Feb. 10th, 2016 - spread of tail fragments from the 130 mm projectile
