TECHNICAL ASSESSMENT
EXPLOSION AT TUZLA MAY 25th, 1995

MISSION DATED FEBRUARY 9th, 2016

Pierre LAURENT
Expert commissioned by Appeal Court of Paris, IPC
Arms, Ammunitions, Ballistics, Pyrotechnics
INPG engineer, Msc, DEA, DBA, Marines Troops Captain (R)

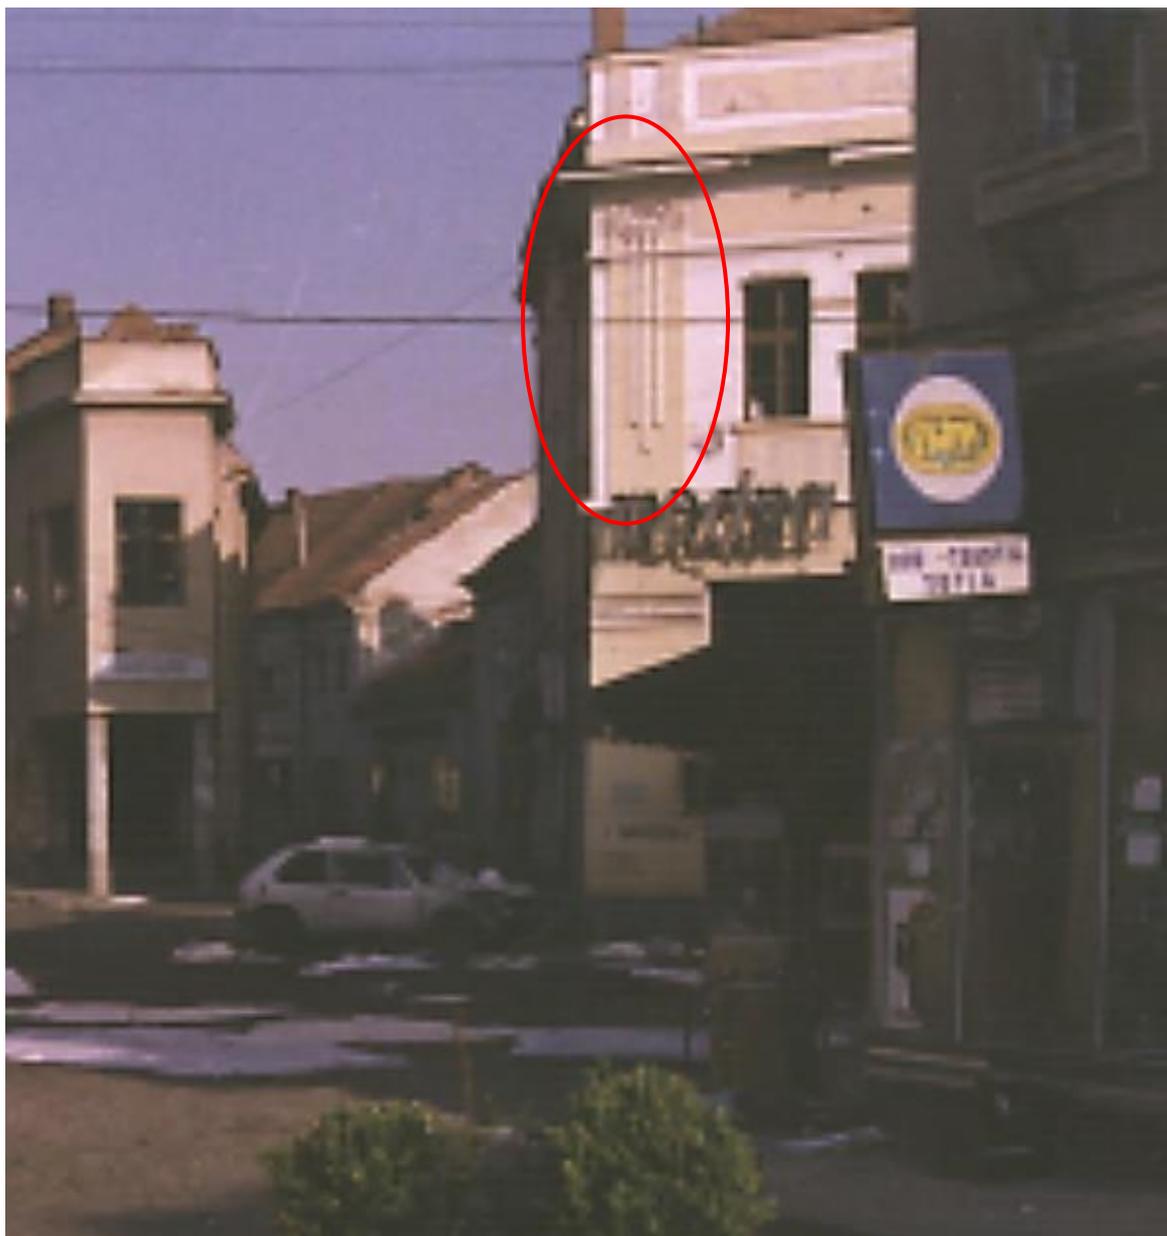
No trace of tail fragment impacts in 1995 on South corner of the actual NIK building

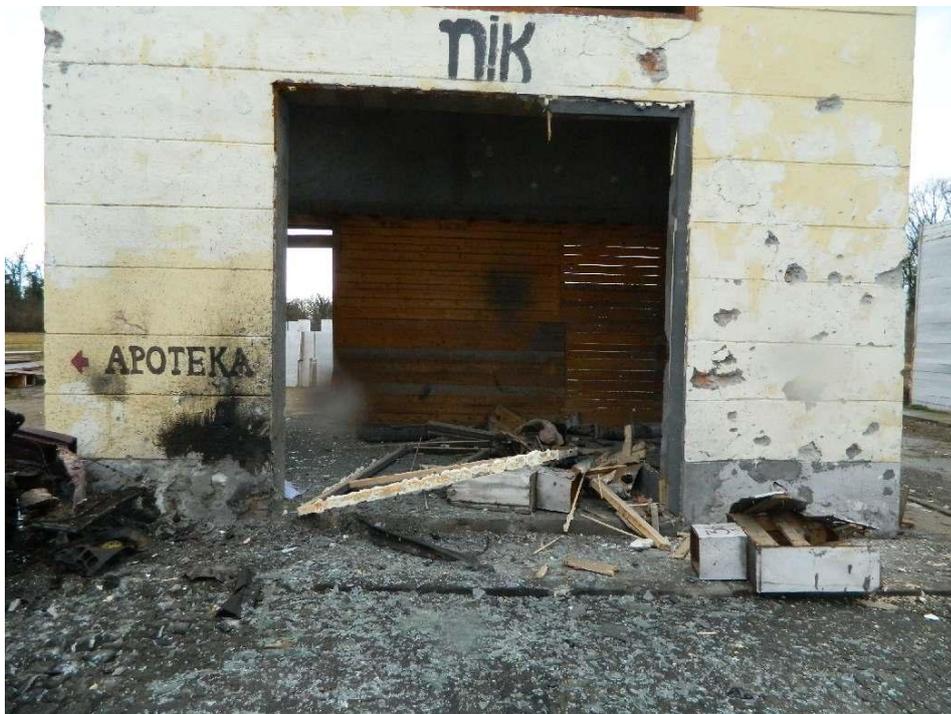
Impacts on the north side of the mock-up NIK building

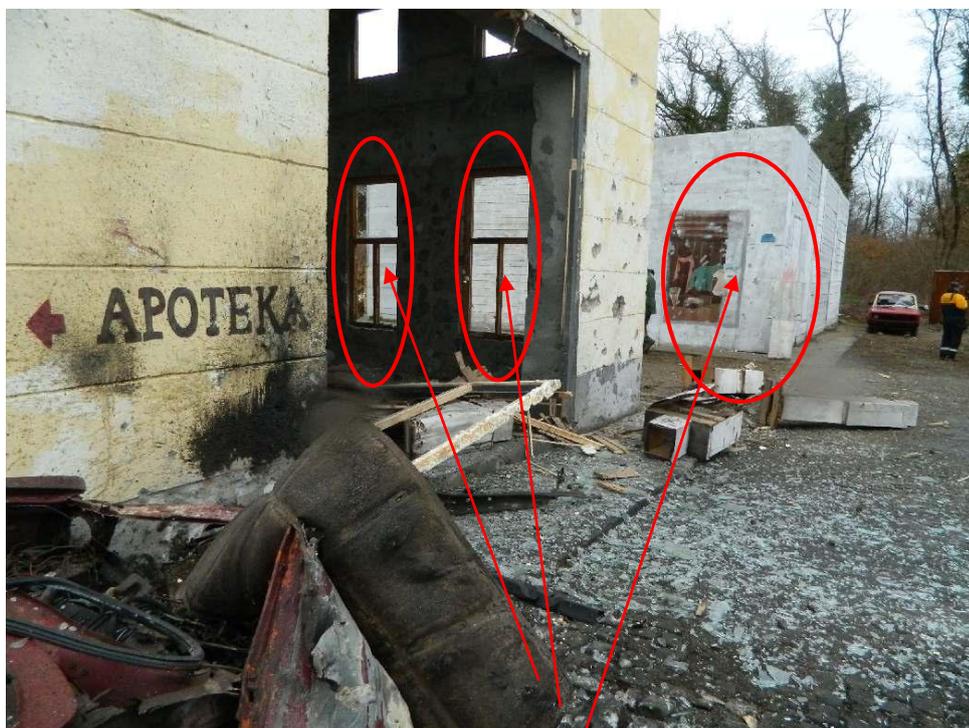
Impacts on the building across the M. Mujbegovica Street.
Some fragments went through the side windows of NIK building.

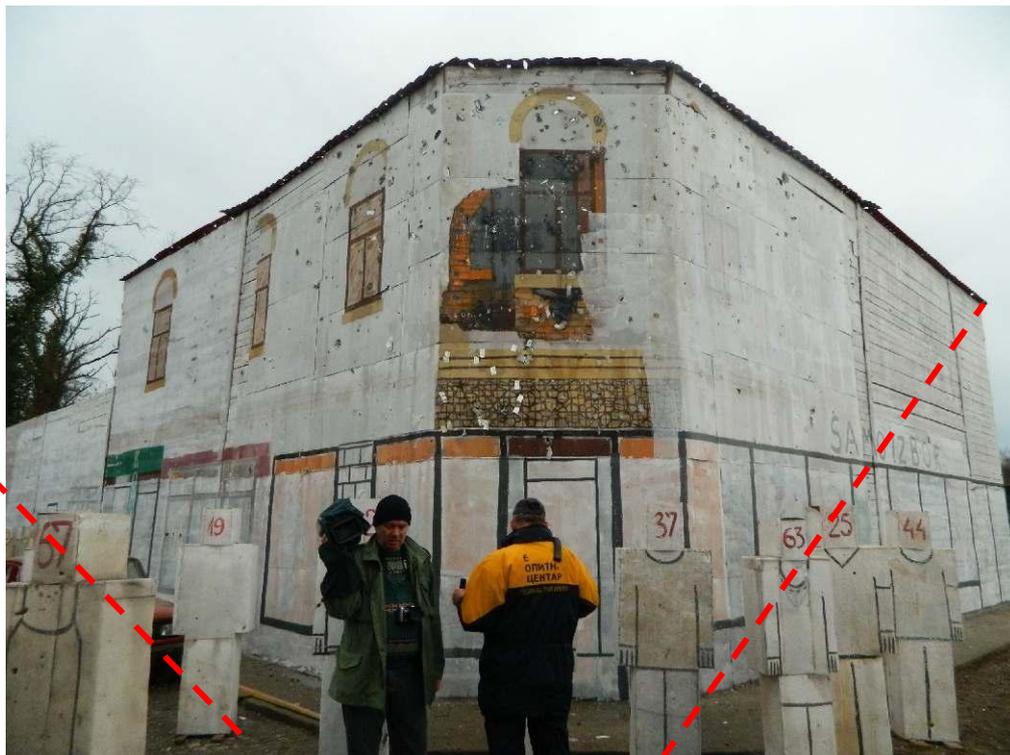
Numerous impacts are identified at the top of the corner of Samoizbor building, but dolls at the corner have been touched as well.

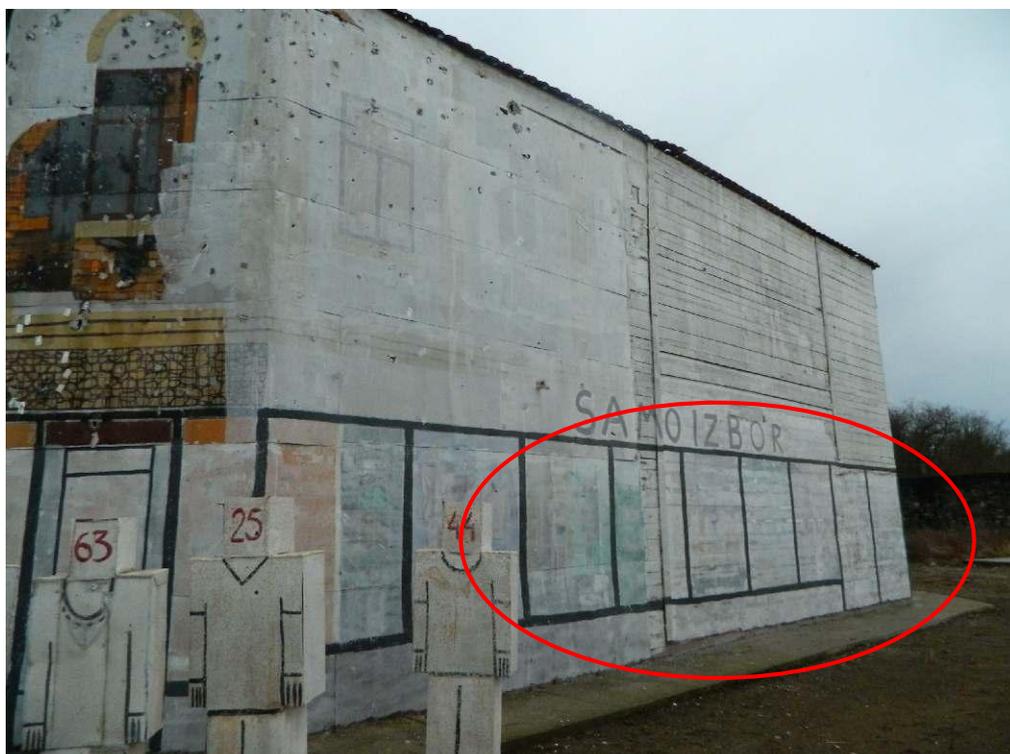
"Safe" zone along Samoizbor building is compatible with the lack of known victims there, but it do not match with the huge damages on and in the Samoizbor building

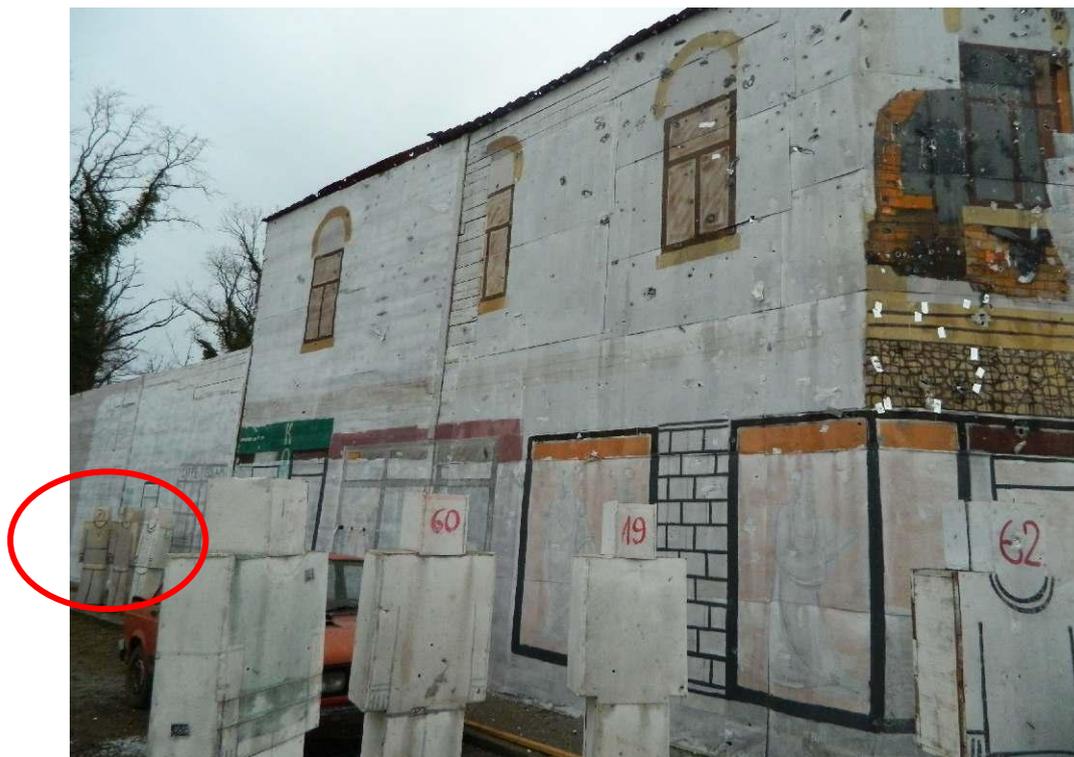
The zone further down north Partizanska street (in red) is supposed to be safe but 4 people suffered fatal injuries there

In our experiment, only one doll was touched

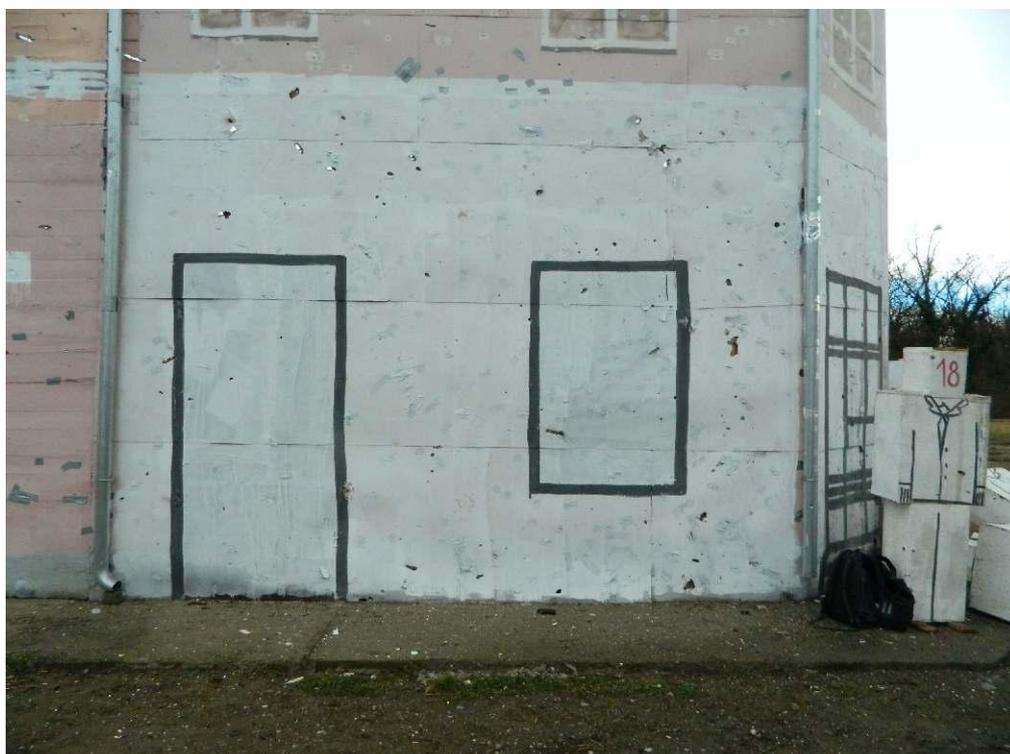
The north corner of Leonardo building is littered with impacts. The dolls are touched in the experiment, which is in line with what happened in Kapija square.

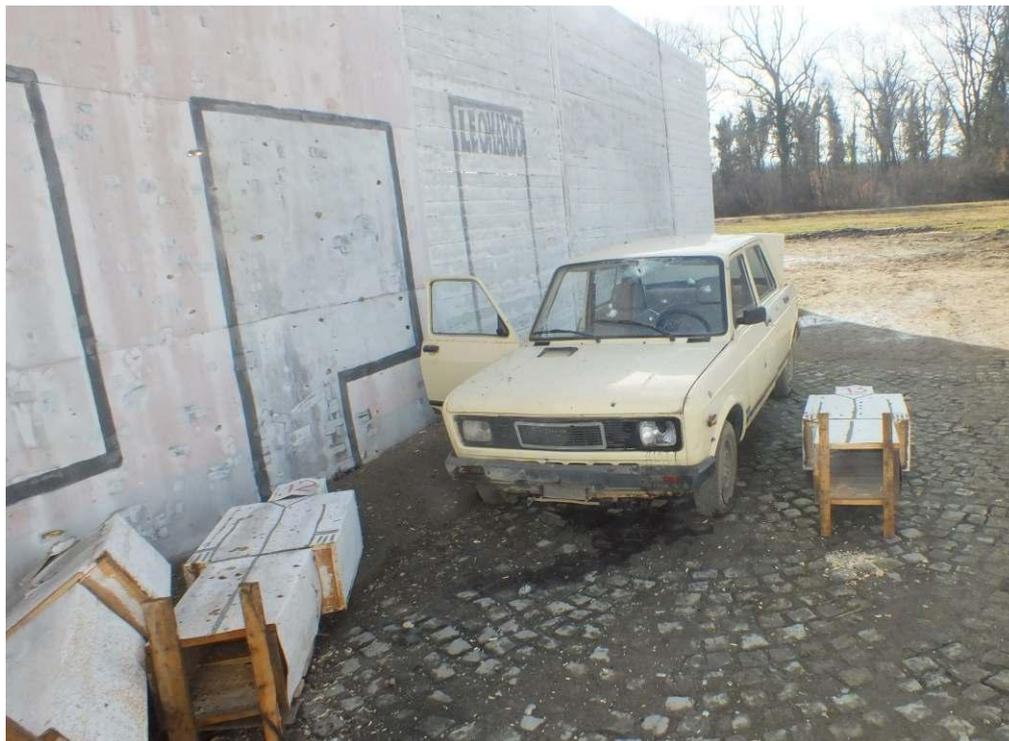
This car positioned in front of Leonardo café was hit by a number of fragments, which is compatible with the impacts on the dolls. In the real case at TUZLA, the victims were hit in the same manner but not the car. The car might not have been there at all at the moment of the explosion

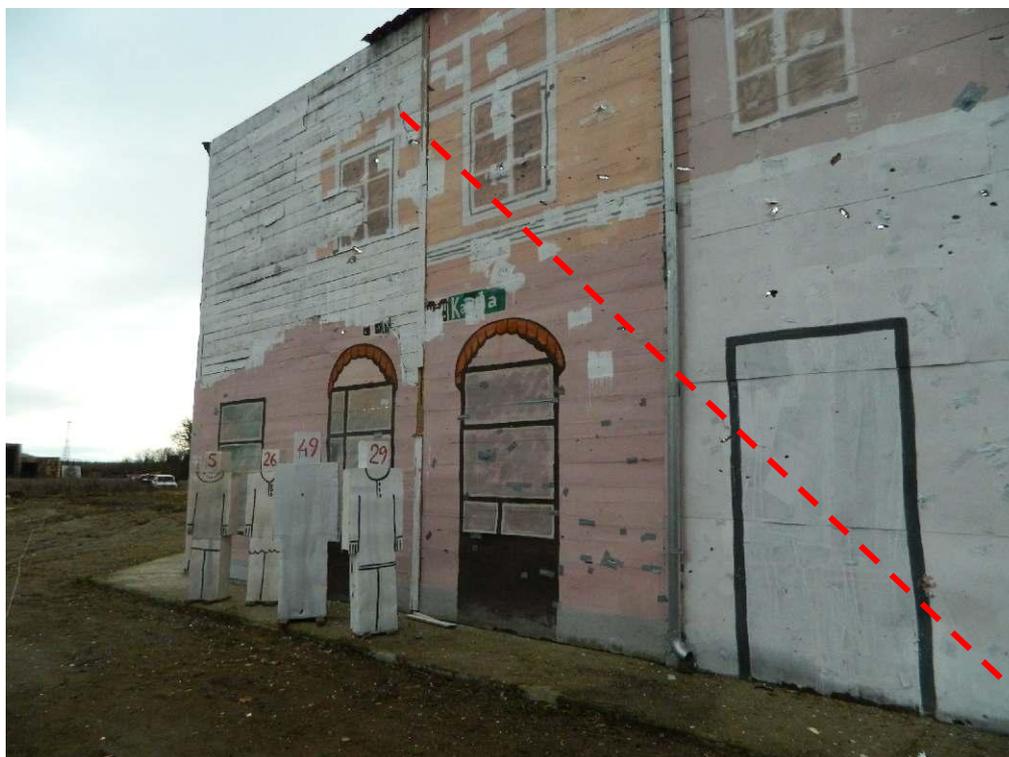
The zone further down the square from Leonardo building north corner is safer with only one doll touched. At TUZLA, 4 people died.

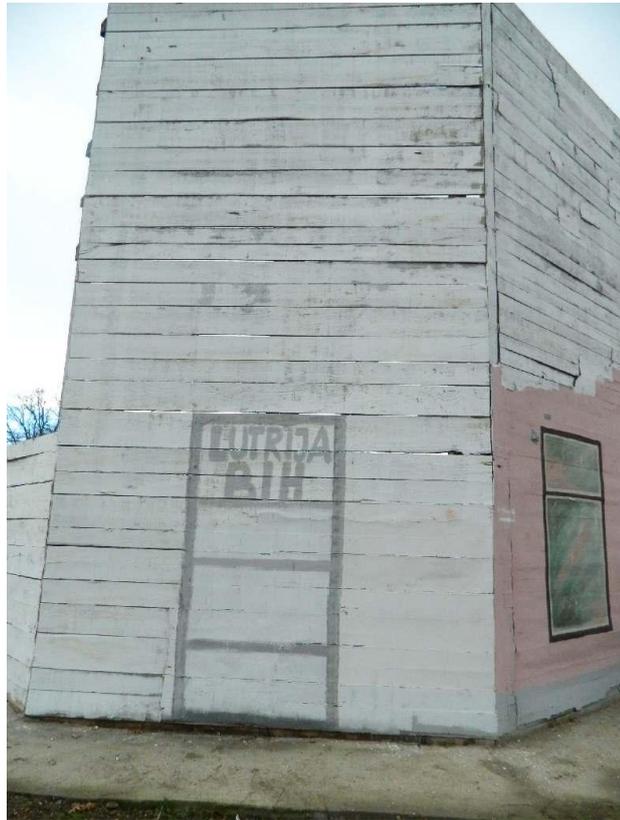
East corner of Leonardo café building (Lutrija BIH) was untouched in the experiment, which is normal since this side is not in line of sight from the explosion crater

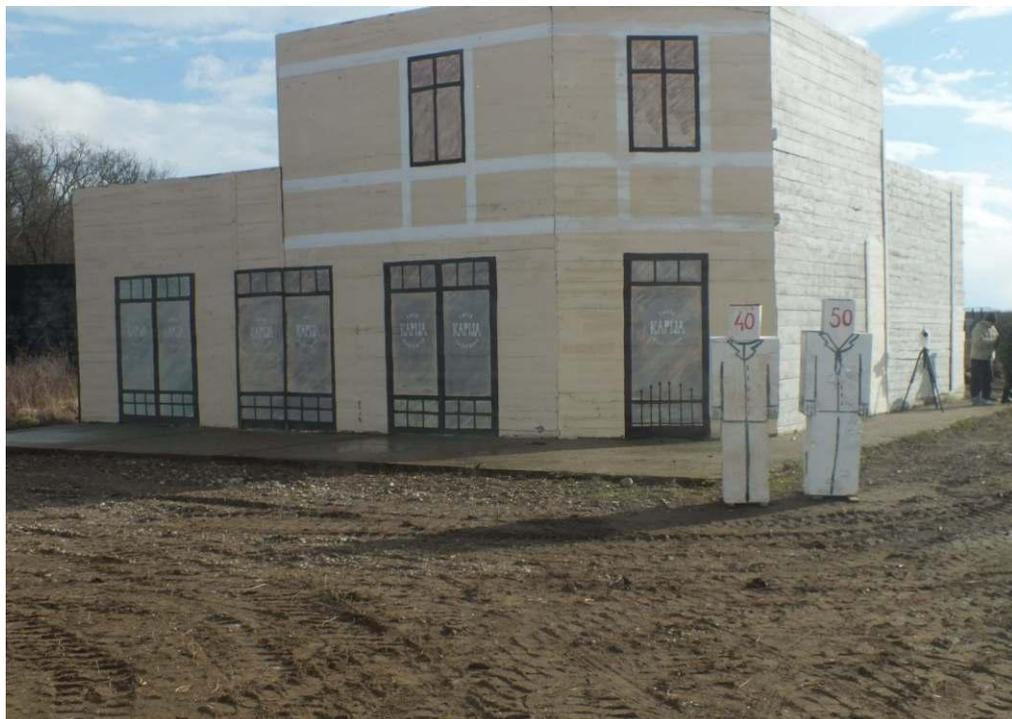
Across the square (36 m from burst point, café Kapija was virtually untouched by fragments during the experiment,

In the real case, about 40 victims were injured, half of them in the lower legs and feet, 3 victims at least died, numerous fragments touched the glazing, the tables...

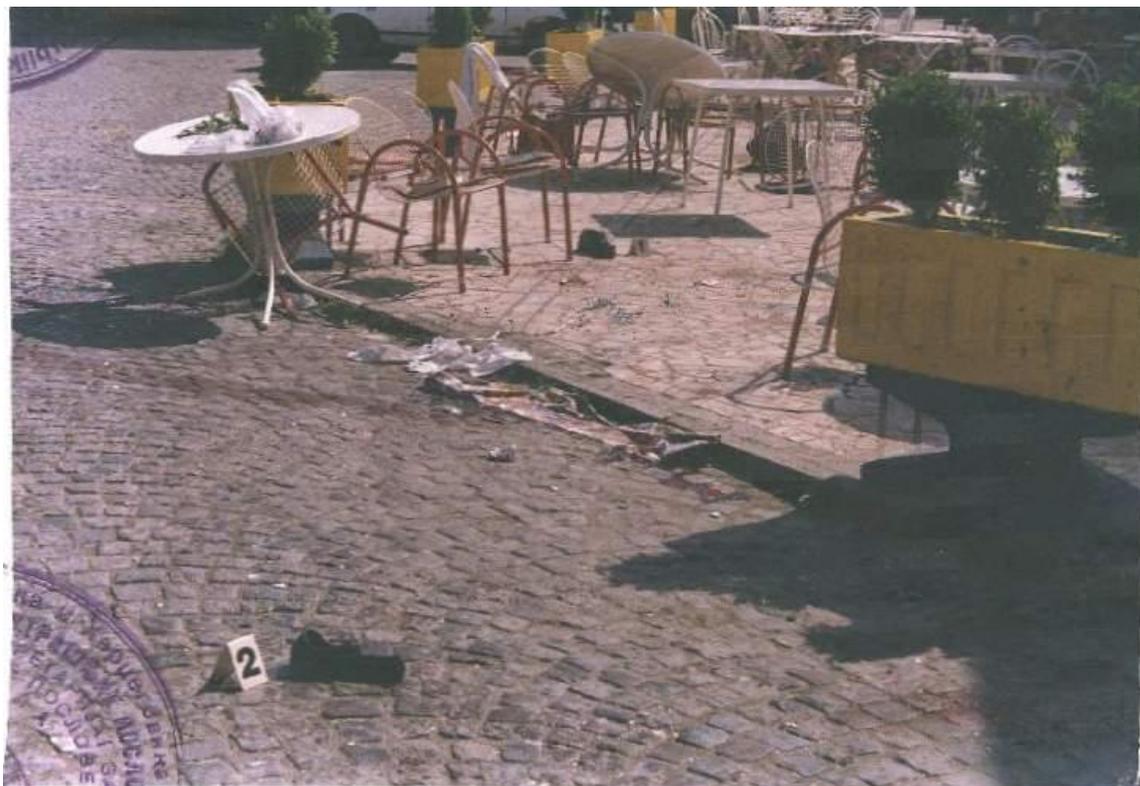
Impacts were found on the flower pots, tables, Kapija café building.

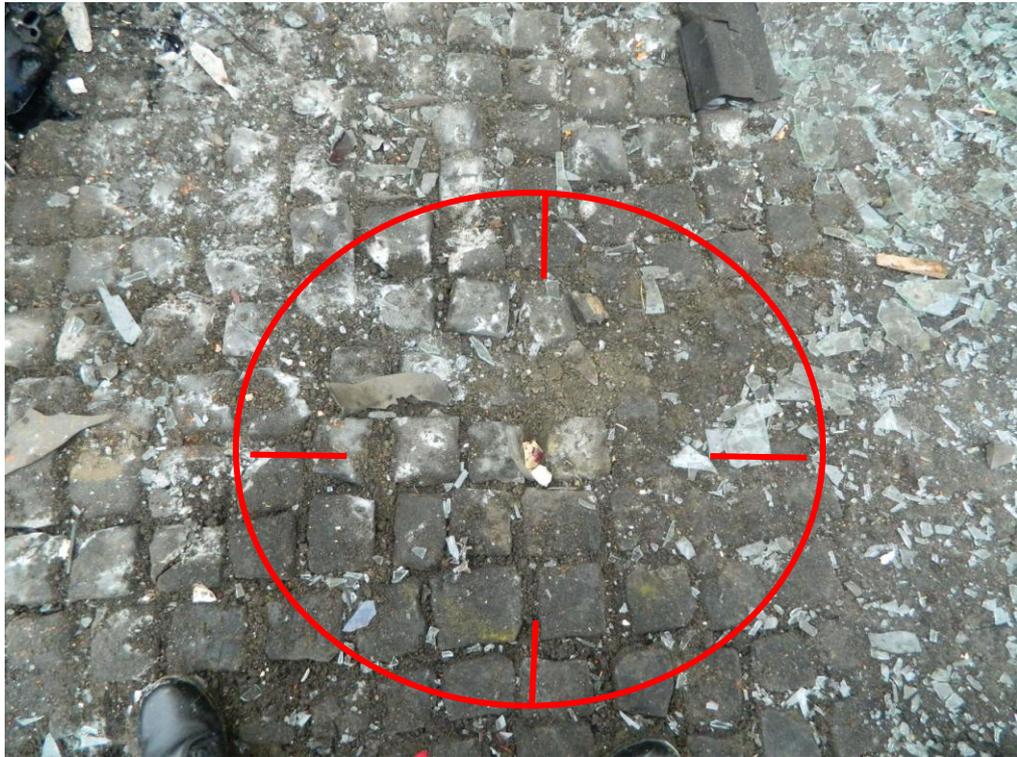
During the experiment, no real crater was formed

When an impact fuze 130 mm projectile lands on hard stone or concrete, there is virtually no crater as such due to the explosion, just traces and a small indent due to the fuze impact.

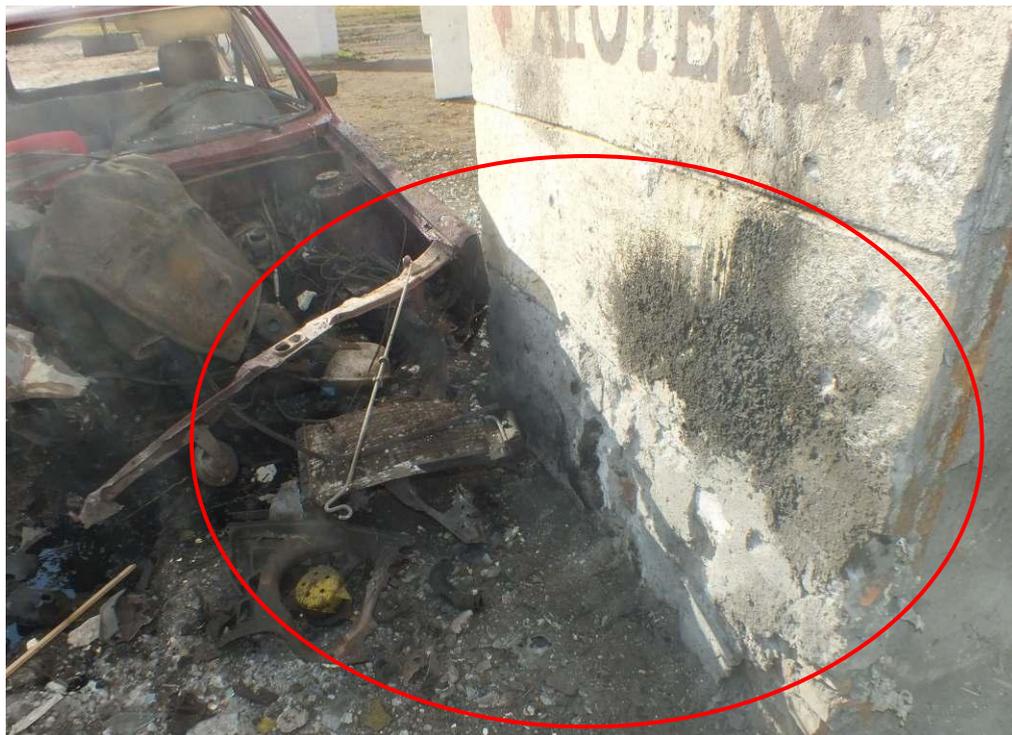
Similarly, granite cubes are very hard and we did not expect much of a crater. At least, we were not able to create one under the condition of the test. Nevertheless, the softer material between the cubes was partly ejected by the blast. This material can be found at the bottom of the NIK building as shown on the image here after.

Accumulation of dirt on NIK building coming essentially for the material that was between the granite cubes
