1. REPORT DATE April 2016			2. REPORT TYPE Technical report		3. DATES COVERED	
4. TITLE AND SUBTITLE Review of <u>Dr. Zecevic</u> expert opinion report conclusions regarding the causes and results of the explosion occurred at Kapiia square in the city of Tuzla on 25/05/1995					5a. CONTRACT NUMBER	
					5b. GRANT NUMBER	
					5c. PROGRAM ELEMENT NUMBER

6. AUTHOR(S) Sharon Joseph					5e. TASK NUMBER	
					5f. WORK UNIT NUMBER	
					8. PERFORMING ORGANIZATION REPORT NUMBER 32-16	
7. PERFORMING ORGANIZATION NAME(S) AND ADDRESS(ES) <u>Temech-Consultants</u> Tel-el 2516700 Israel					8. PERFORMING ORGANIZATION REPORT NUMBER 32-16

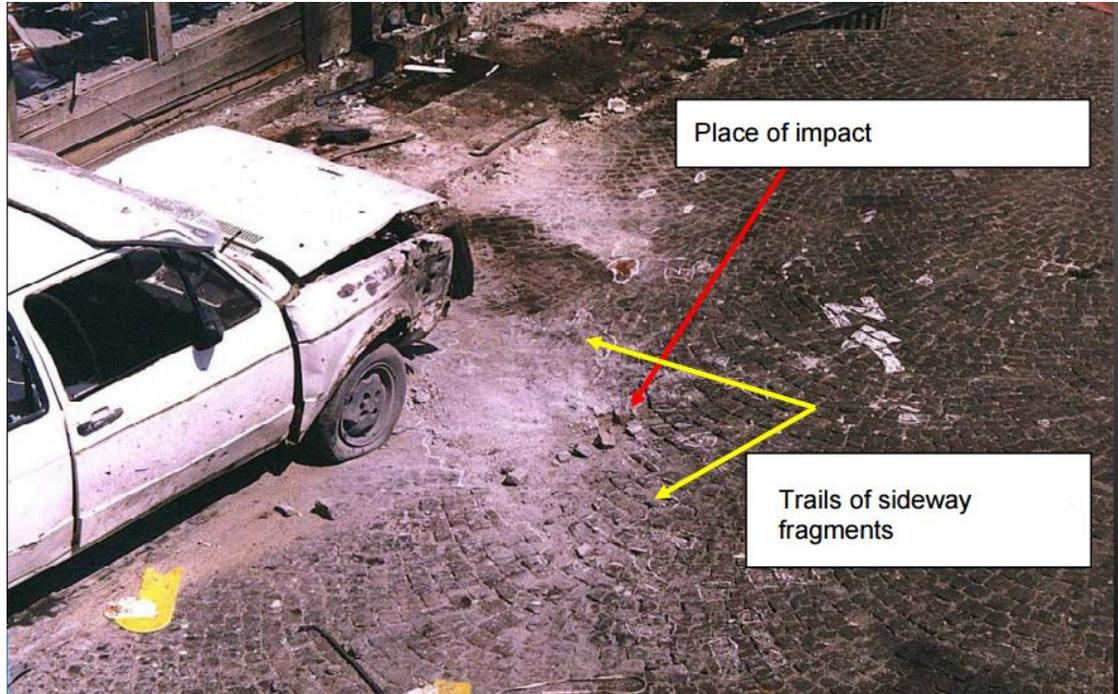
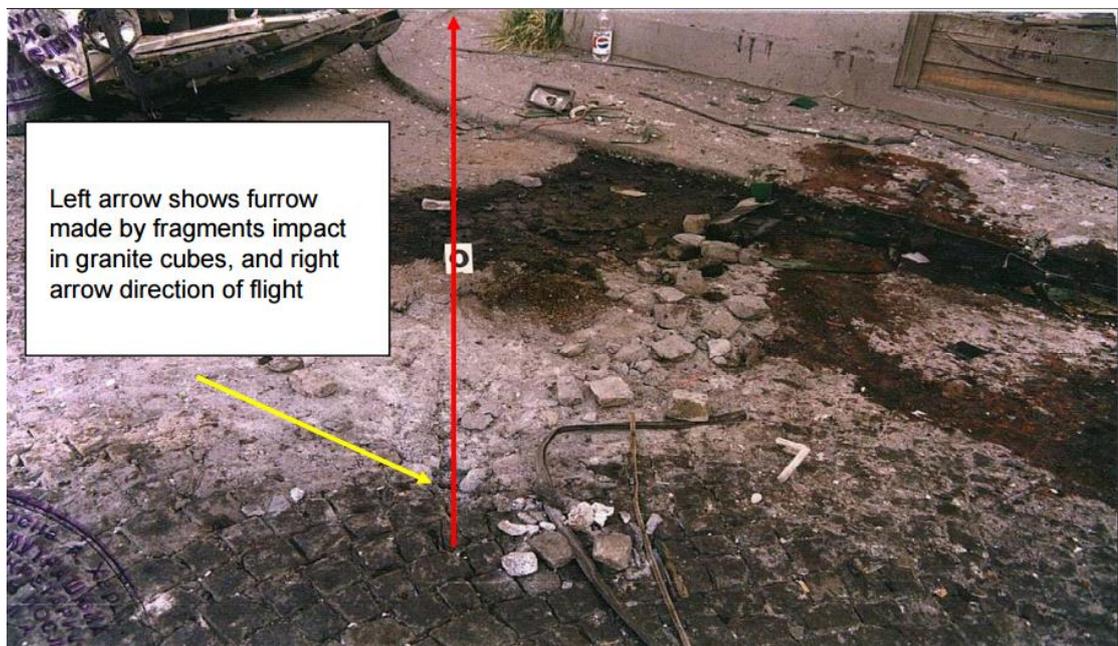
It is fitting to take note of this picture in which there is reference to the fracturing of the centers of the stone surfaces in the East-West direction, in view of which Dr. Zecevic determined the direction of firing.

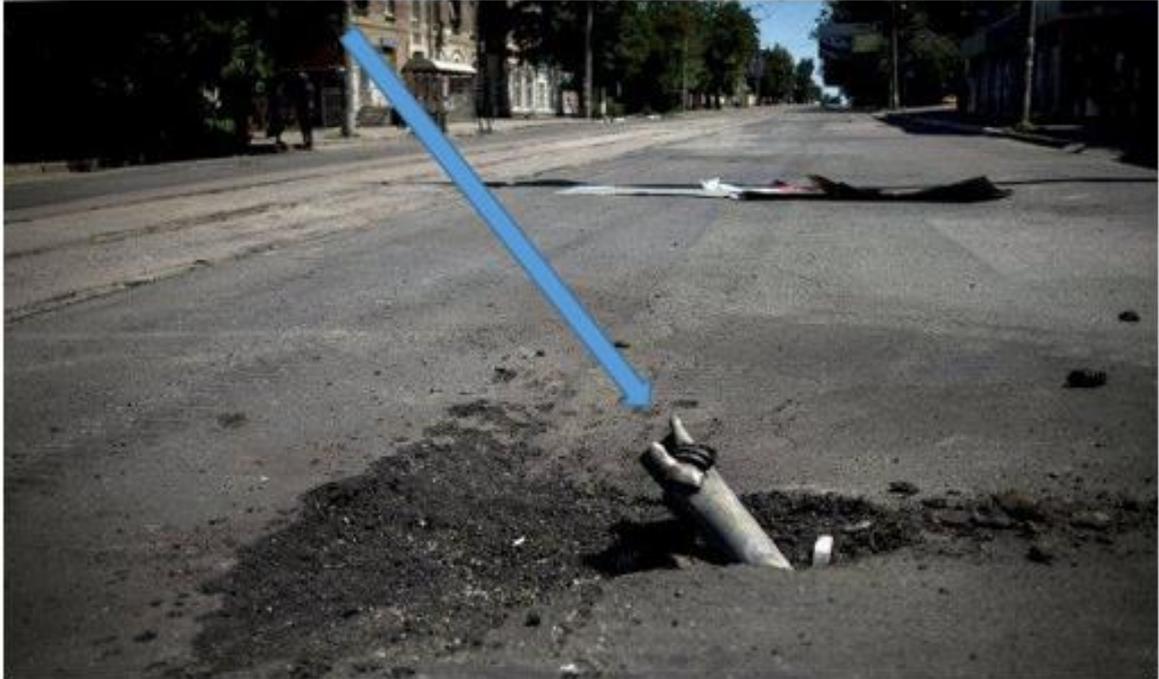
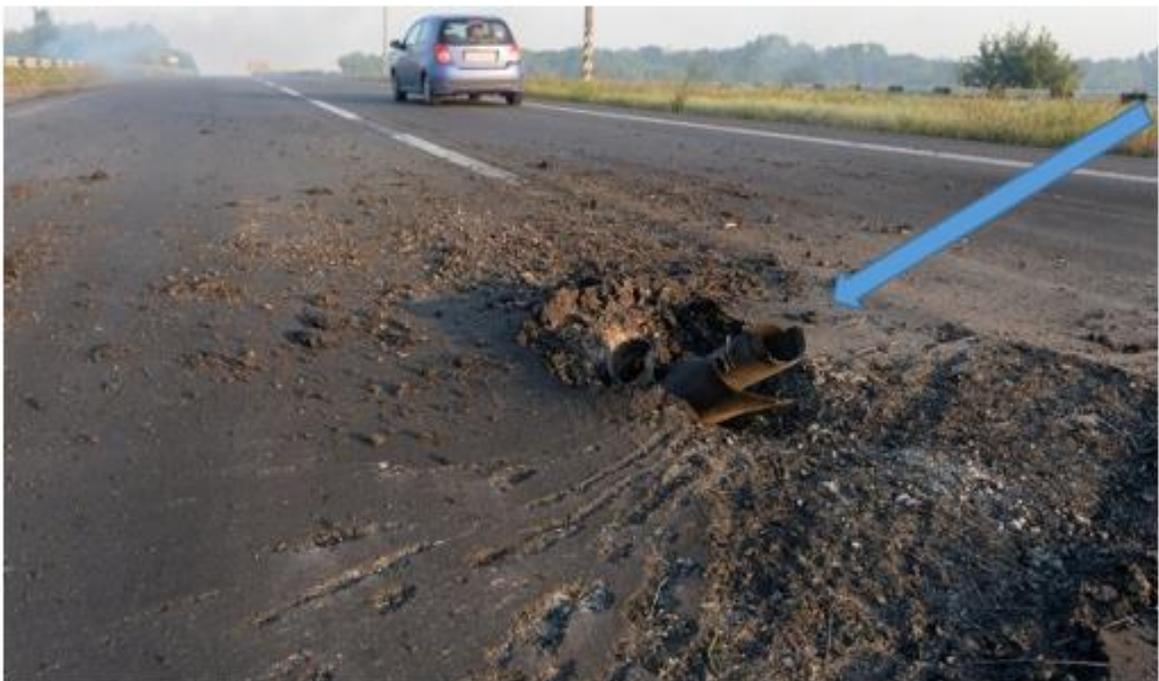
Comparative photographs of the Ground Fragmentation Spreads of explosive warheads – Ground Fragmentation Spreads are found in the direction of the source of the fire. Pay attention to the symmetry of the Ground Fragmentation Spread – the center of the blast is located at the vertex of an equilateral triangle. This enables precise determination of the direction of the shooting. At the arrow is the direction of the impact of the shell.

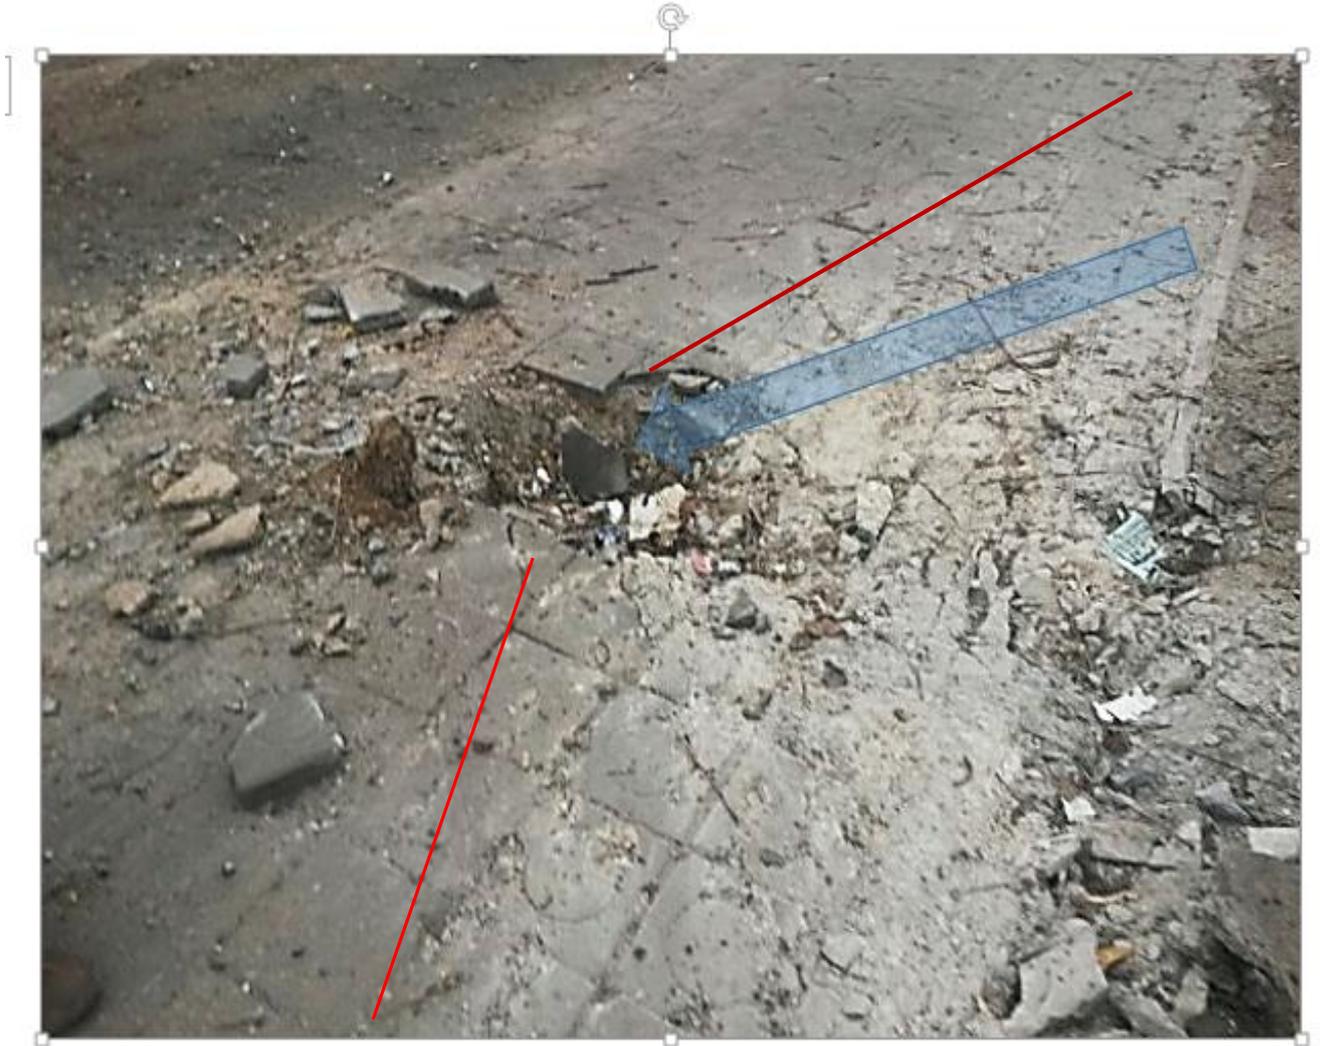
The center of the warhead explosion on the surface paved with tiles. Pay attention to the similarity of the Ground Fragmentation Spread in terms of characteristics of color, grooving and fracturing of the surface at Tuzla, despite the difference in the type of paving.

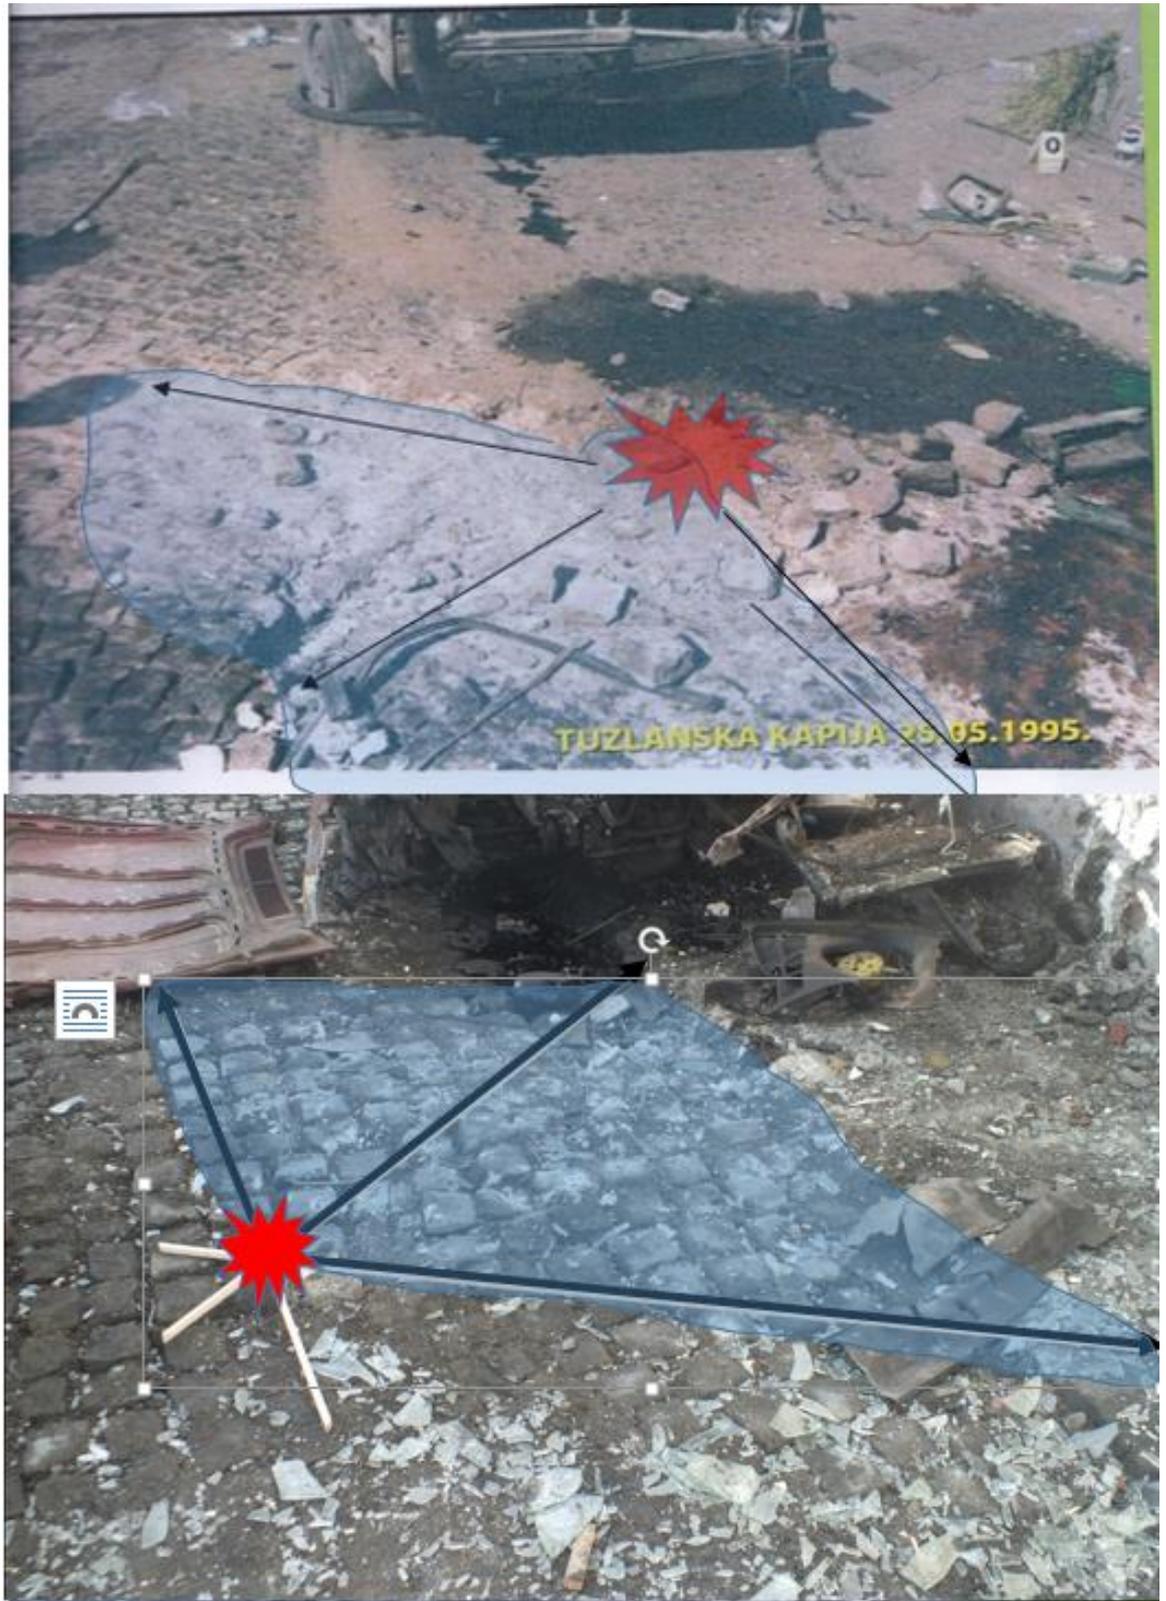
The results indicate totally opposite directions of the Ground Fragmentation Spread between the Tuzla event and test no. 1.

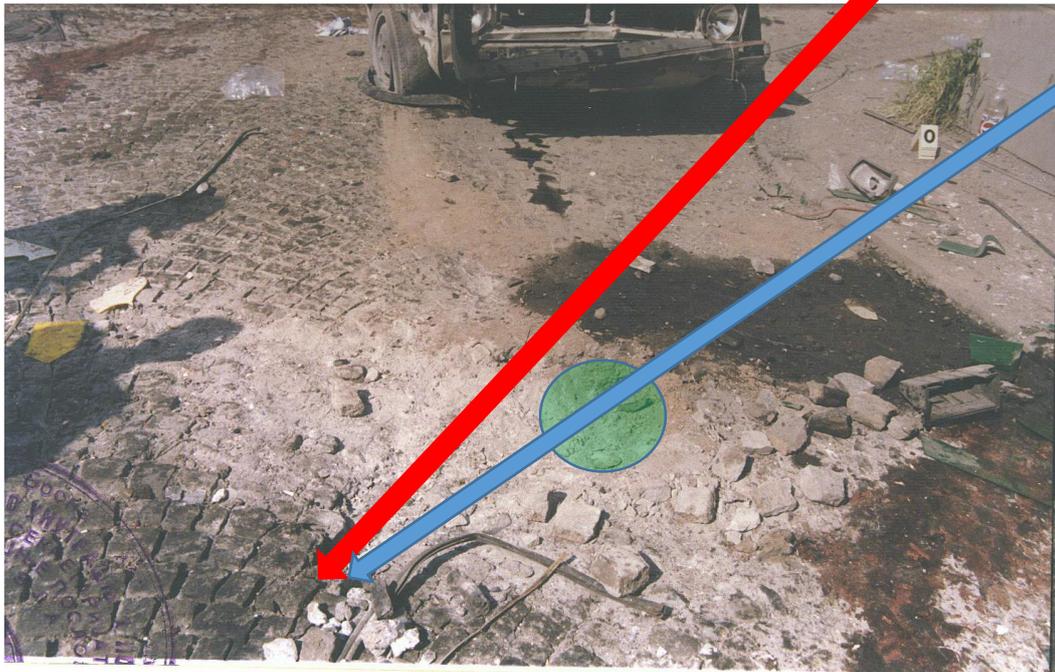
Dr. Zecevic implemented measurement that contradicts even the methods indicated in his own opinion. Analysis of the direction of firing, according to commonly accepted methods, indicates that the source of the fire should be found in the Northwest direction, (blue arrow) -opposite the facade of the adjacent Nik building and not in the west direction as pointed out by Dr. Zecevic. In other words, the shell was supposed to penetrate the wall of the “NIK” structure prior to exploding. This totally invalidates that possibility.

In blue – the direction towards the source of the firing, based on standard measurement methods

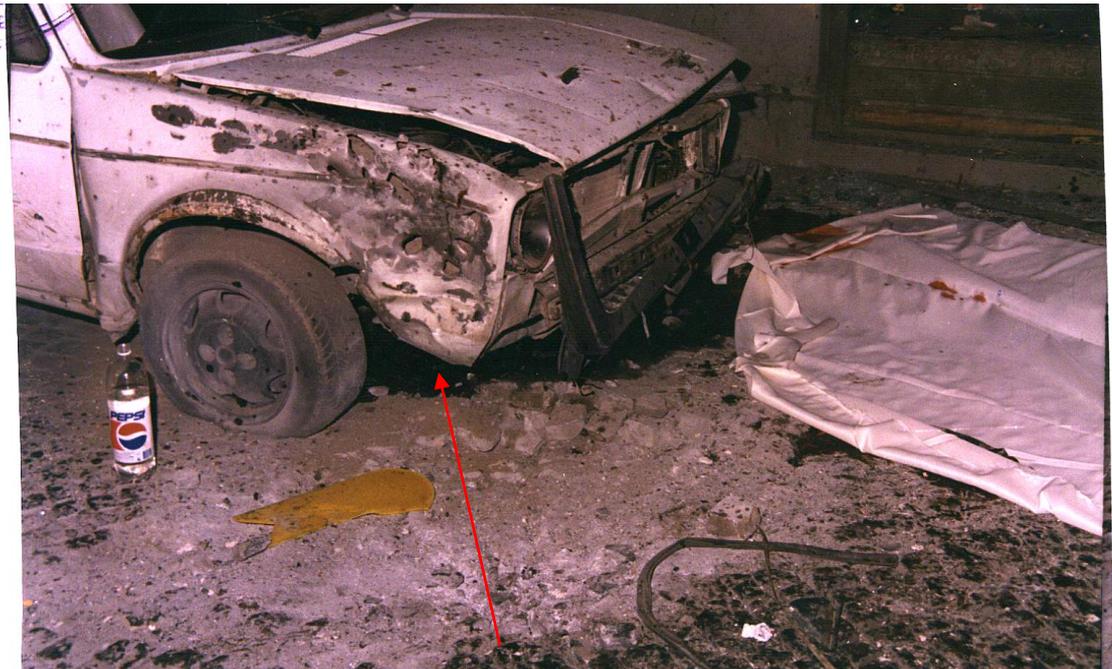
The vehicle, as photographed at the scene prior to being moved – the oil stain is found under the engine of the vehicle

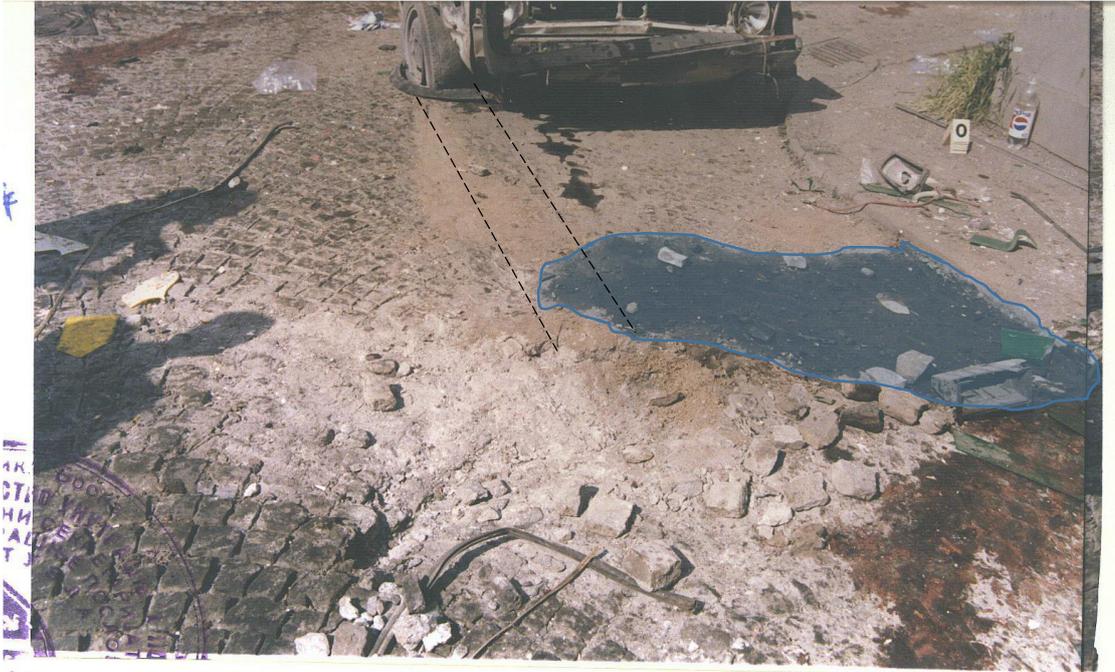
The oil stain after the vehicle was moved – it is clearly apparent that the oil stain is found only on the road and not on the sidewalk as it would have been if the vehicle had in fact parked on the sidewalk prior to the explosion. The towing marks testify that the vehicle was positioned only on the road.

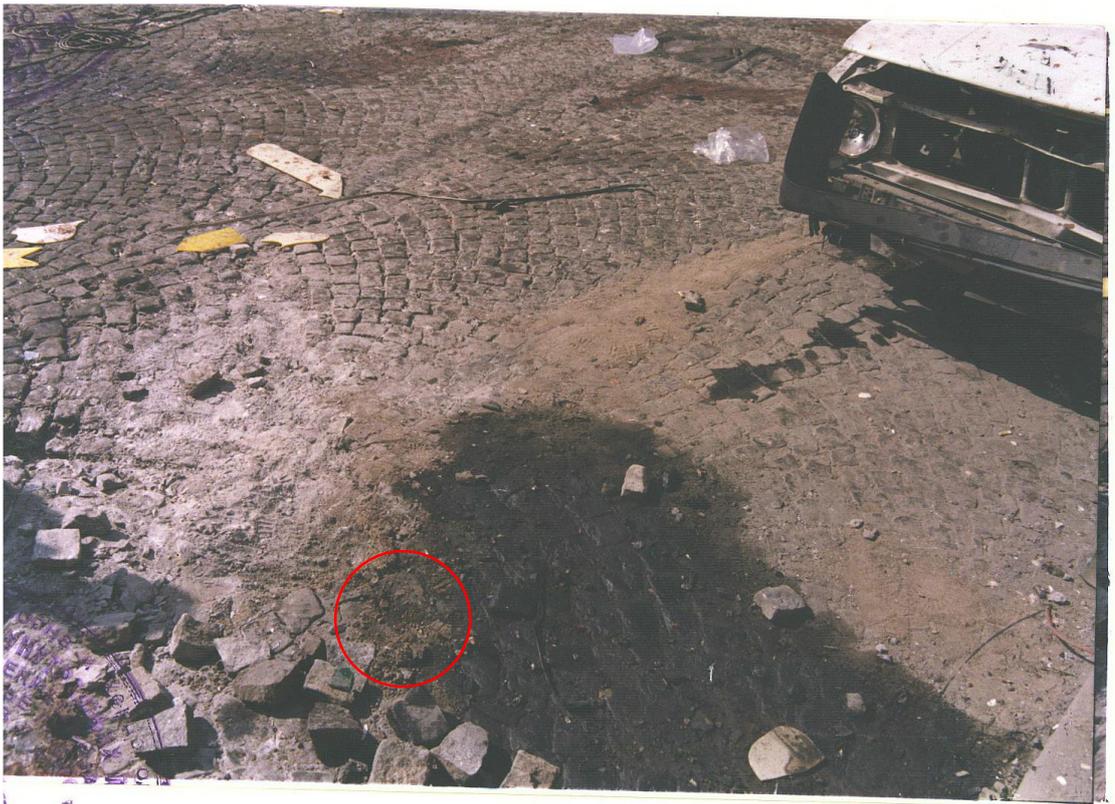
The vehicle after it was moved from its location – the oil stain indicates the exact location of the vehicle in relation to the center of the explosion and the sidewalk.

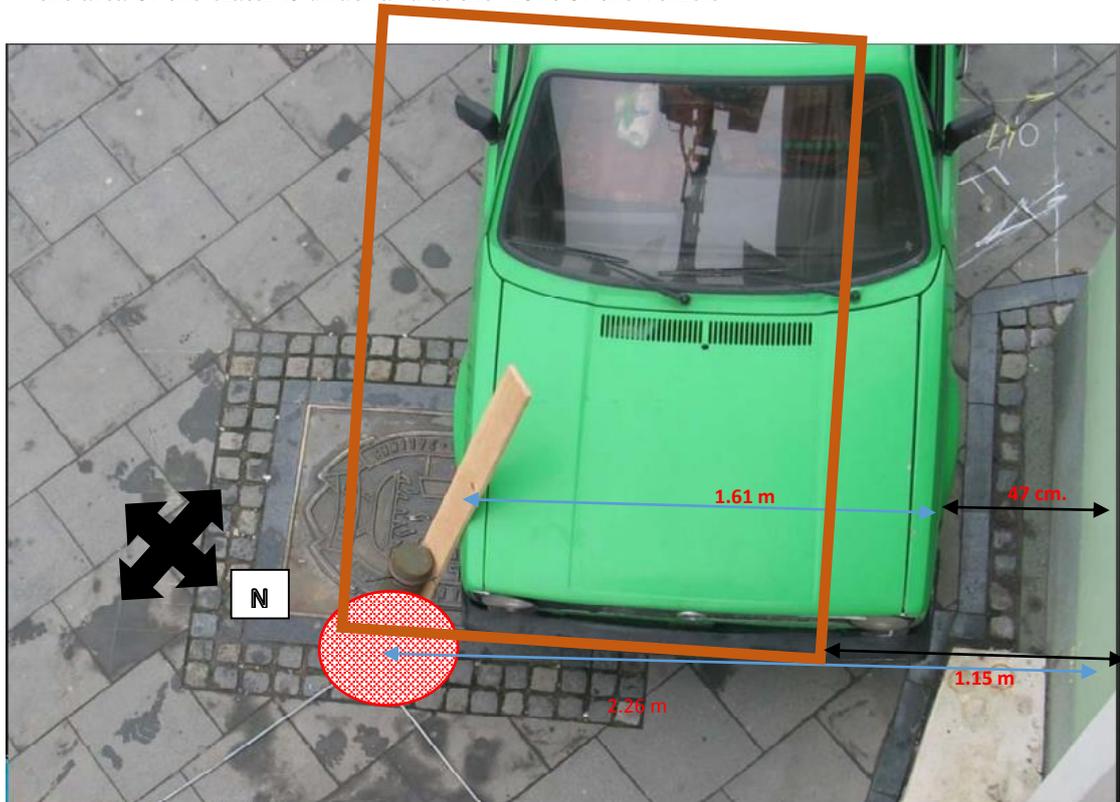
Simulation of the location and size of the center of the explosion, relative to the vehicle, according to the measurements as stated in the opinion of Dr. Zecevic (marked in red). This position is the result of determining the diameter of the explosion crater – 50 cm, and the configuration of the crater relative to the location and angle of impact of the shell. It can be seen, as previously mentioned, that this location, places the crater entirely outside the limits of the sides of the vehicle.

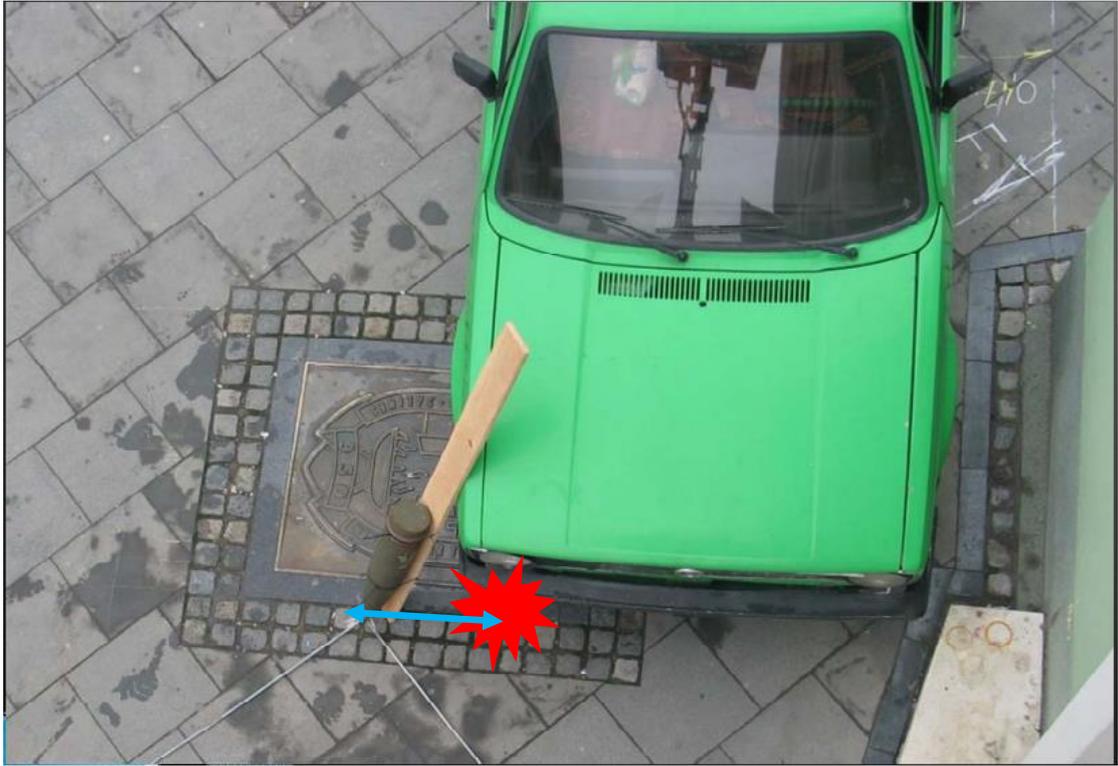
Actual location of explosion crater (in red) in accordance with Dr. Zecevic's version

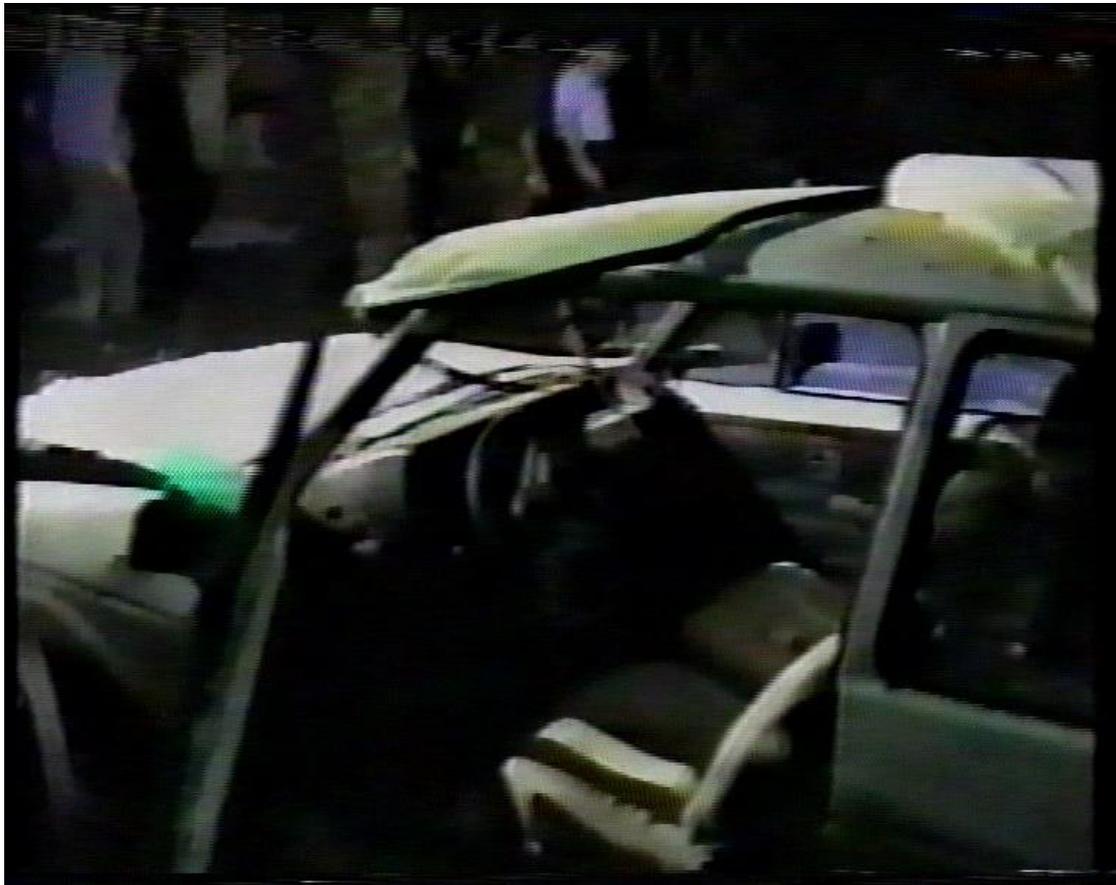
The inside of the vehicle. There is no evidence of serious damage to the inner assemblies of the vehicle including the seats.

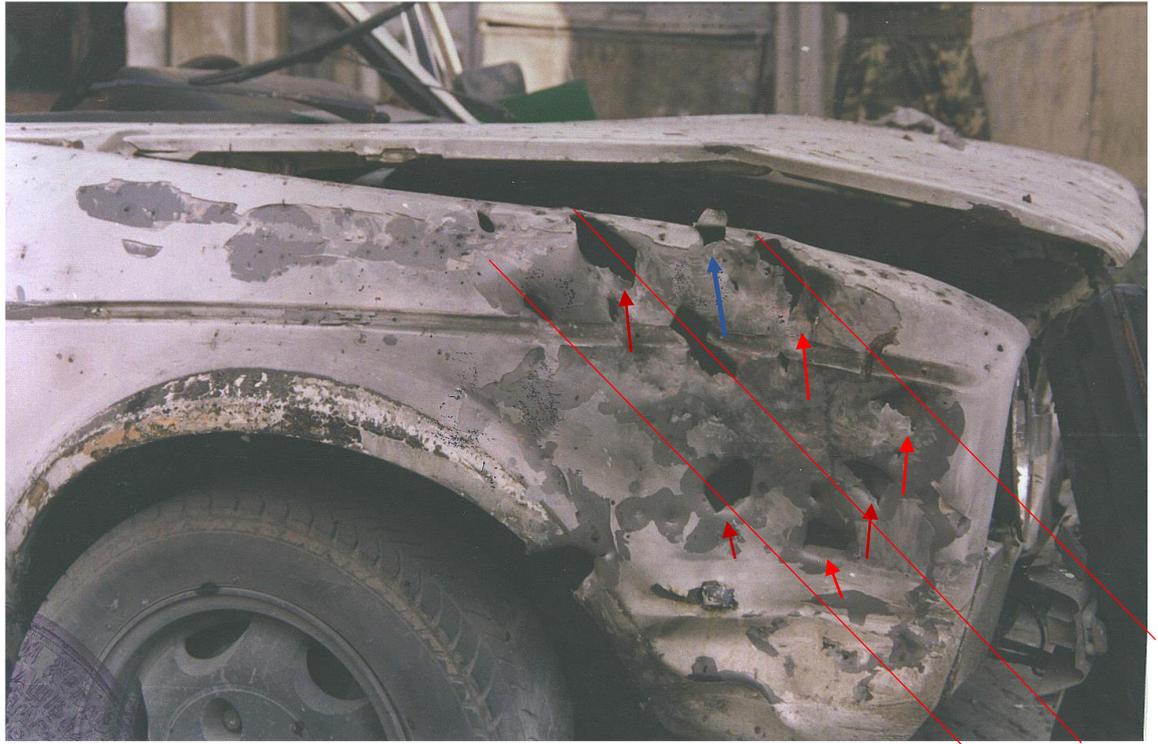
An analysis was performed of the angles of impact of the shrapnel on the side. In general it was found that the impact angles are at an angle of about 50 degrees relative to the plane of the ground.

In the lower part of the wing, the shrapnel damage is perpendicular to the side of the vehicle, which indicates that the shell body was physically opposite the penetration points. At the upper section of the wing, the shrapnel penetration indicates the direction of the angle of penetration being upwards.

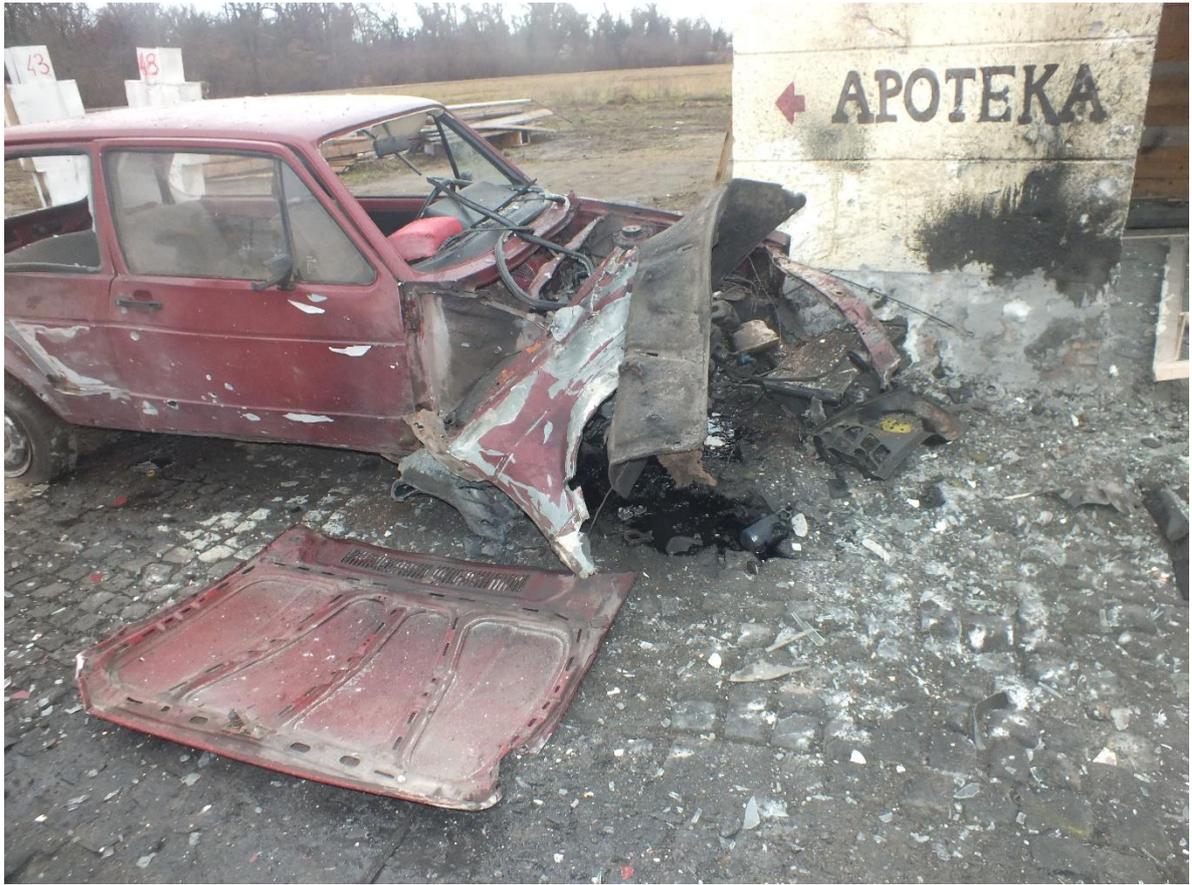
Comparison of the damage to the front and the wing of the vehicle at the “Tuzla” event and the test results conducted on 10.02.2016 at the Technical Test Center in accordance with the expert opinion of Dr. Zecevic (see below), which verifies and emphasizes the significant differences between the cases.

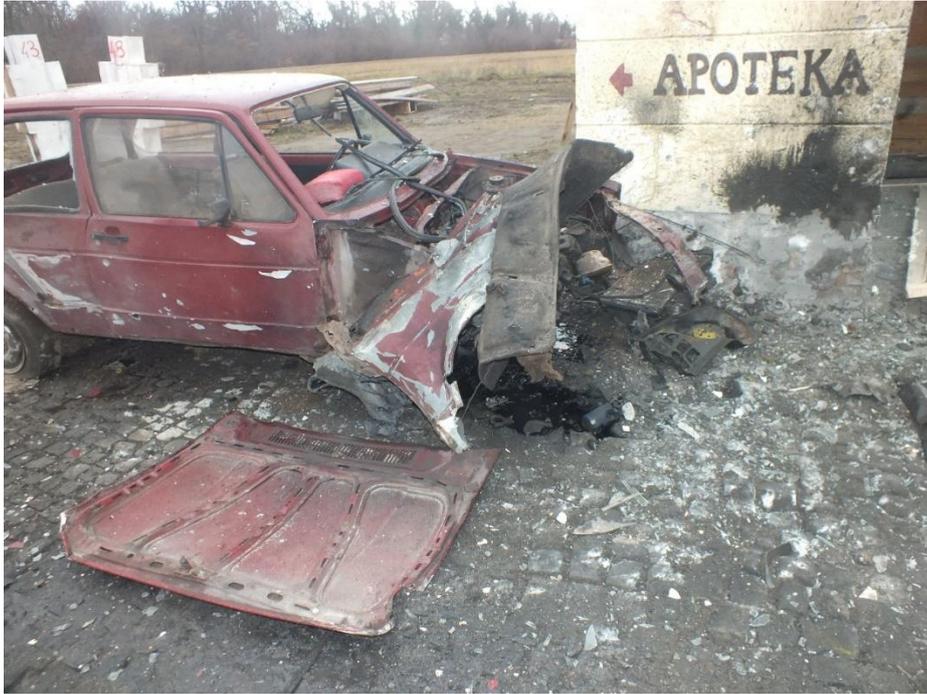
Damage to the Golf vehicle as it was flung toward the west direction as a result of the shockwave– test result

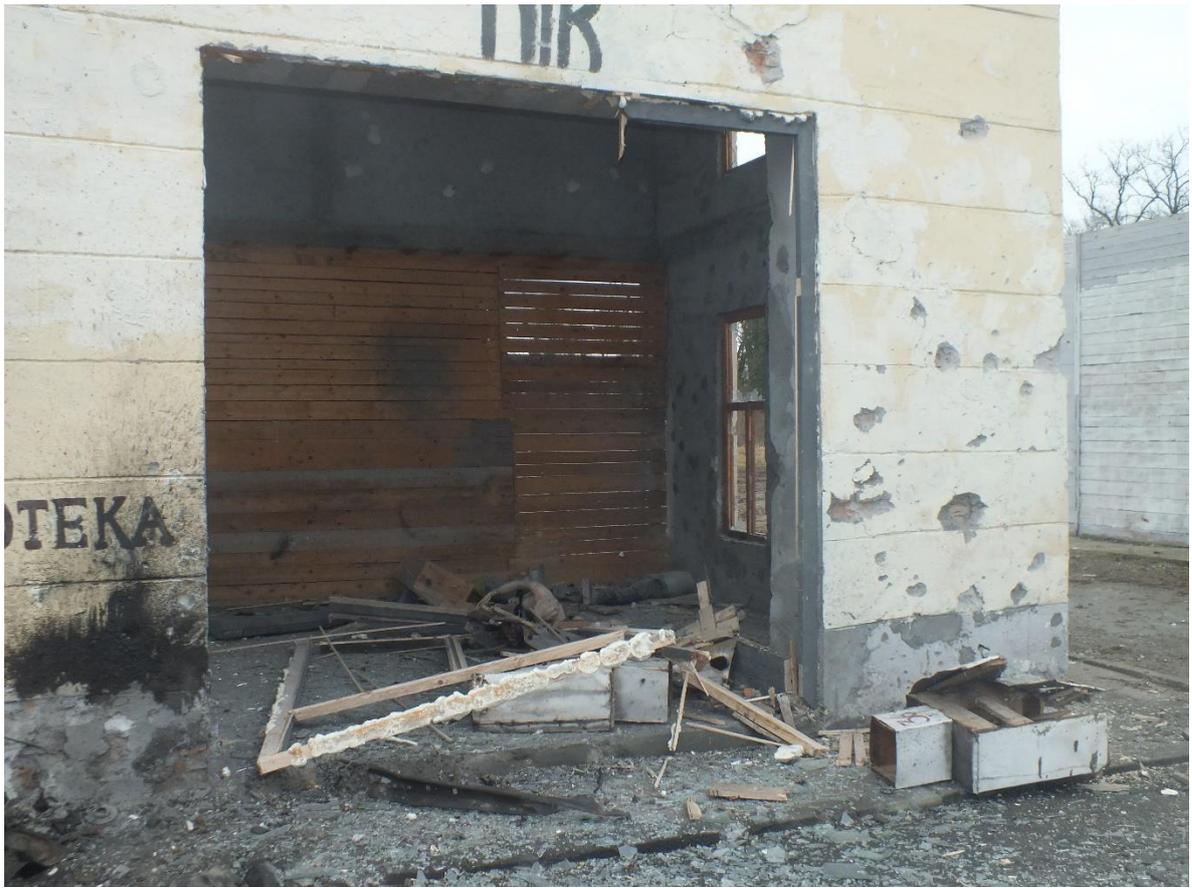
Debris, stone fragments and heavy damage to the road and sidewalk in front of the NIK building – test result

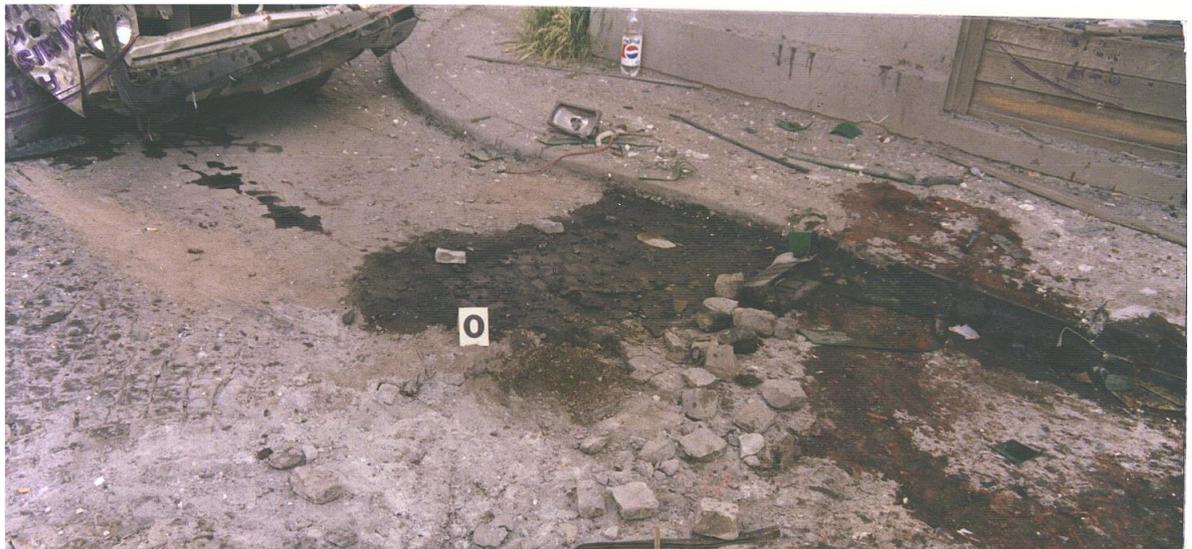
Debris, minimal stone fragments on the sidewalk in front of the NIK building – original event

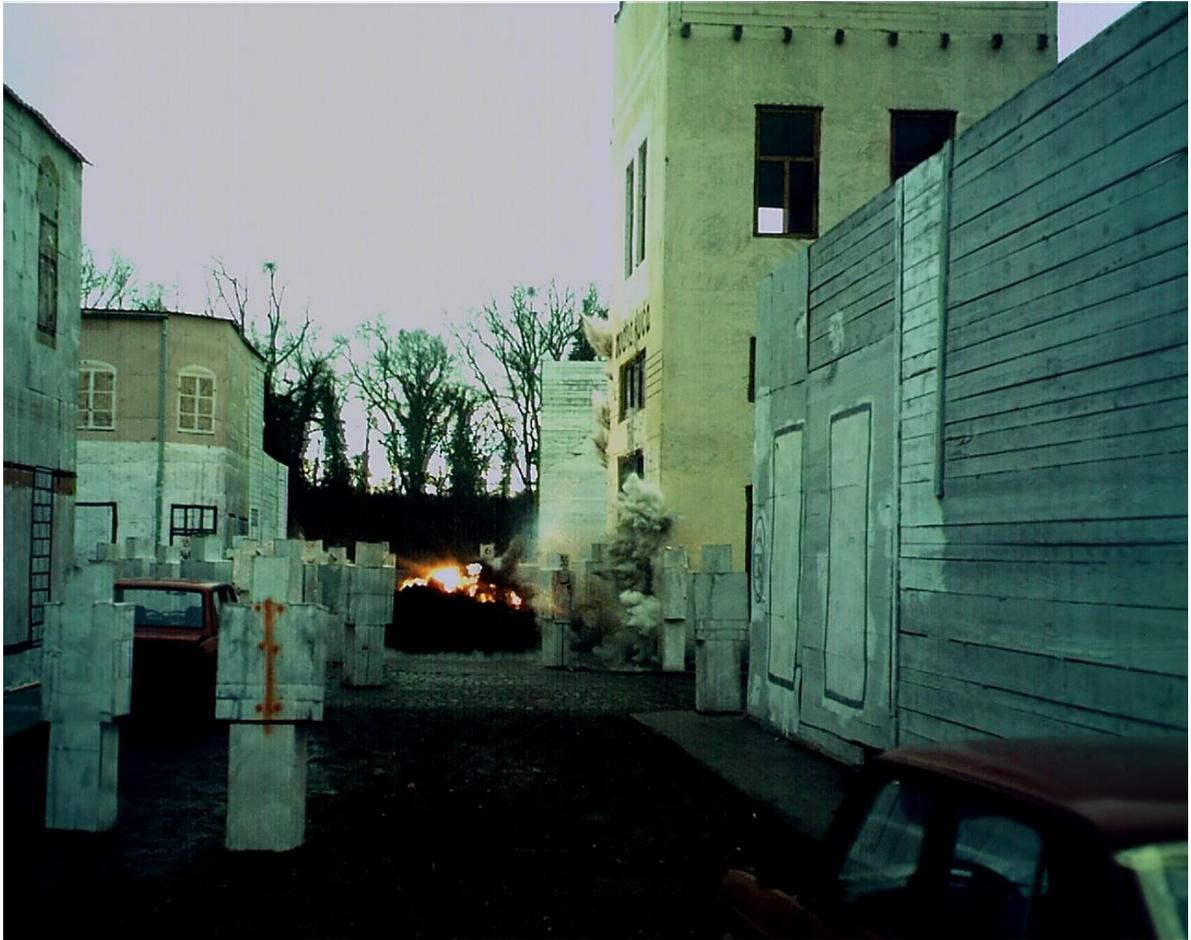
Fragmentation damage on NIK building walls – from fast camera film

Two sites of fragmenting damage were found on the building's exterior walls. The first site - 17 places of fragmentation damage were found on the northern side of the NIK building façade, most of them up to about 2.50 meters height. Another fragment was found in the area between the store doorframe and the frames of the upper windows.

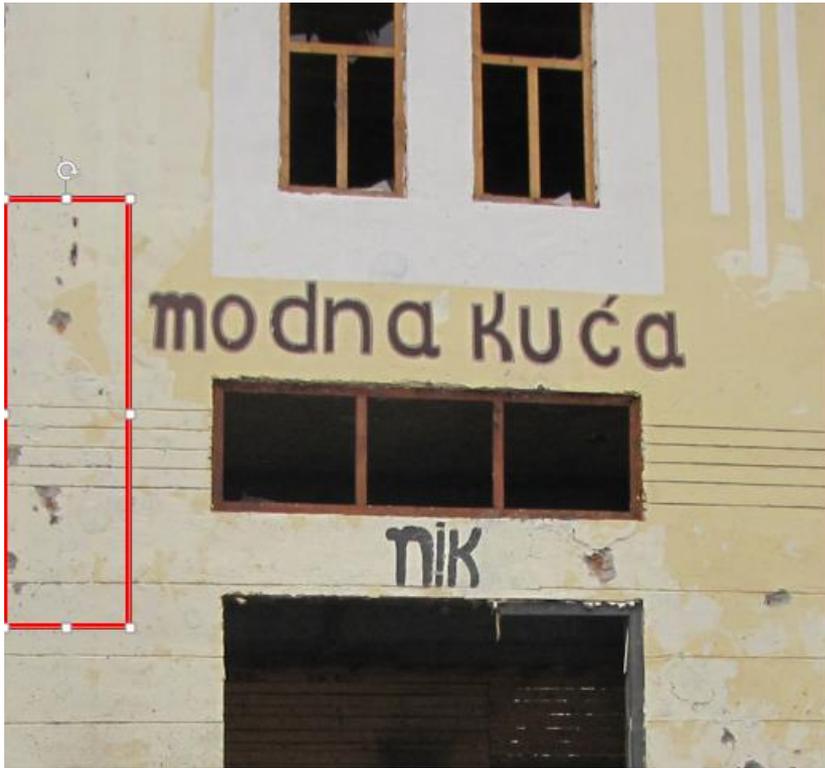
At the Kapija event - fragmentation damages were not found on the side of the building, only 4 places of fragmentation damage at the center of the building façade, at a height of about 10 m.

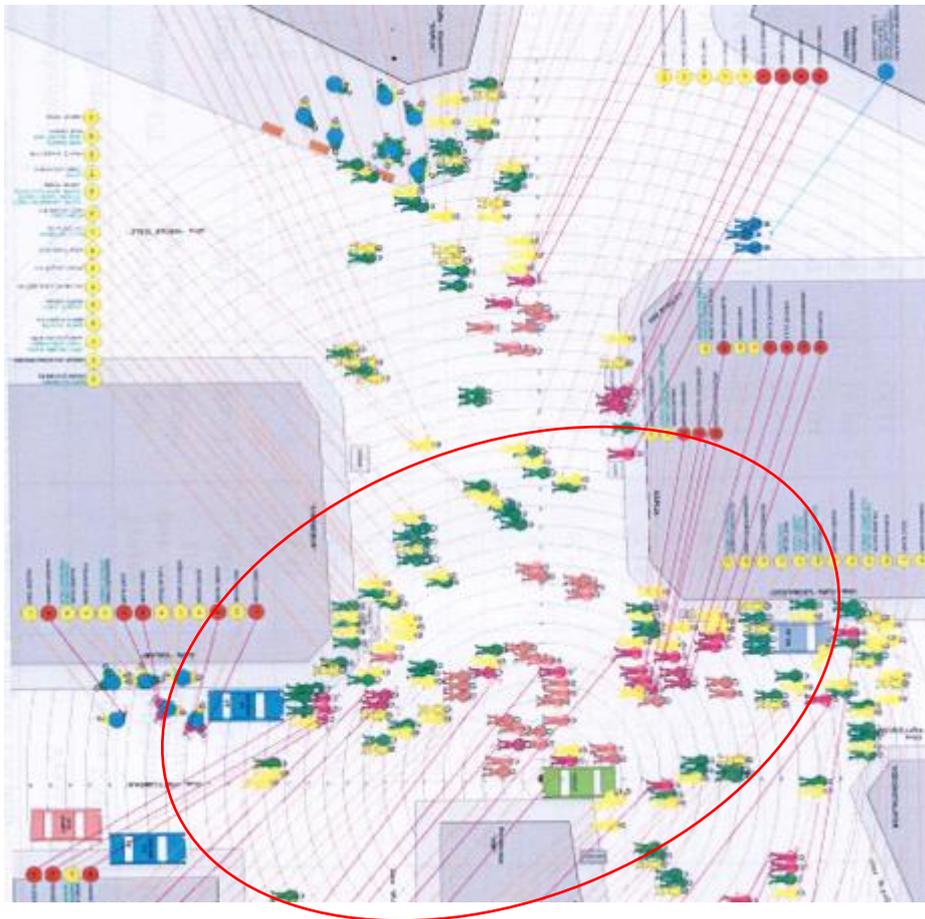
A map representing the known and the estimated location of casualties in Tuzla on 25/05/1995. In circle, the area of damages to human figures in test No. 1 done with accordance of Dr. Zecevic expert opinion which left an unexplained casualties areas outside the damage area

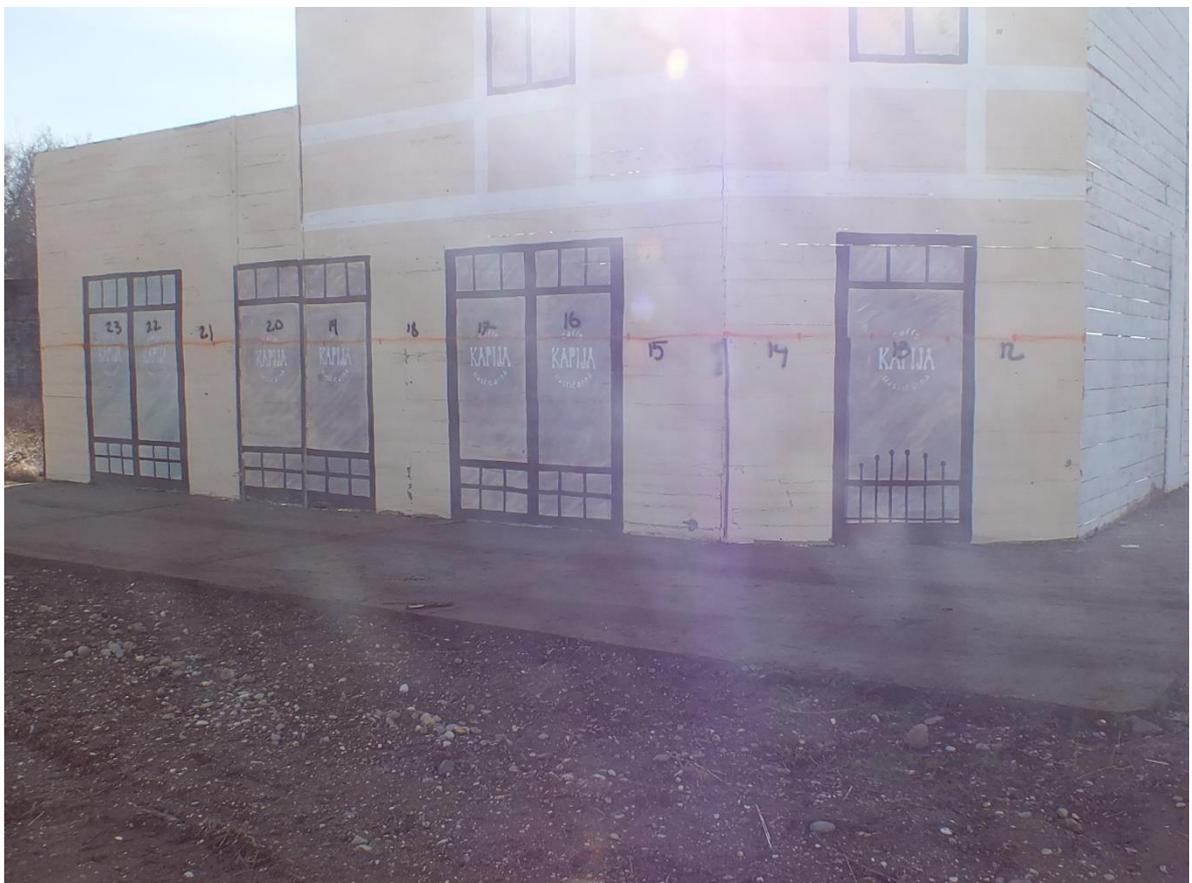
In the test only three effective fragments were found in the southern part of the Northwest wall of the building – facing the square

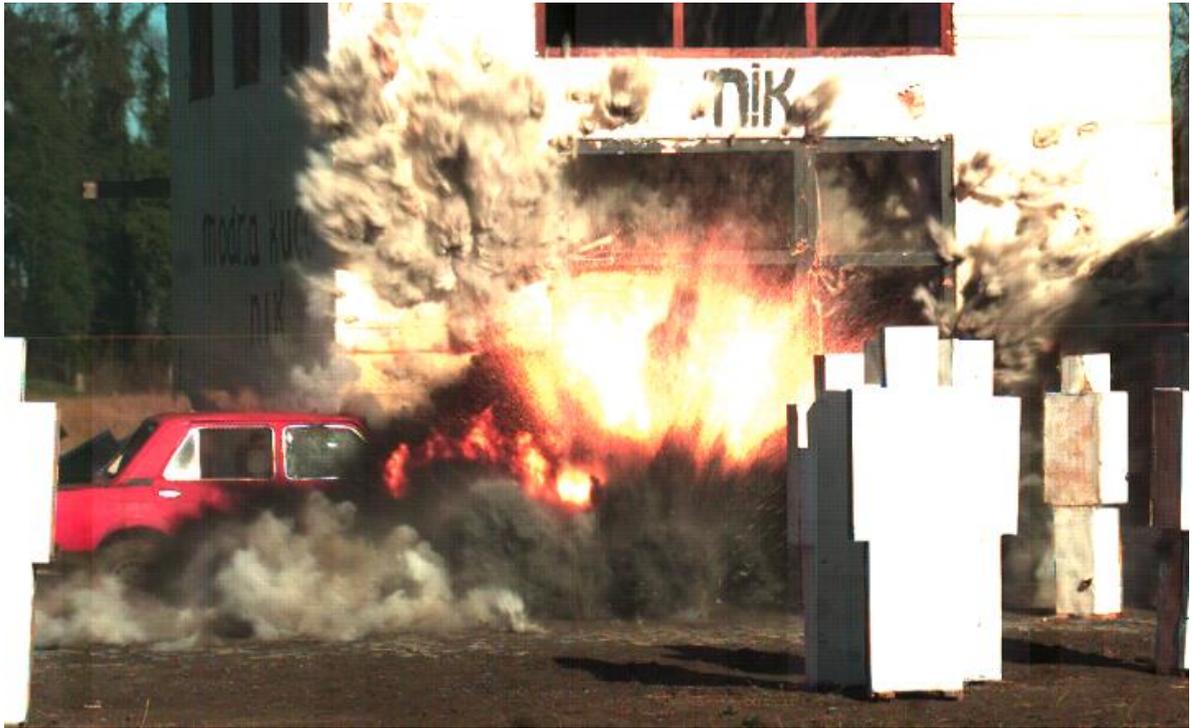
Photograph of rapid camera towards the Northwest- pay attention to the dust arising because of the fragmentation hits on the granite stones.
