1. REPORT DATE April 2016			2. REPORT TYPE Technical report		3. DATES COVERED	
4. TITLE AND SUBTITLE Review of <u>Dr. Zecevic</u> expert opinion report conclusions regarding the causes and results of the explosion occurred at Kapiia square in the city of Tuzla on 25/05/1995					5a. CONTRACT NUMBER	
					5b. GRANT NUMBER	
					5c. PROGRAM ELEMENT NUMBER

6. AUTHOR(S) Sharon Joseph					5e. TASK NUMBER	
					5f. WORK UNIT NUMBER	
					8. PERFORMING ORGANIZATION REPORT NUMBER 32-16	
7. PERFORMING ORGANIZATION NAME(S) AND ADDRESS(ES) <u>Temech-Consultants</u> Tel-el 2516700 Israel					8. PERFORMING ORGANIZATION REPORT NUMBER 32-16

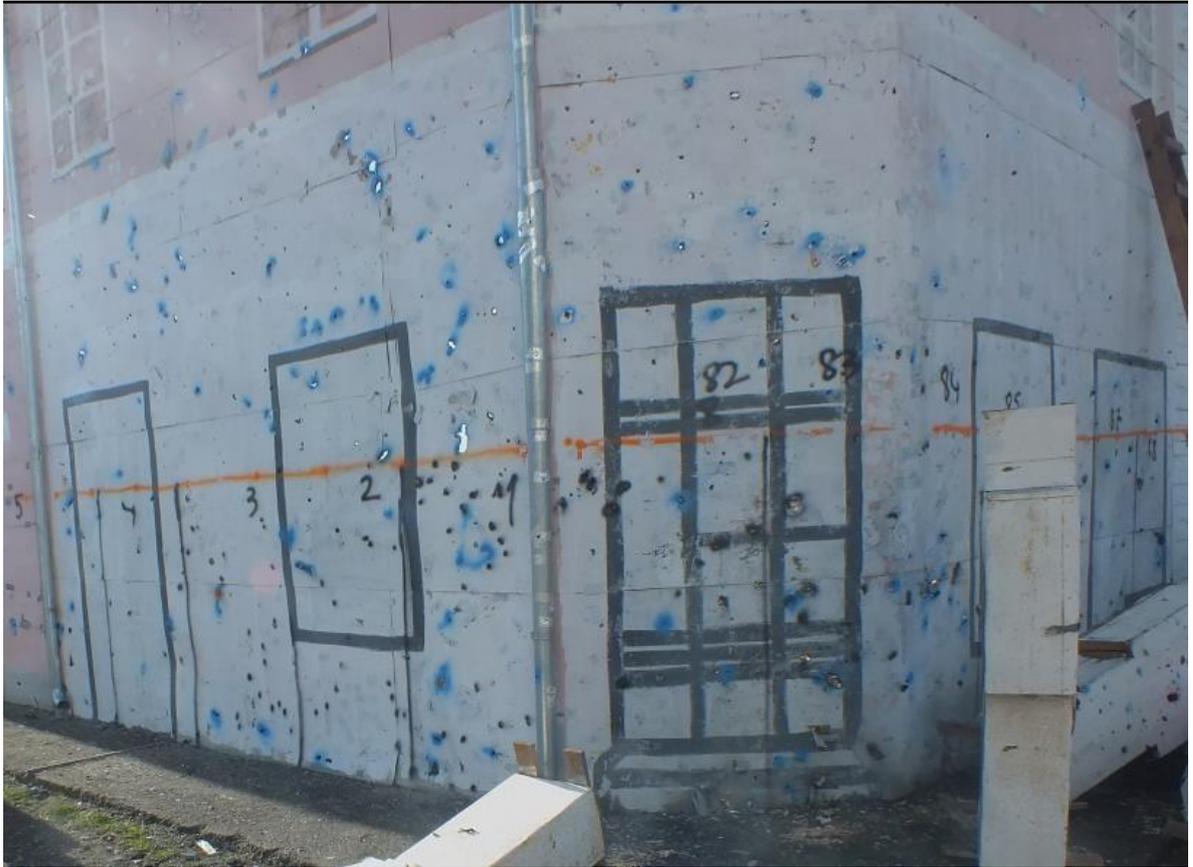
Kapija North corner – it can be seen that in this area, dispersion and amount of fragmentation in test no. 1 (in blue) are significantly greater in higher areas, while most fragmentation in test no. 2 (black color) is concentrated in the lower part of the building.

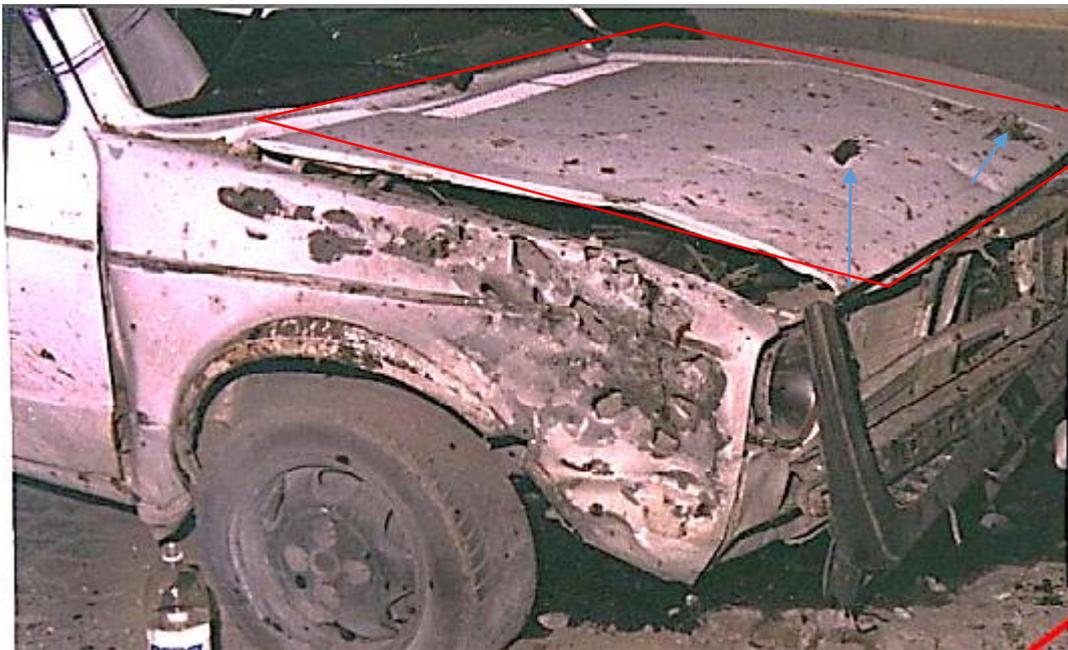
Pieces of flesh and probable bloodstains on the side of the vehicle and engine hood

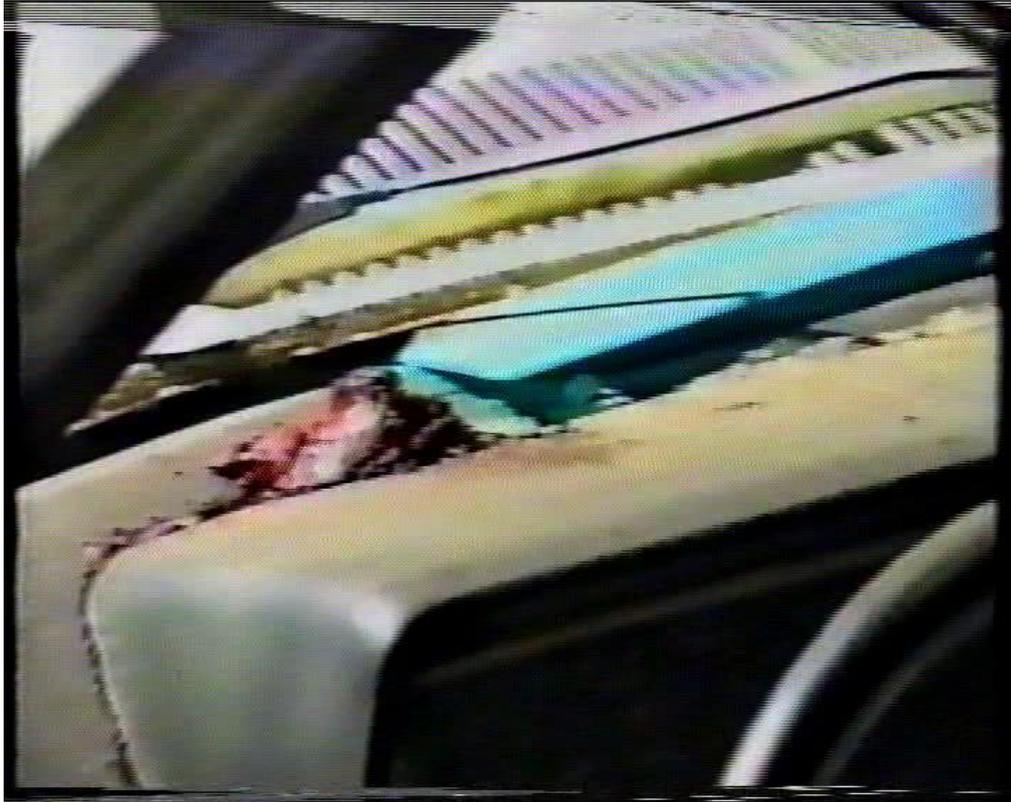
Human tissue on the dashboard of the Golf vehicle
