**ADDITIONAL BALLISTIC EXPERTISE ASSOCIATED TO THE
EVENT AND CIRCUMSTANCES IN CASE OF EXPLOSION AT
"KAPIJA" LOCALITY IN TUZLA ON 25 MAY 1995**

REPORT AND OPINION

**Court expert for ballistics, firearms and cold weapons MSc. Vlada Kostić,
B.Sc.M.E., in cooperation with qualified person for ballistics Branka
Luković, B.Sc.M.E.**

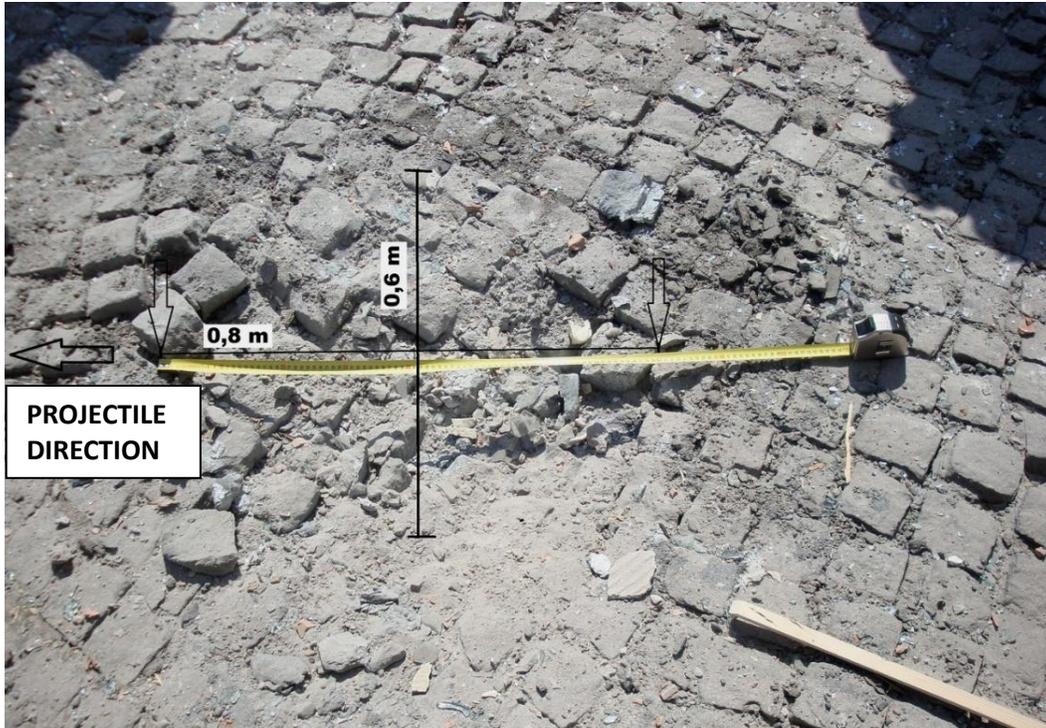
- On the immediate explosion site the projectile has formed a crater with approximate shape of ellipsoidal calotte, with length approximately 0.8m and width up to 0.6m, Figure 8 of the Report;

Figure 8 – A closer look at the appearance of the crater formed by projectile activated for experimental purposes on 29 August 2014 in front of "NIK" store object

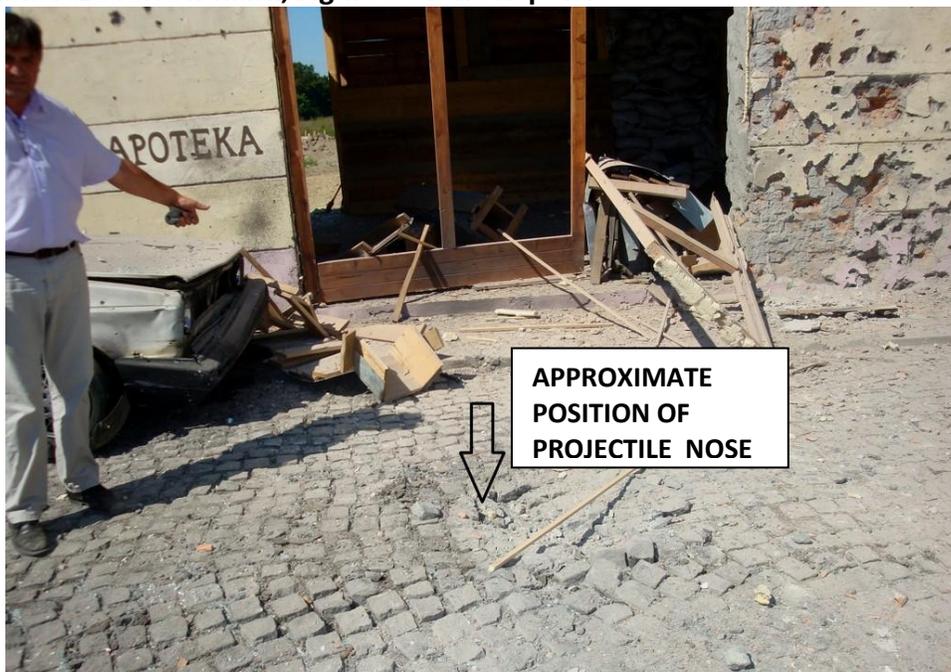
- From the spot where projectile fuze was, towards the vehicle, it was determined that there was no visible fuze furrow mark, Figure 9 of the Report:

Figure 9 – Wider appearance of crater, made by projectile explosion, without noticeable fuze furrow mark, with appearance of the shopwindow, lower-right part of "NIK" store facade and remains of dolls in front of the shopwindow

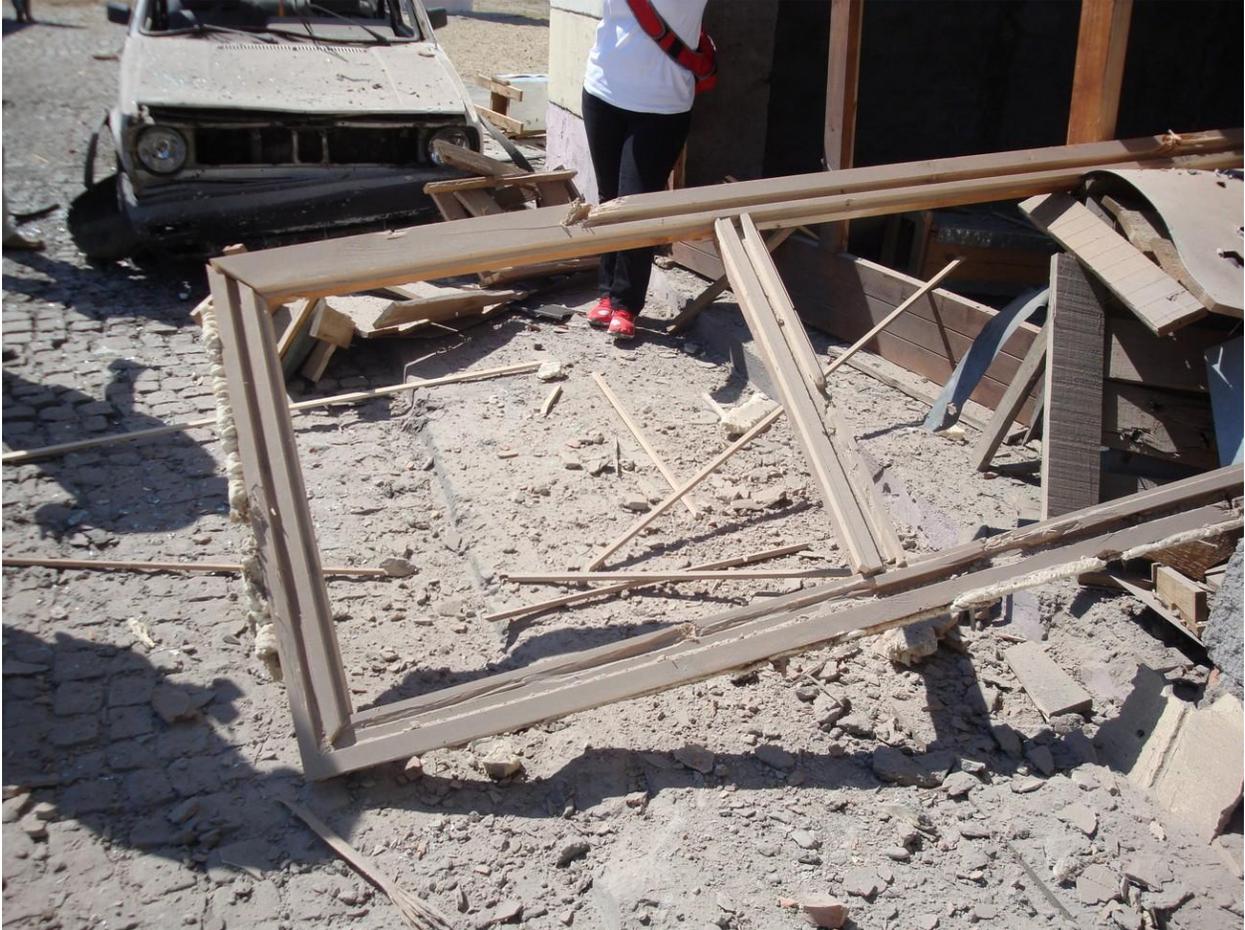
- Both dolls set up in front of shopwindow of "NIK" store object, which represented Hasanović Senad and Alispahić Admir, were completely disintegrated, i.e., destroyed, Figure 10 of the Report;

Figure 10 – Appearance of remains of the dolls, set up in front of "NIK" store object, after the explosion, with ripped-out frame of shop door

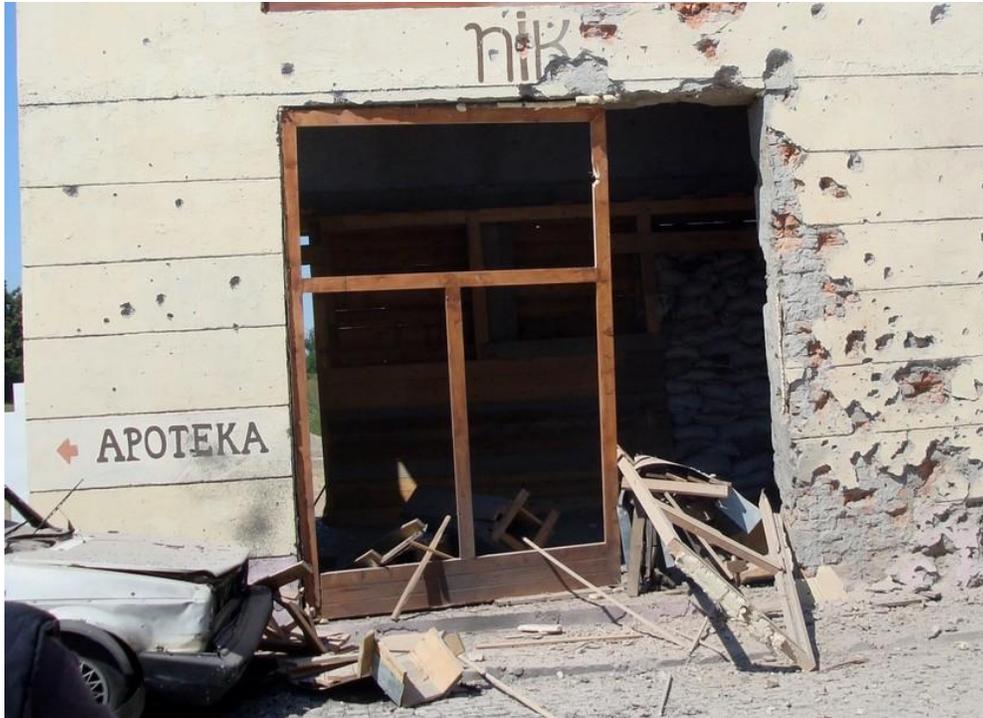
- Both dolls, set up in the shopwindow of the mentioned store model, were knocked-down and damaged by products of projectile explosion, Figure 11 of the Report:

Figure 11 – Appearance of knocked-down and damaged dolls which were set up inside the shopwindow of "NIK" store object

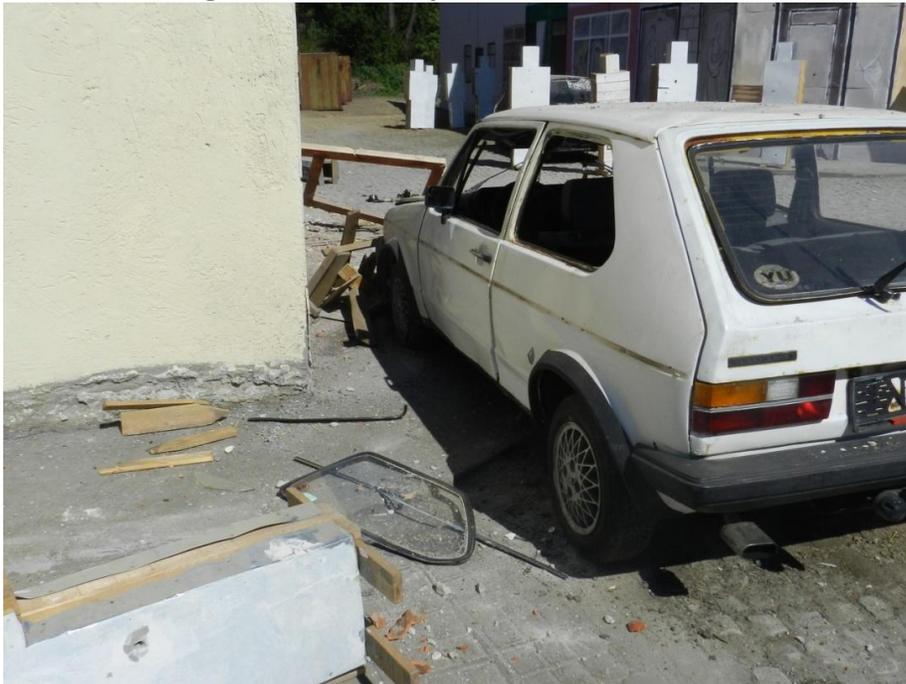
- Doll which was leaning on the left backside part of the car was knocked down by the products of projectile explosion, with visible piercing on left (upper) side approximately at the height of its stomach, Figure 12 of the Report:

Figure 12 – Appearance of the knocked-down doll which was set up – leaned on the left back part of the "GOLF 1" car

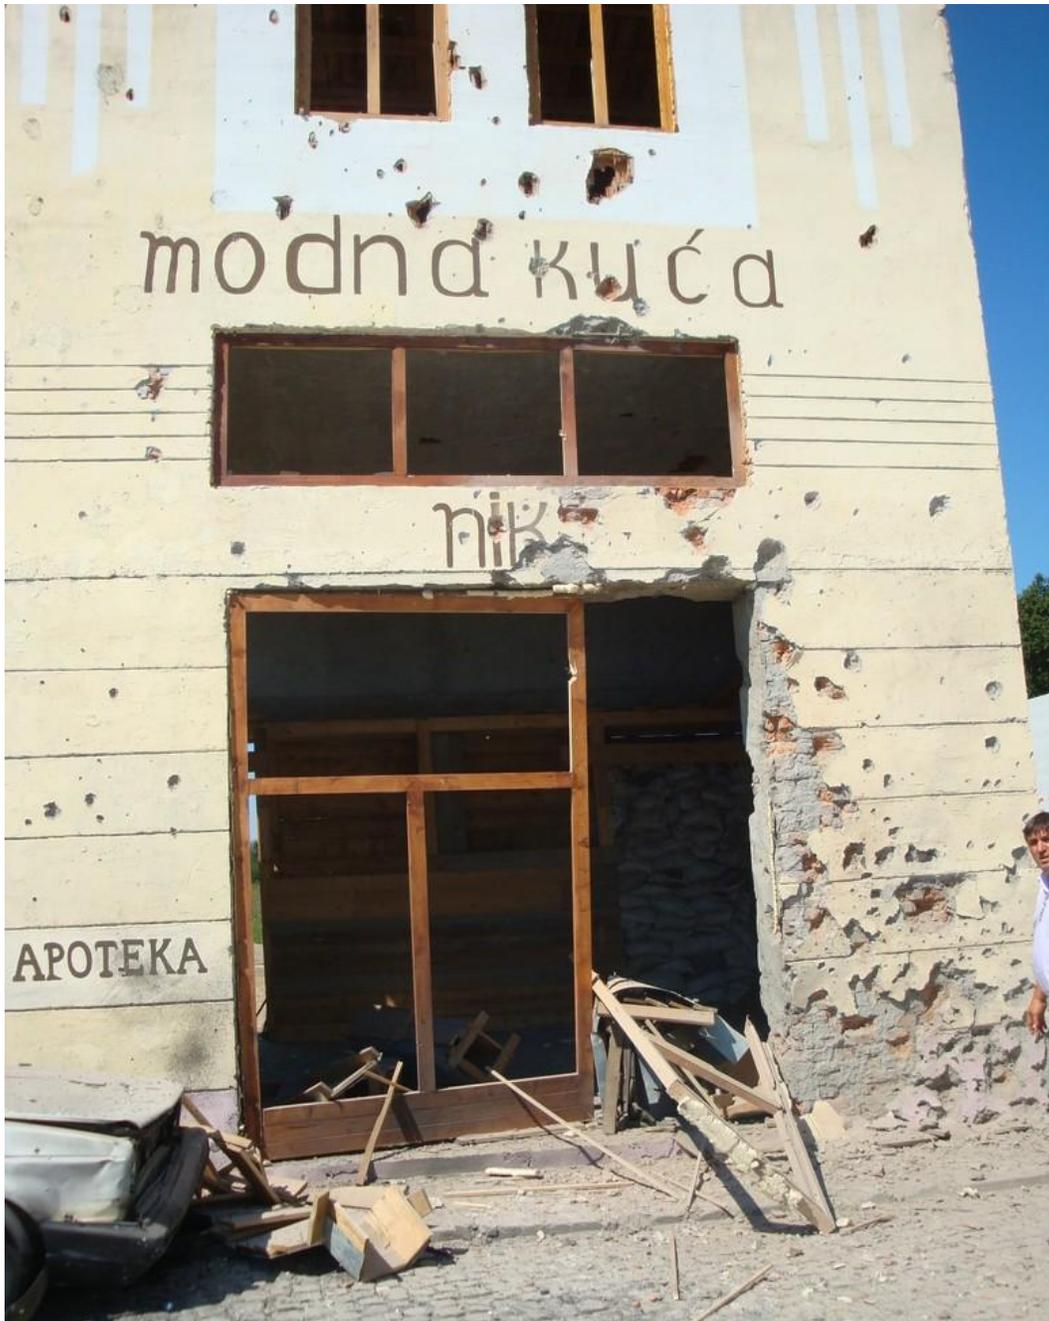
- Facade of "NIK" store object, right from entrance door, has suffered extremely high level of damage, especially in the area close to the ground, which then spreads up to the level above the shopwindow, i.e., windows, Figure 13 of the Report:

Figure 13 – Appearance of the lower right part of "NIK" store object facade, and part of facade above shopwindow

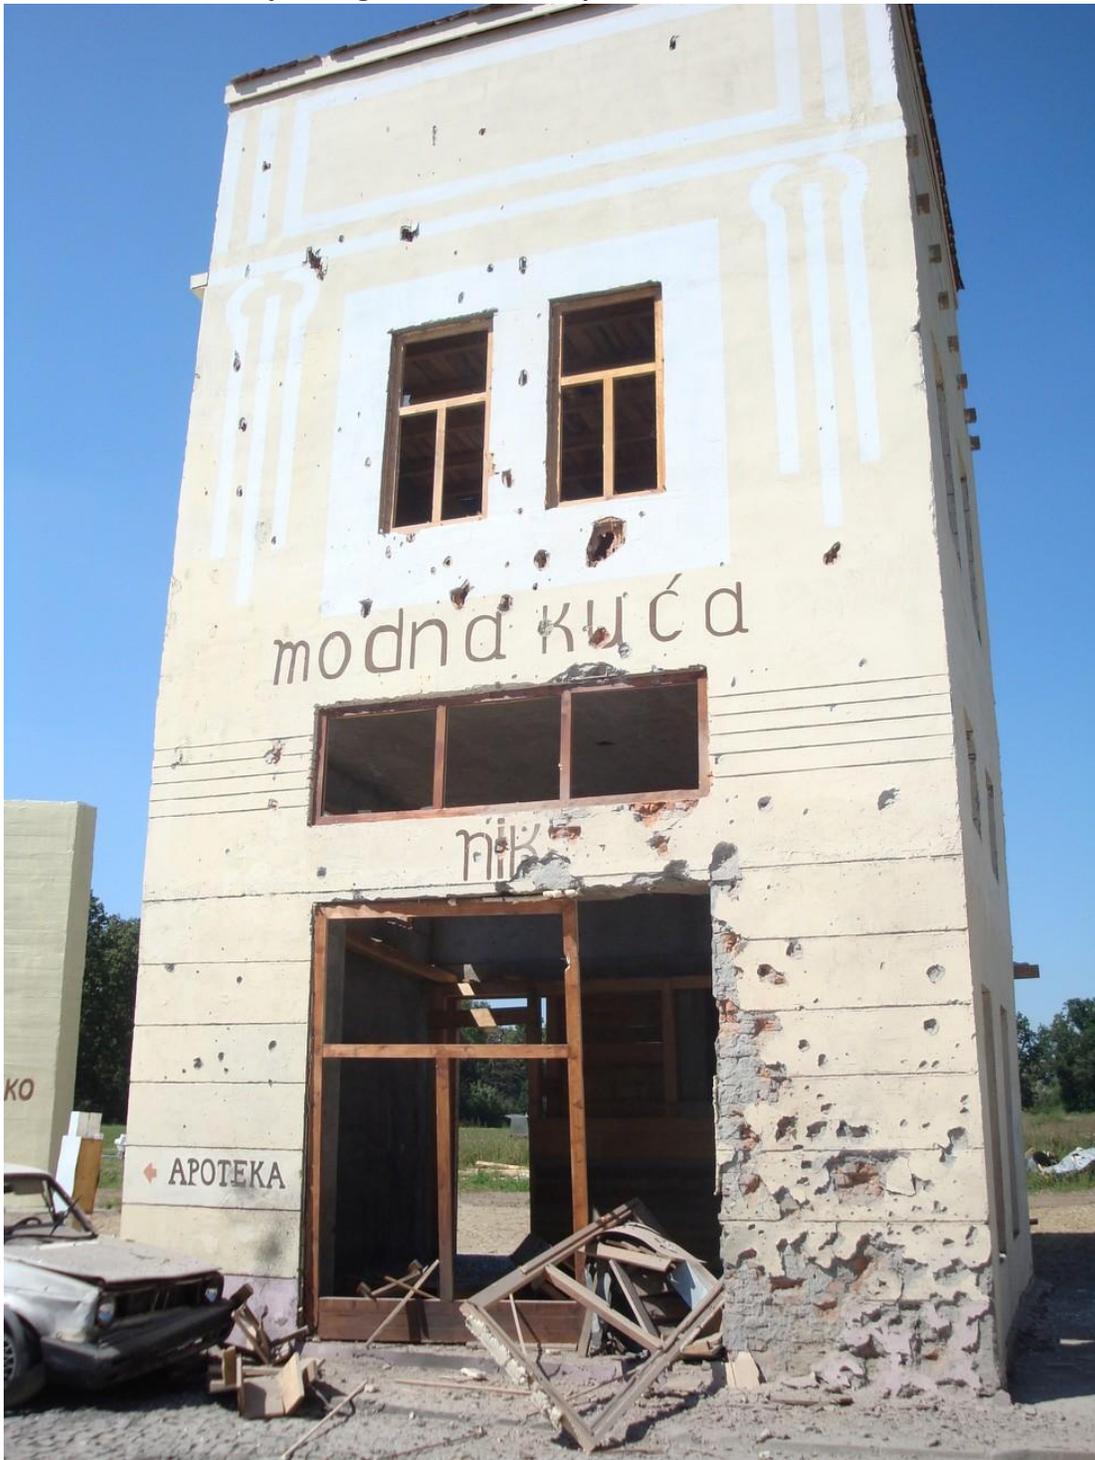
- Above the mentioned level, one can clearly notice several dozens of piercings and penetrations of different size, made by fragment action of the projectile, which are relatively evenly spread across the area of the upper part of the facade, and they spread nearly up to

the roof of "NIK" store object, Figure 14 of the Report:

Figure 14 – Appearance of "NIK" store object facade with damage made by fragment action of the projectile

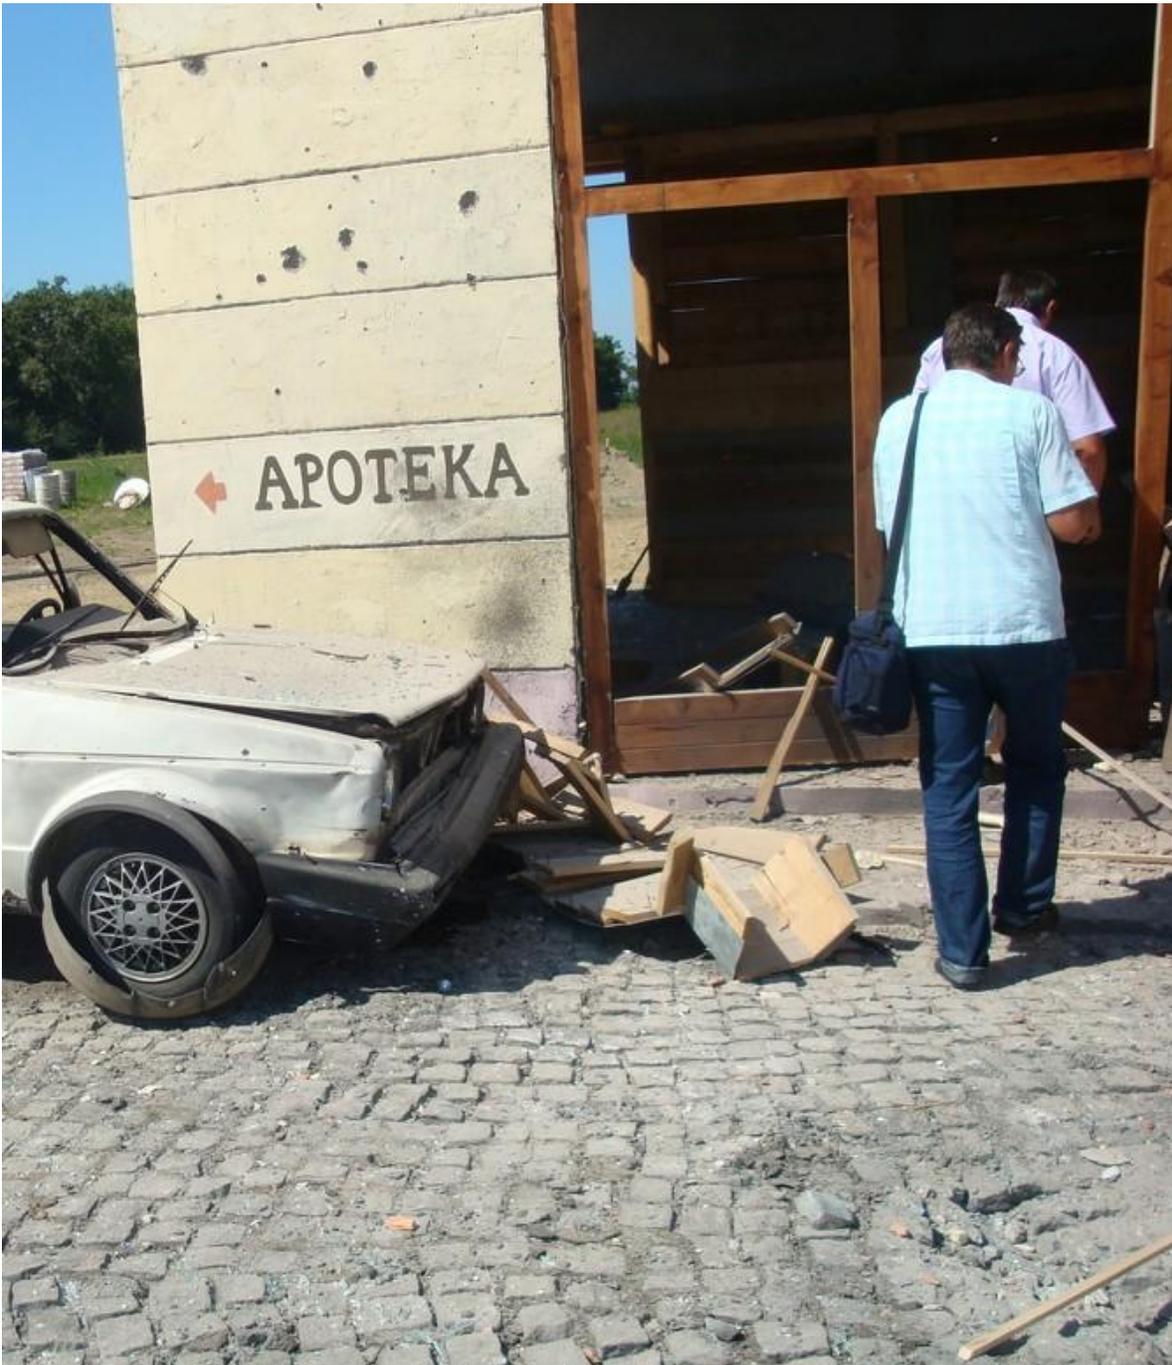
- On the lower part of facade, left from the "NIK" store shopwindow, one can notice several relatively small penetrations made by fragment action of the projectile, and level of damage

to that side of facade is significantly lower compared to the right side, all looked upon from the direction towards the facade, Figure 15 of the Report:

Figure 15 – Appearance of damage to the left part of "NIK" store object facade

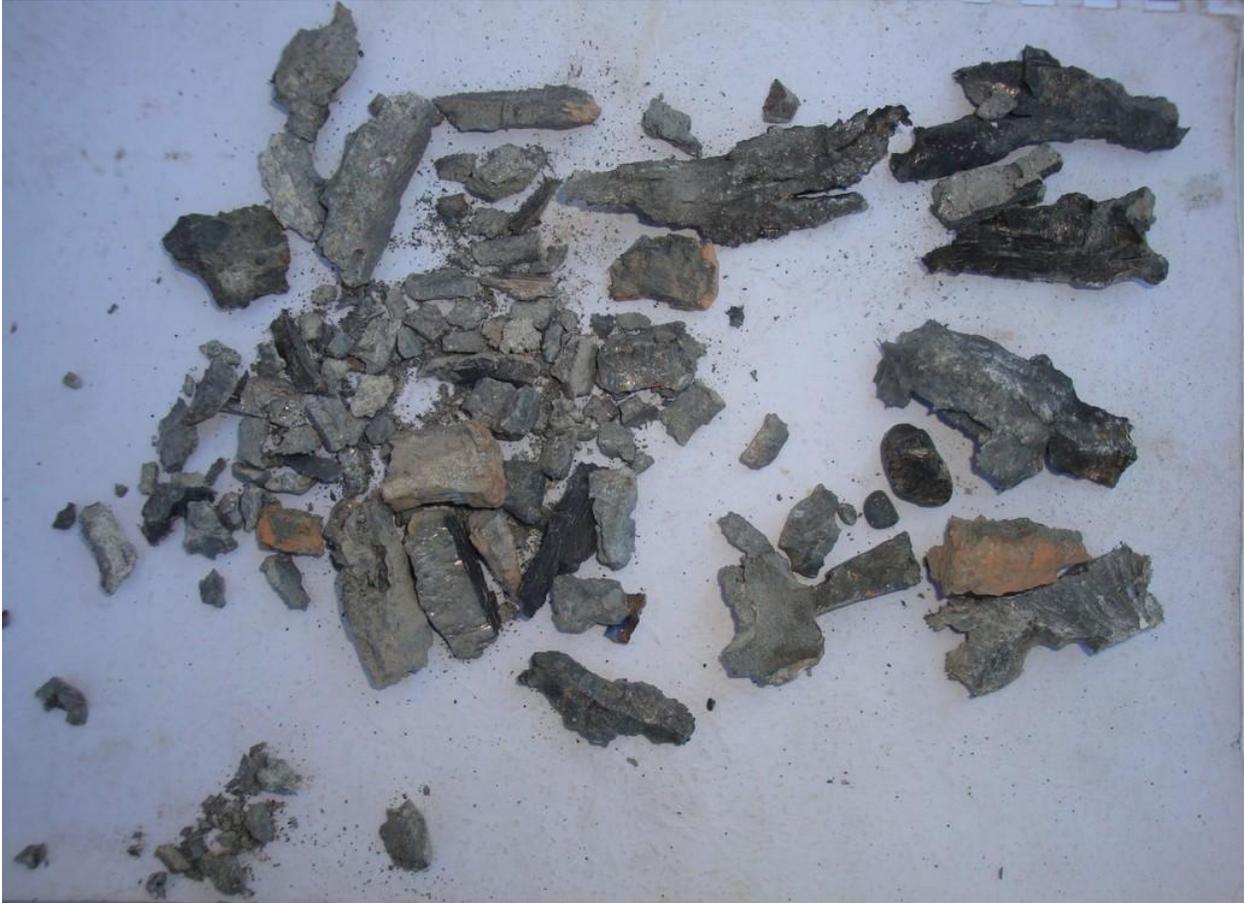
- During examination of collapsed and knocked-out parts of construction material, on the ground on the right side of the model facade, several dozen pieces of projectile body were found, different in size, Figure 16 of the Report:

Figure 16 – Pieces of projectile body, found on the ground on the right side of "NIK store" model facade

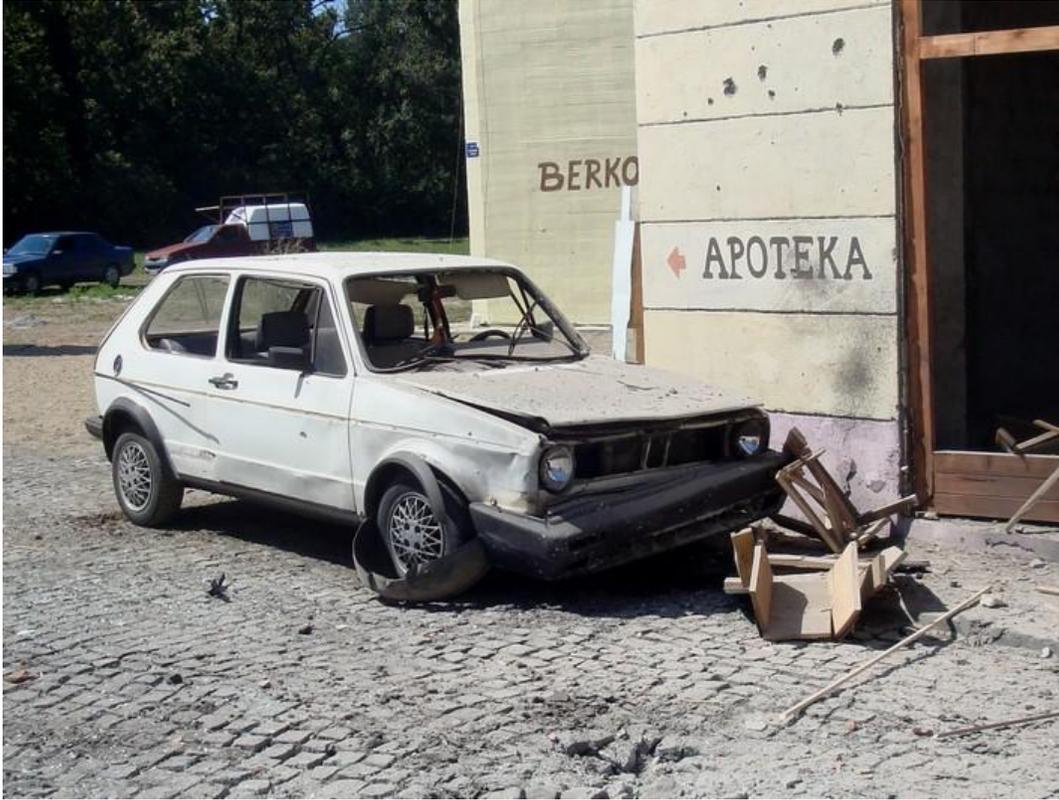
Figure 17 – Appearance of marks of oil leakage from the "GOLF 1" car

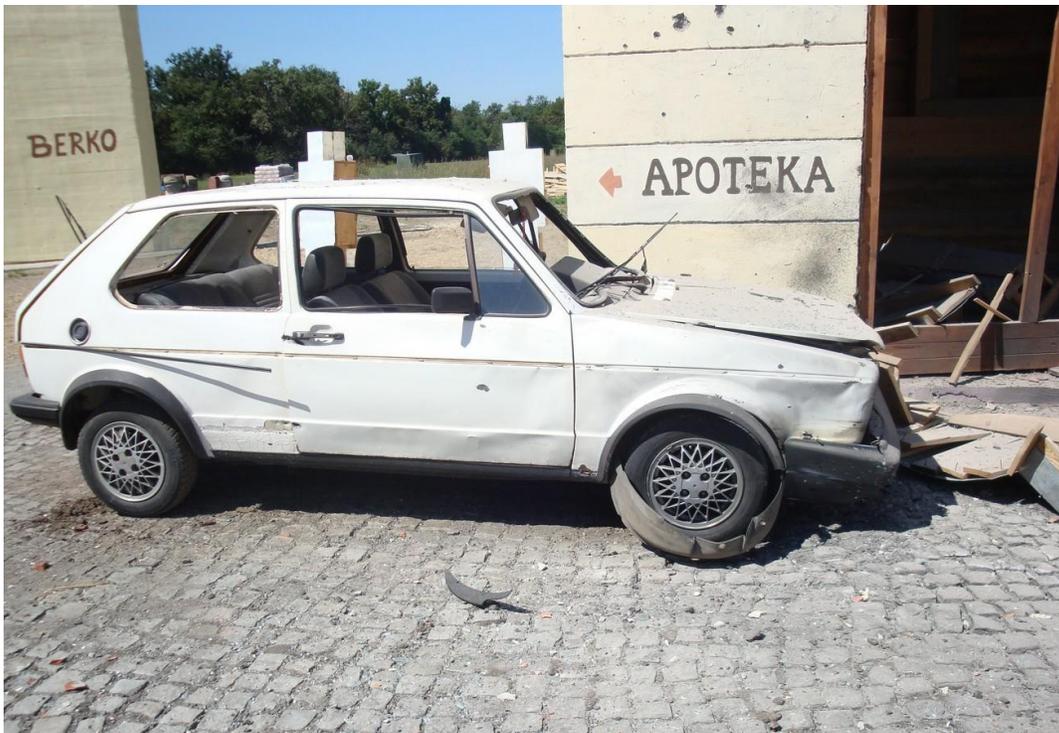
- "GOLF 1" car suffered relatively low level of damage: broken windshield, both windows on the right and left lateral side, roof of the car was bent inwards, bonnet was visibly deformed, front right fender was visibly bent on the spot in front of the wheel. On the right lateral side of the car three piercings made by fragment action were noted: on the fender behind the front wheel, two piercings on back vertical edge of front right door, one piercing immediately behind vertical edge of front right door, as well as three smaller ricochet marks- one on front right fender, one on right door, one immediately behind right door of the car. Glass on both headlights and grille of engine compartment were completely demolished i.e. destroyed, and front fender was partially ripped-off on the right side. Below the car, on the place of oil container, a trace of oil leakage is clearly visible, Figures 15 and 17 of the Report. Appearance of the car after the explosion can be seen on Figures 15, 16, 17 and 18 of the Report;

Figure 18 – Appearance of the car after the explosion, from the right side and partial appearance of the left side of the facade of "NIK" store object

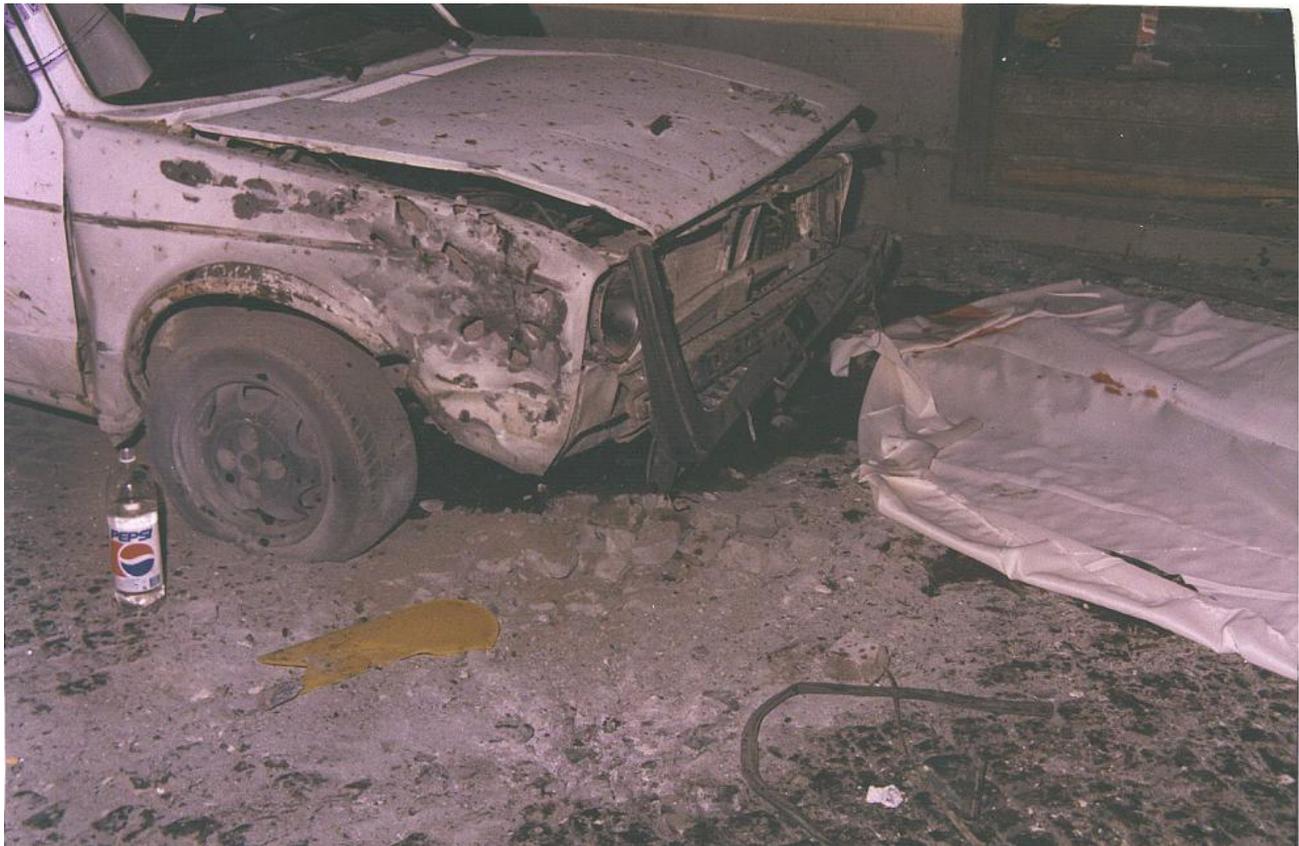
1. Crater shape and dimensions are noticeably different. Physical dimensions of the crater on the subject RCS from 25 May 1995 were described in the Record of investigation 25/26 May 1995, as a round form with diameter around 0.5m, Figure 19 of the Report.

Figure 19 – Place of crater in seen condition on the RCS during investigation on 25 May 1995

- From traceological aspect site of immediate explosion (crater) of OF-482M 130mm caliber projectile has no objective similarities with the crater which was found and determined as a trace during the investigation on 25/26 May 1995 on the place in front of "NIK" store;

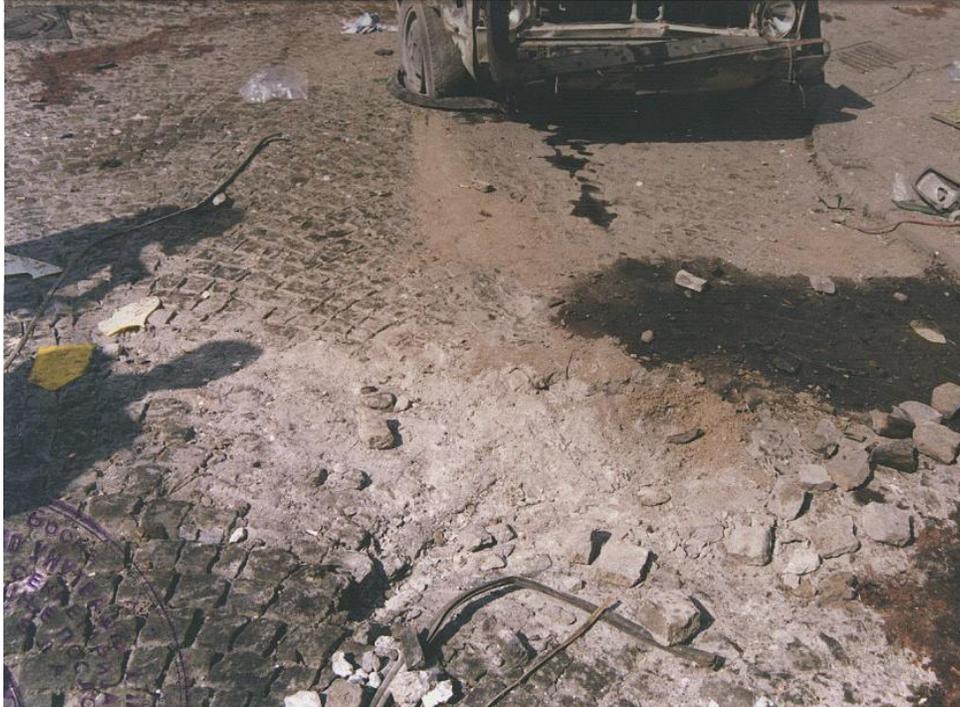
2. After clearing out the location of the crater on the site, on granite cube ground a crater was visible, with dimensions around 0.4m x 0.2m, evaluated depth 10 to mostly 15cm, from the same crater a furrow was visible which pointed its peak approximately in the direction where the front right wheel of the car was at the moment of explosion, Figure 20 of the Report;

Figure 20 – Appearance of the crater on the site of subject event

4. From the crater on the site of subject case a furrow clearly goes out, which can be, from traceological aspect, defined or explained as a furrow from a fuze or some other metal object ejected by an explosion, Figure 20 of the Report. From the crater obtained by experiment there isn't a visible mark from fuze furrow, and pieces which could be identified as fuze body were not found. This points out to an objective possibility that it, during the explosion, broke by hitting a granite cube which was in its immediate vicinity at the moment of explosion;

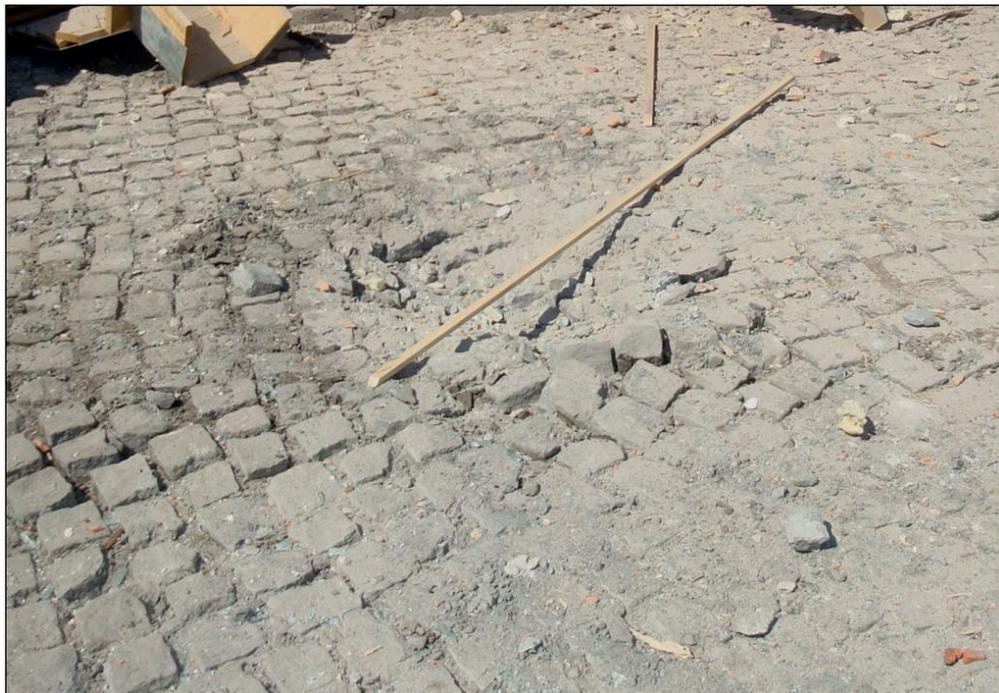
3. Appearance of the crater obtained after experimental explosion caused on 29 August 2014, it is ellipsoidal in form (ellipsoidal calotte) with dimensions around 0.8m x 0.6m, depth around 15cm, Figure 21 of the Report;

Figure 21 – Appearance of the crater obtained with experimental explosion

- The fact that during the experiment from 29 August 2014 all of granite cubes remained inside the crater and obviously without significant damage, gives base for objective and expertly correct claim that on the RCS from 25 May 1995 in Tuzla did not explode any kind of projectile;

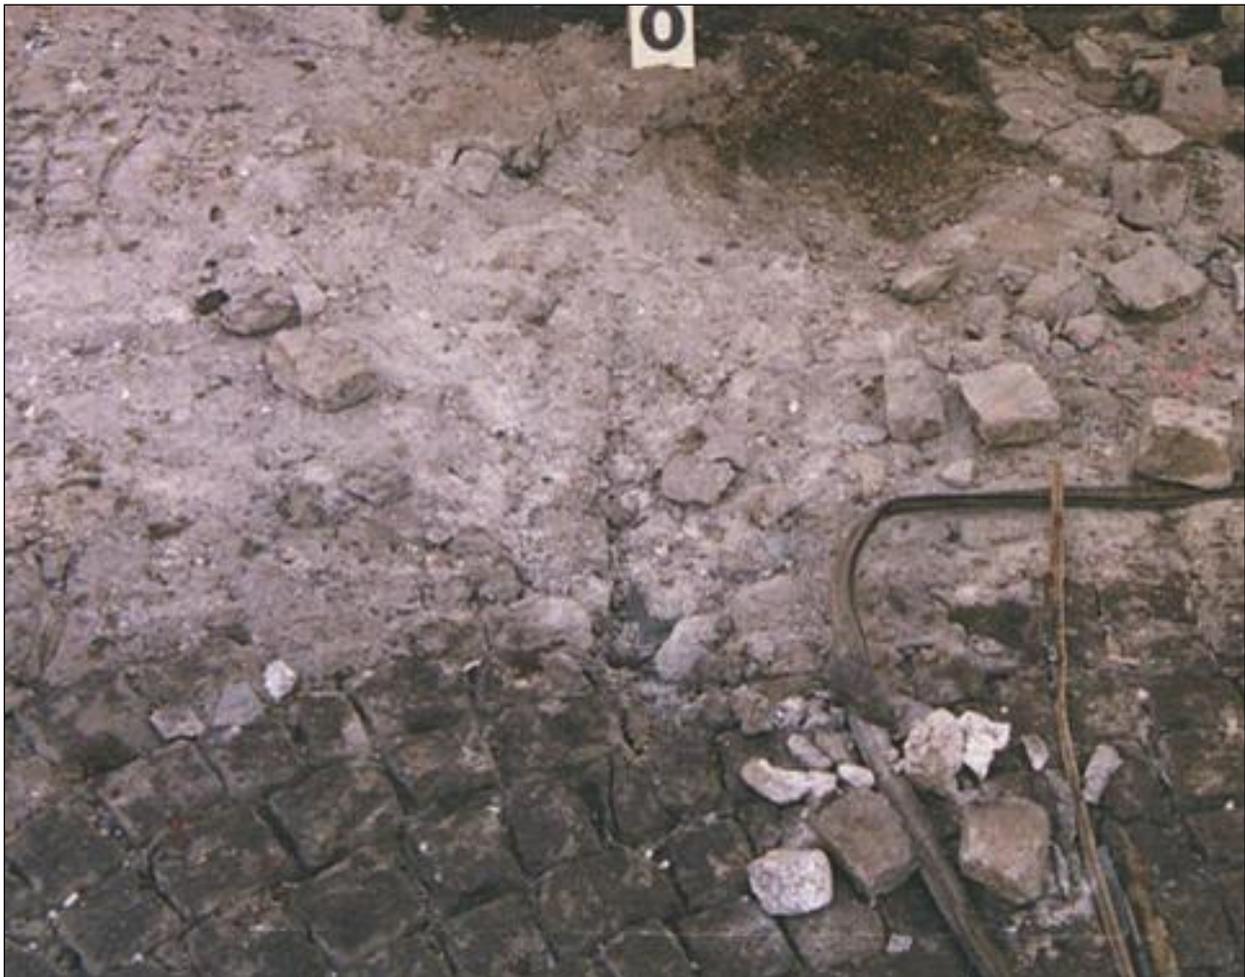
5. On the site around experimental crater there are no significant marks from granite cubes, sand or dust, which could originate from the crater, Figures 20 and 22 of the Report, whereas in the subject case on Kapija locality, i.e., on the RCS, ground moving traces are clearly visible, granite cubes, sand or dust, and in the amounts which cannot be explained by effects of explosion of any explosive device. The only logical explanation for presence of the mentioned ground moving traces on the RCS, is that they were brought to the place, from a possible reason- to change ground configuration of the RCS;

Figure 22 – Appearance of furrow made by fuze or some other metal object with ground moving traces from granite cubes, dust or sand

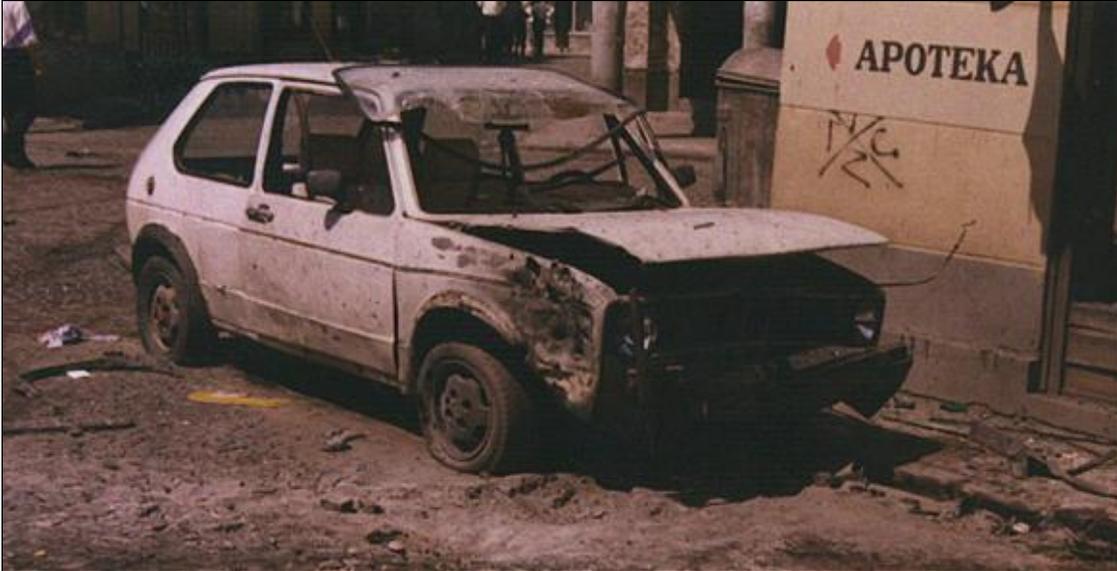
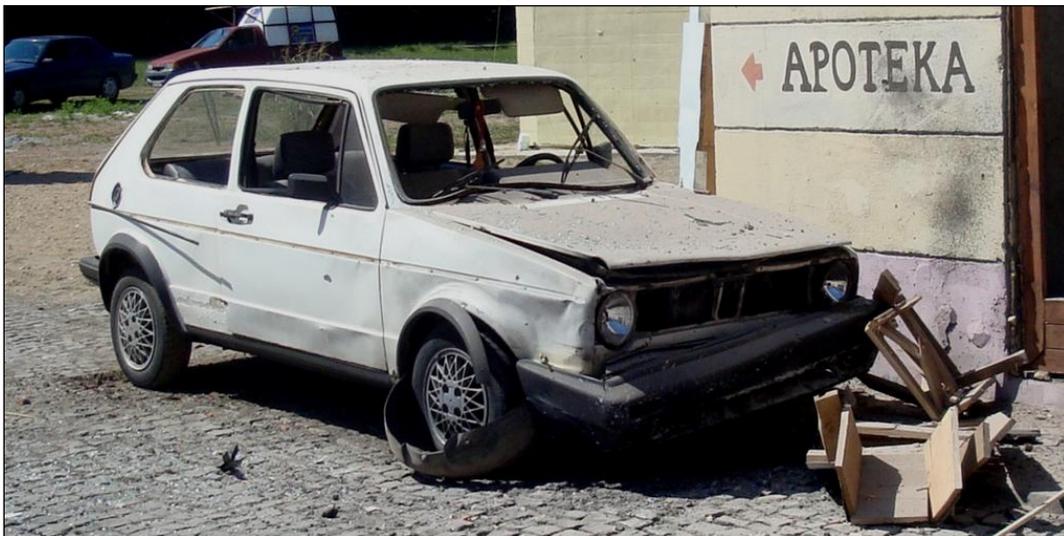
6. Damage to vehicles model VW "GOLF 1" are apparently and completely different, so a special comparative analysis of damage to first and second vehicle has no real expert sense. The only same thing in found damage to both vehicles is the damage to oil container and engine radiator, due to which, beneath the vehicles puddles can be seen, which can originate from motor oil and coolant fluid, Figures 23 and 24 of the Report;

Figure 23 – Appearance of the subject car "GOLF 1" with visible consequences of the explosion

Figure 24 – Appearance of the "GOLF 1" car used during experimental projectile explosion, with visible consequences of the explosion

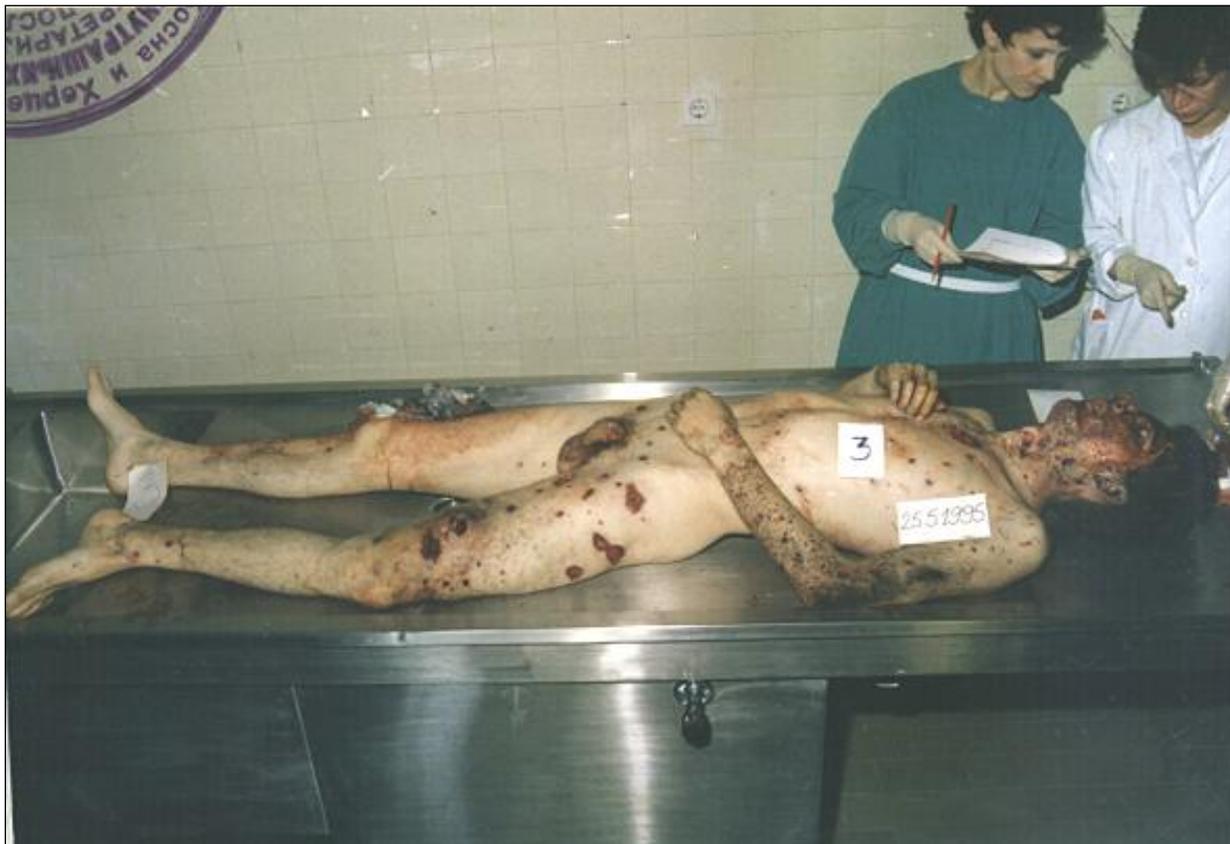
9. Description of injuries to Hasanović Senad's body is as follows: "Defects of skin on the front outer side of body to the left, left arm and left leg, which continue in-depth with multiple fractures of left thigh bone", Figure 25 of the Report;

Figure 25 – Appearance of injuries to body of deceased Hasanović Senad

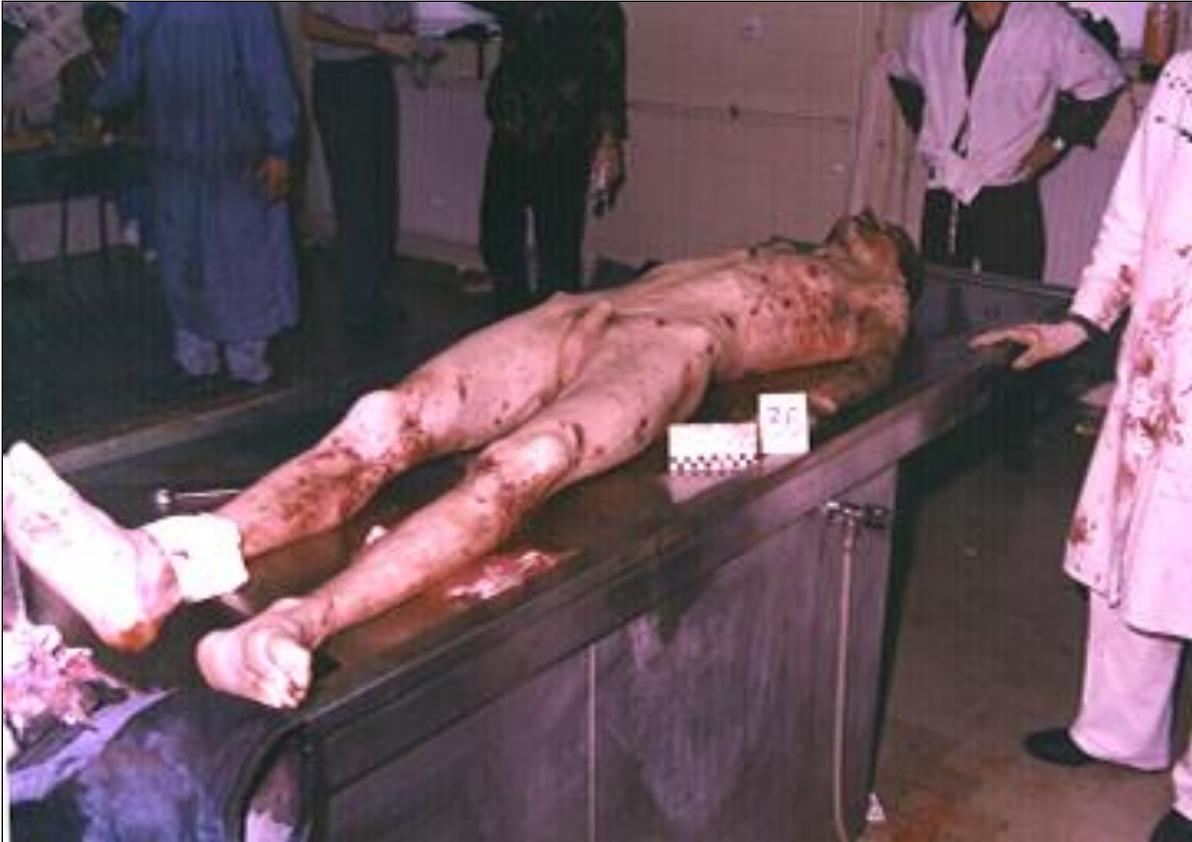
10. Description of injuries to Alispahić Admir's body is as follows: "Numerous small defects of skin to the left lateral side of body, limbs, and inner part of right leg", Figure 26 of the Report;

Figure 26 – Appearance of injuries to the body of deceased Alispahić Admir

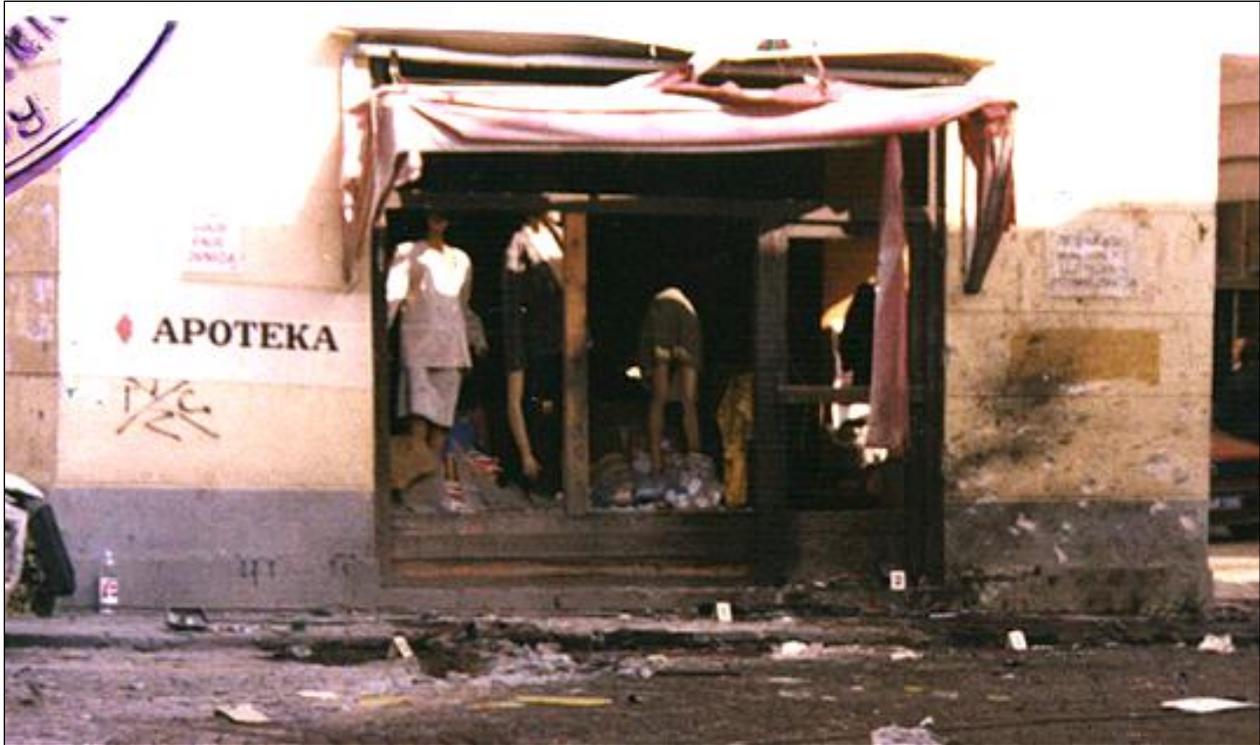
11. The fact that both dolls set up in the shopwindow of "NIK" store object fell during the experimental projectile activation, and that they suffered significant damage and hits from fragments of projectile body, and that dolls in the shopwindow of "NIK" store at the RCS weren't even knocked down and that they remained basically undamaged, Figure 27 of the Report, objectively points out to the fact that conditions and spreading of explosion action products on RCS were significantly different, which also points out that in the considered cases, devices which exploded have completely different characteristics of action on the target. On the same Figure, on the facade on the left side of "NIK" store shopwindow, there are no visible traces of fragmentation action above the inscription "APOTEKA" (*means: PHARMACY*), as in the case of projectile experimental activation on the proving ground in Nikinci on 29 August 2014, which can clearly be seen on Figure 15 of the Report;

Figure 27 – Appearance of dolls in “NIK” store shopwindow, on the RCS
