**ADDITIONAL BALLISTIC EXPERTISE ASSOCIATED TO THE
EVENT AND CIRCUMSTANCES IN CASE OF EXPLOSION AT
"KAPIJA" LOCALITY IN TUZLA ON 25 MAY 1995**

REPORT AND OPINION

**Court expert for ballistics, firearms and cold weapons MSc. Vlada Kostić,
B.Sc.M.E., in cooperation with qualified person for ballistics Branka
Luković, B.Sc.M.E.**

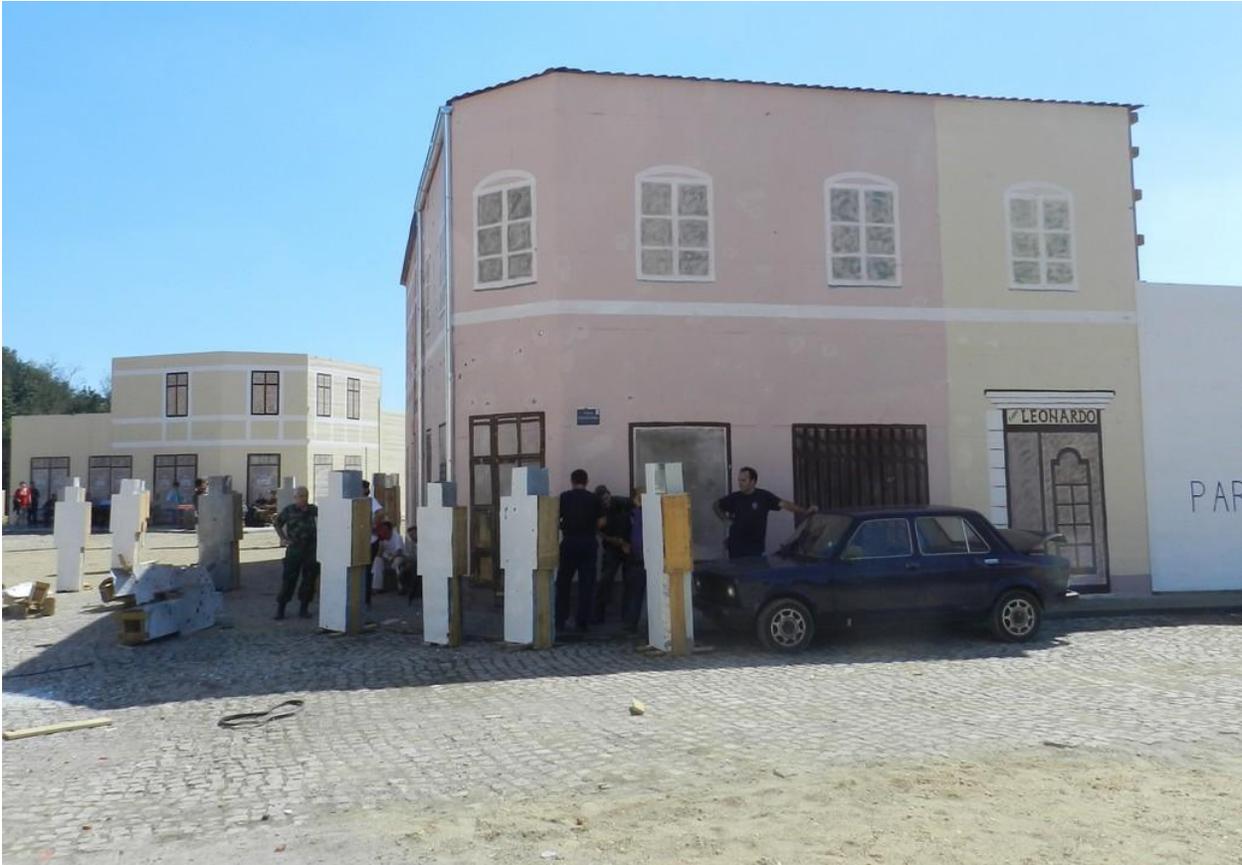
12. Appearance of fragmentation action on the corner of building, to the left from cafe “Leonardo”, after experimental projectile activation, with visible fragmentation action traces on the lower half of facade on the corner. To the left from building, three dolls are visible, knocked down by fragmentation action of projectile explosion, as well as one doll standing, across from the door on the corner, hit by fragments. According to the Wider sketch of the site No. 20-1/02-3-9-7-195/95, on the place of knocked down dolls there were no biological traces found, i.e., injuries of people, Figure 28 of the Report;

Figure 28 – Appearance of fragmentation action on building corner, left from “Leonardo” cafe, after experimental projectile activation, with visible fragmentation action traces on lower half of building facade, on the corner

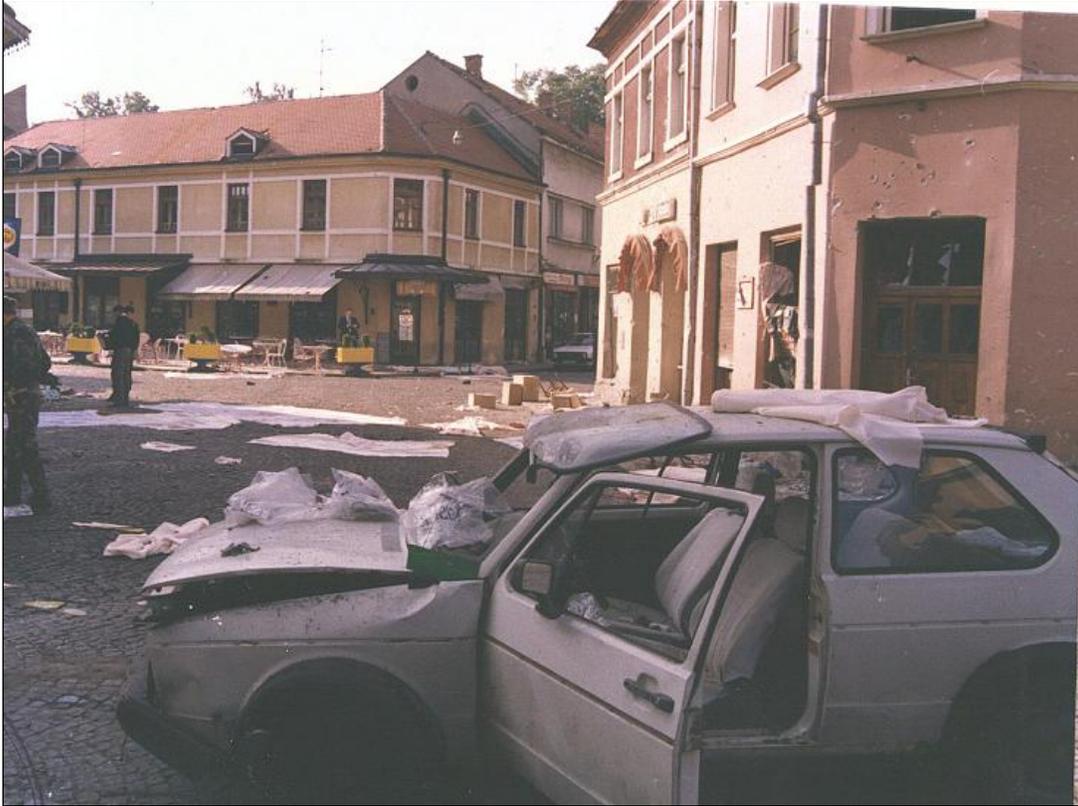
13. Appearance of fragmentation action on building corner, left from “Leonardo” cafe, on the RCS, with outnumbering and clearer fragmentation action traces on and above the door and on the lower half of building facade, Figure 29 of the Report, compared to traces on corresponding object shown on Figure 28 of the Report;

Figure 29 – Fragmentation action appearance on building corner, left from “Leonardo” cafe, on the RCS

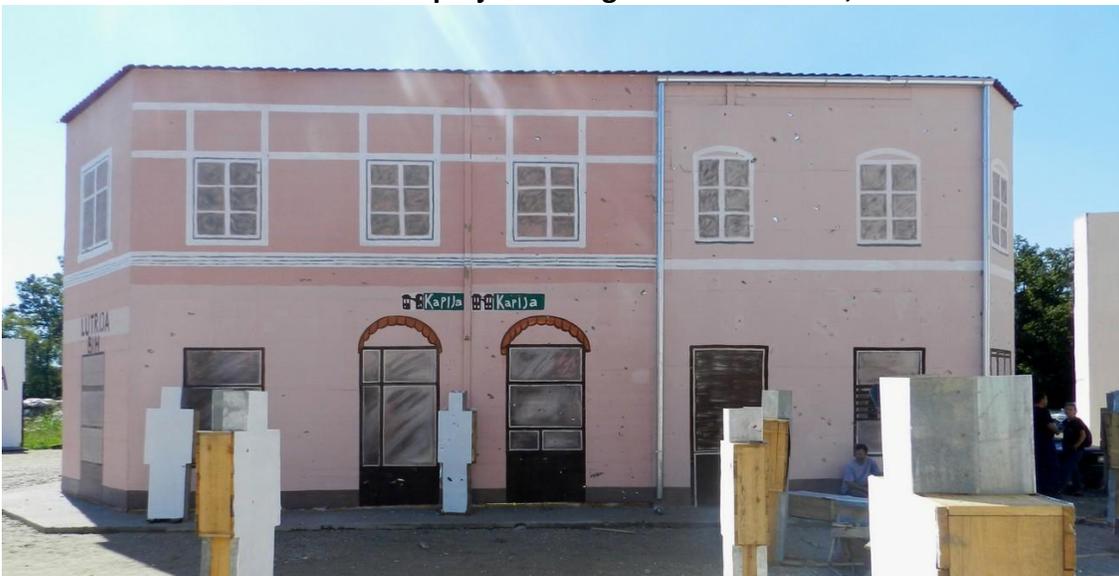
14. Appearance of central facade part on “Kapija” premises with fragmentation action traces of projectile activated during the experiment, with doll between entrances to premises, on which also can be observed traces of projectile fragmentation action;

Figure 30 – Appearance of central facade part around “Kapija” premises, with visible fragmentation action traces of projectile activated during the experiment

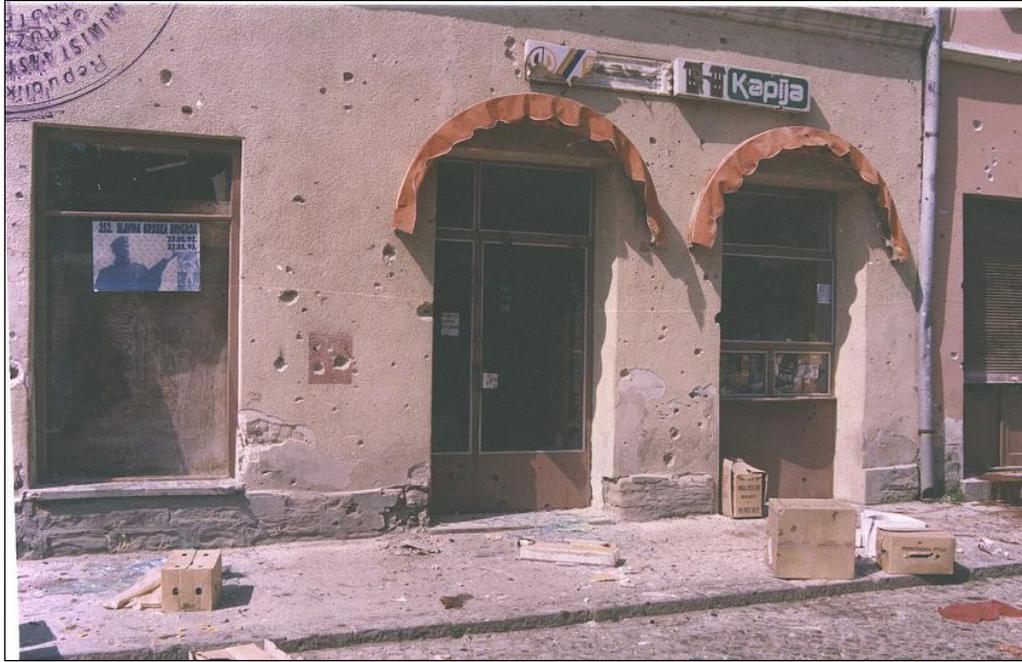
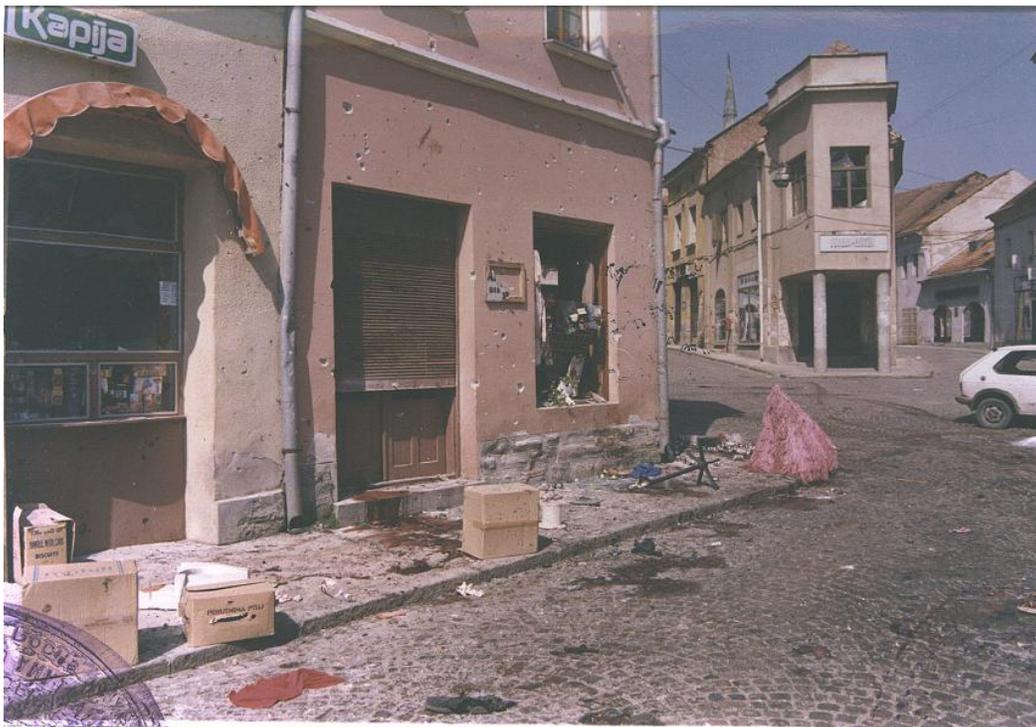
15. Appearance of central and right part of "Kapija" premises facade, on the RCS, Figures 31 and 32 of the Report, with outnumbering, wider and deeper traces of fragmentation action, compared to traces on corresponding object on Figure 30 of the Report, without visible traces of biological origin between entrances to the premises;

Figure 31 – Appearance of central facade part around "Kapija" premises, on the RCS

Figure 32 – Appearance of right facade part around "Kapija" premises, on the RCS

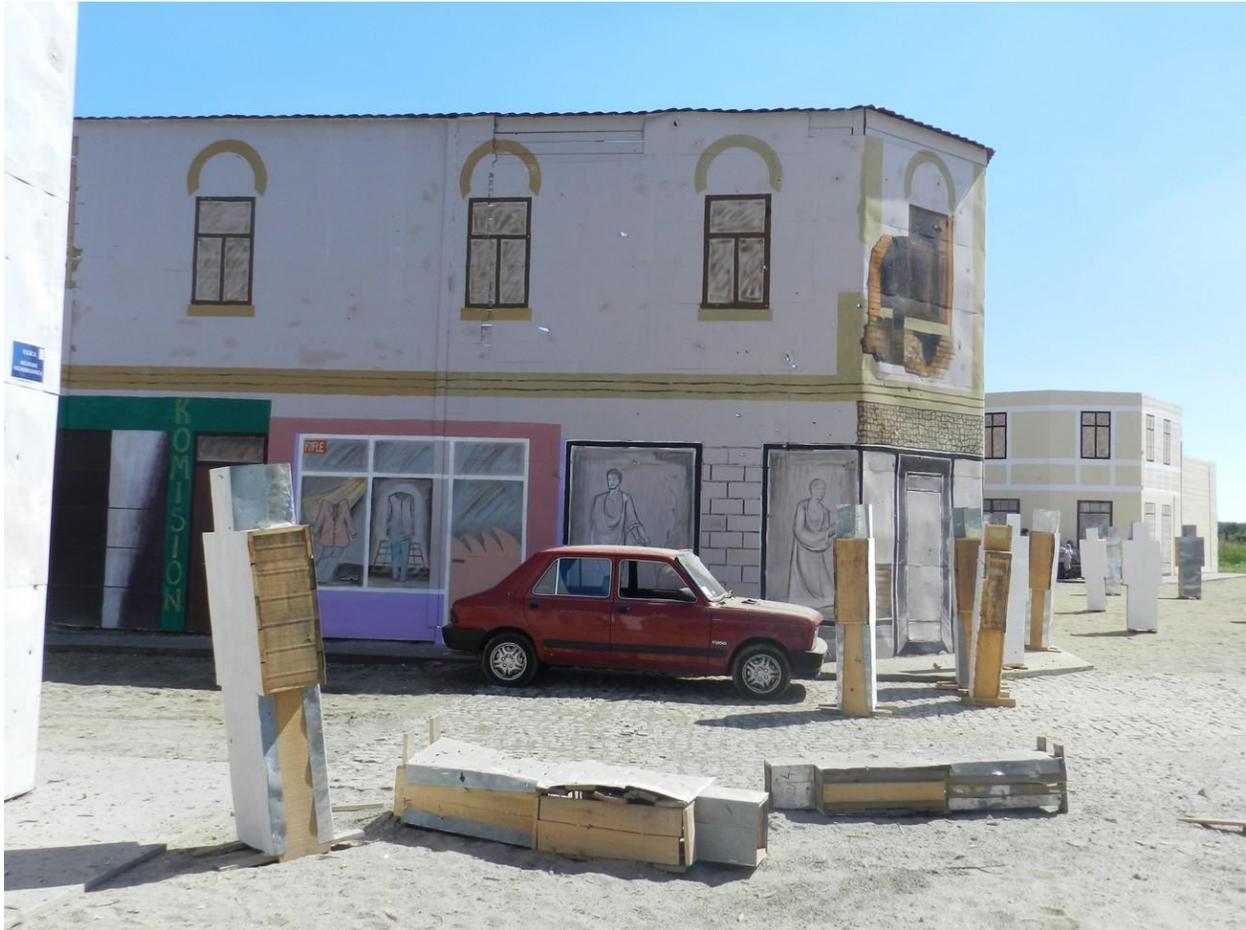
16. Appearance of Partizanska Street right part, on the place of "Komision" store, looked upon from a place in Mustafe Mujbegovića Street, with visible relatively rare traces of projectile fragmentation action on upper part of building's facade and two knocked down dolls on the left side of the same Partizanska Street, crossroads of Mustafe Mujbegovića Street and Partizanska Street, Figure 33 of the report;

Figure 33 – Appearance of right part of Partizanska Street, on the place of "Komision" store, looked upon from the place of experimental explosion

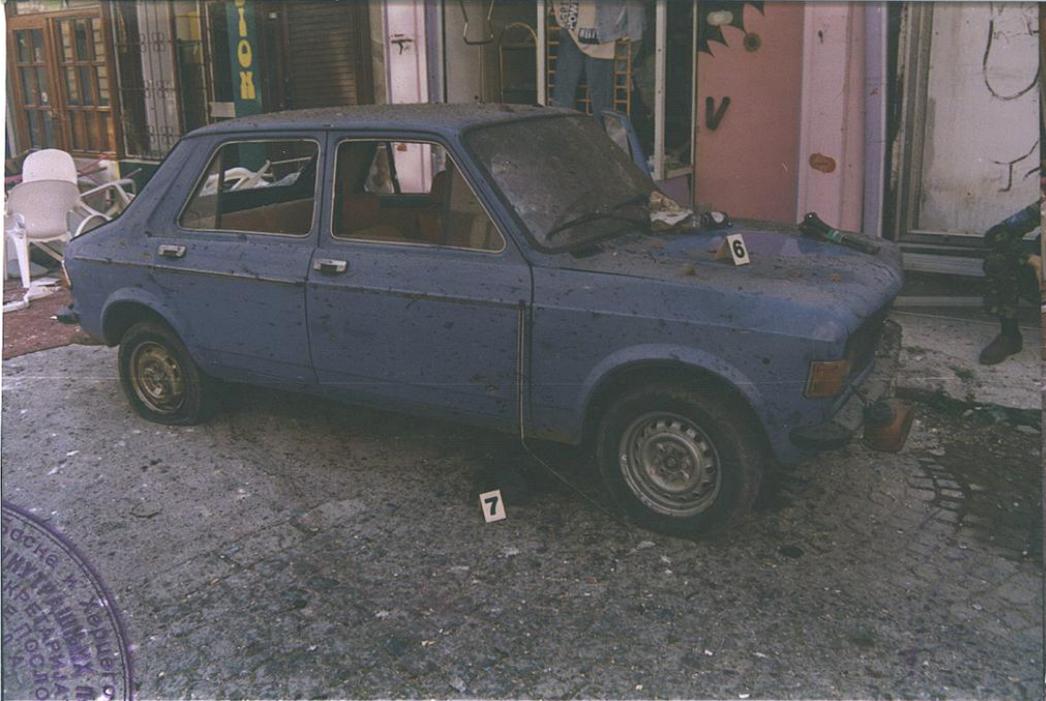
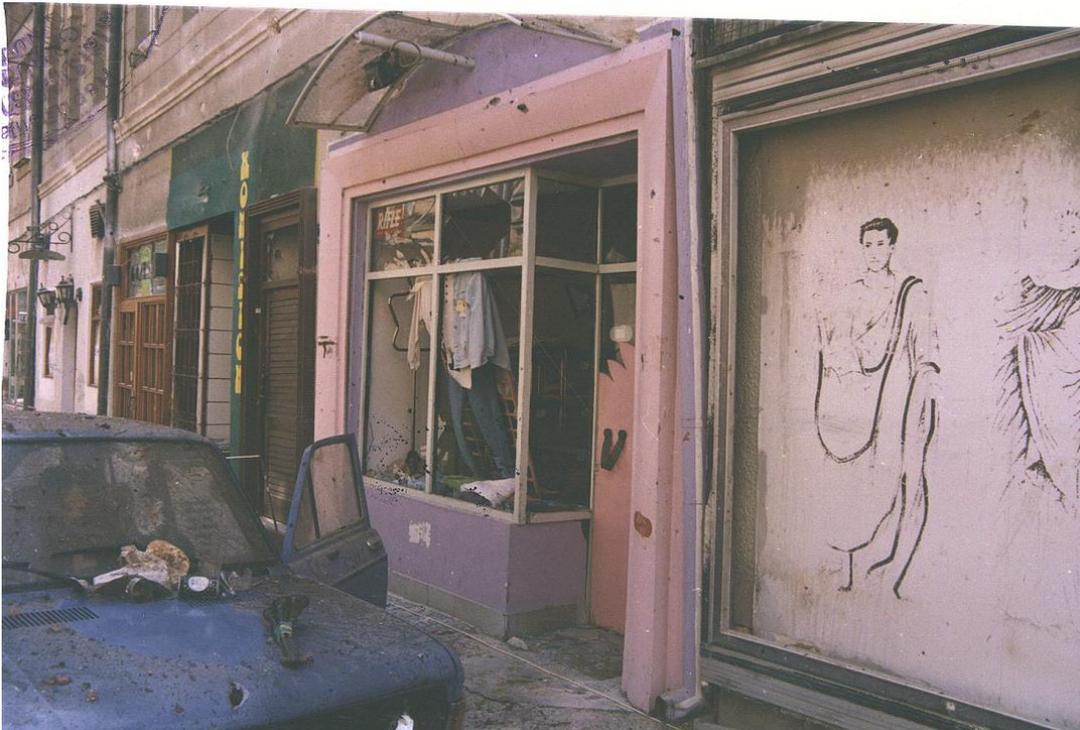
17. Appearance of right part of Partizanska Street on the place of "Komision" store, looked upon from the place of explosion in front of "NIK" store, with visible projectile fragmentation action traces on shopwindows of store and on parked Z-101 blue car, Figures 33 and 34 of the Report;

Figure 33 – Appearance of the right part of Partizanska Street on the place of “Komision” store

Figure 34 – Closer look on the right part of Partizanska Street, on the place of “Komision” store, with shattered shopwindow, damage to the building facade and parked Z-101 car
