TECHNICAL ASSESSMENT
EXPLOSION AT TUZLA MAY 25th, 1995

MISSION DATED FEBRUARY 9th, 2016

Pierre LAURENT
Expert commissioned by Appeal Court of Paris, IPC
Arms, Ammunitions, Ballistics, Pyrotechnics
INPG engineer, Msc, DEA, DBA, Marines Troops Captain (R)

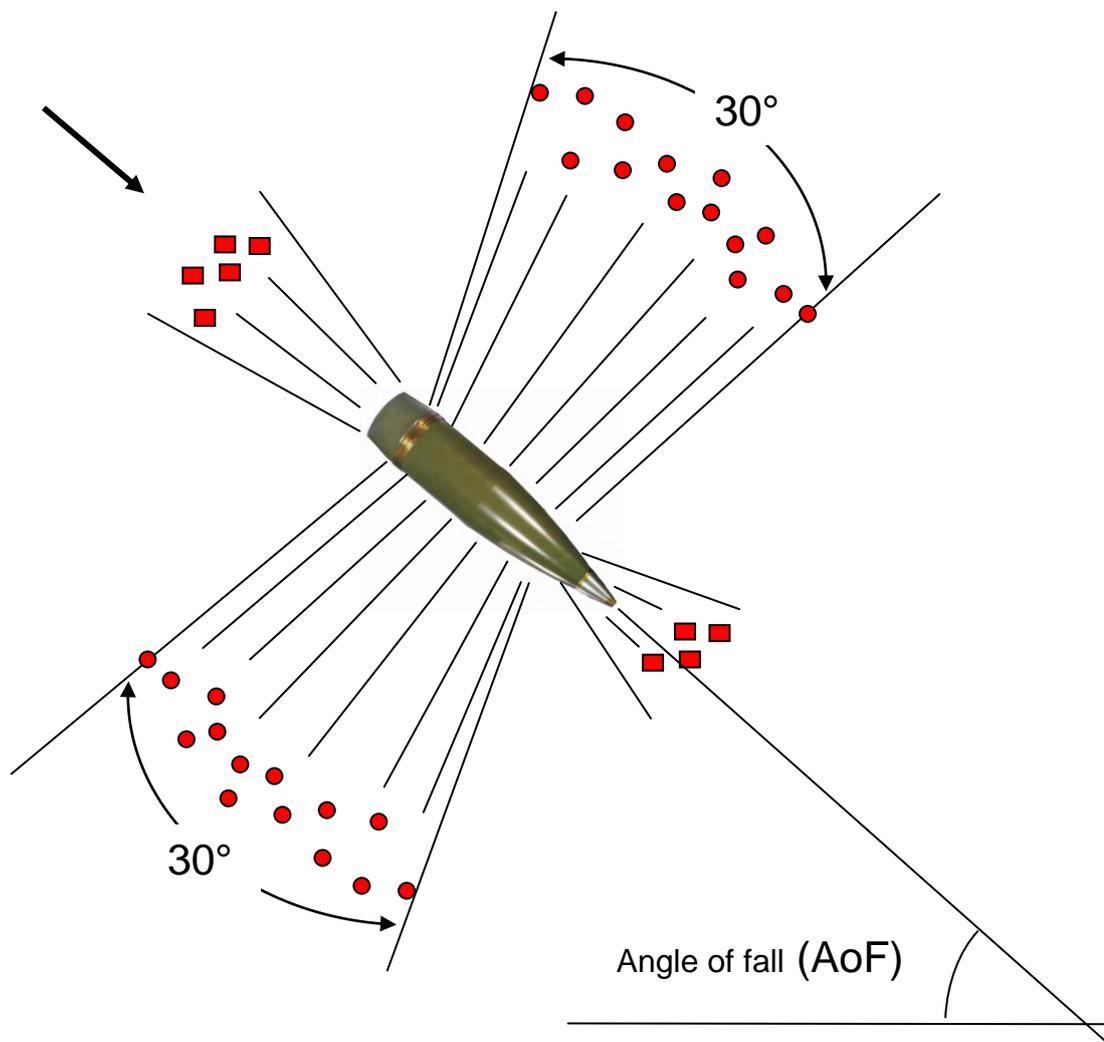
The effect of the projectile is mainly achieved by the kinetic energy of numerous lateral fragments which are calibrated in inflict damage both to soft skin targets and armoured vehicles. The spread of lateral fragment forms a pattern which is typically $\pm 15^\circ$ as per sketch here after. The fragments spreading from the base (tail spread) or the nose (nose spread) are fewer. They have little interest from a tactical point of view when impact fuses are used since these fragments are directed towards the earth or towards the sky.

As already described by Prof. Berko ZECEVIC, the "killing zone" of the lateral fragments depends on the "angle of fall" (AoF).

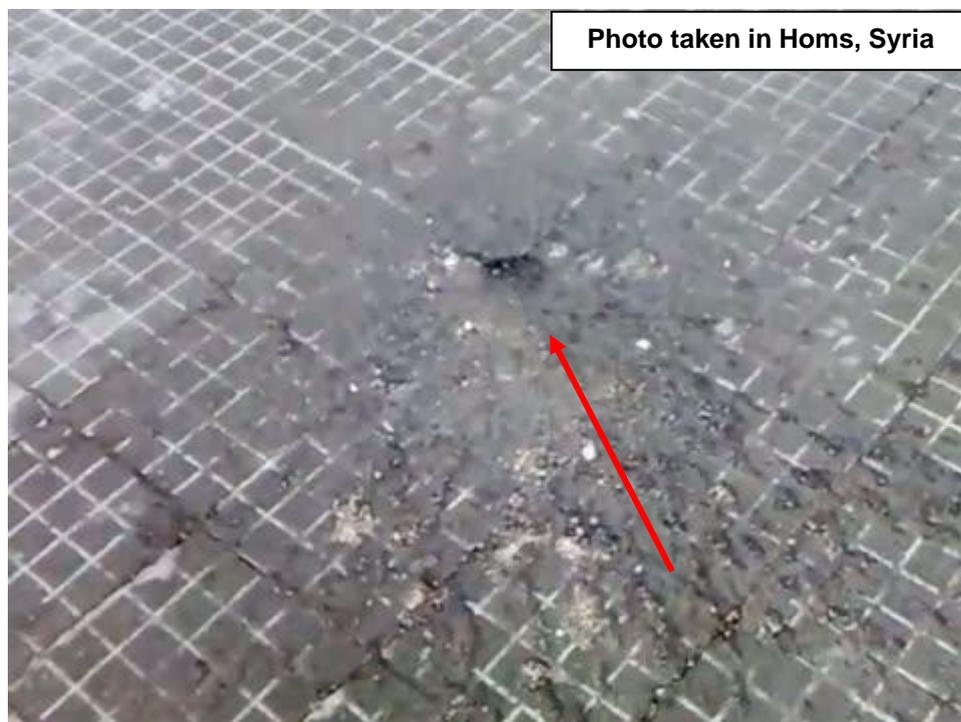
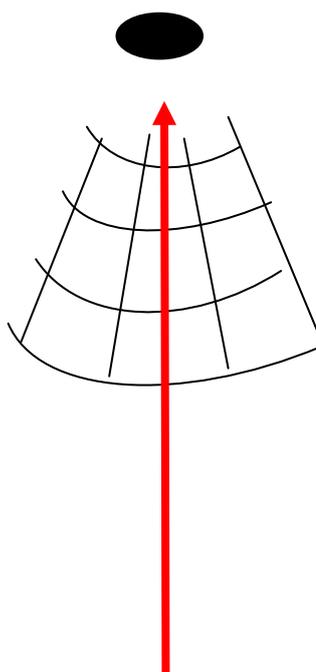
Depending on the Angle of Fall (AoF), traces may be left on the soil that indicates the direction from which the projectile was coming. We show here below an example of an impact on concrete for which the incoming direction is fairly obvious.

If we were to interpret the sketch of crim. tech. Irfan Džinović in that way, it might be envisioned that a projectile came from the East.

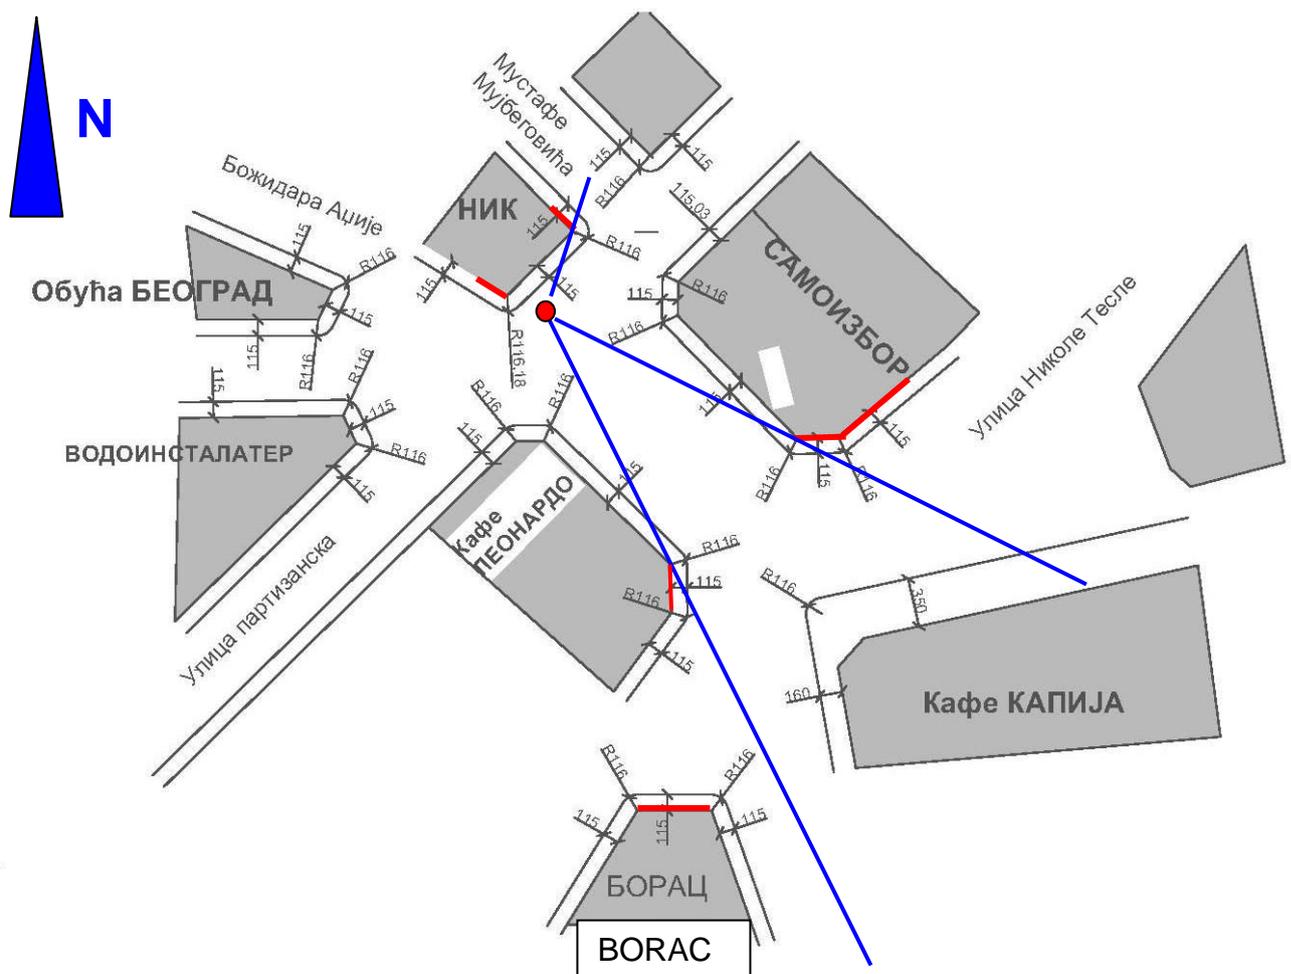
On the sketch here after, in red, are shown places where there should not be any impact from fragments coming from the explosion at the NIK building. Yet, we are sure there are some on the south corner of the building samoizbor and on the Borac building. We suspect there might be some impacts on others places where they are not expected.

These findings might cast a different light on the entire case but were not investigated by Prof. ZECEVIC.

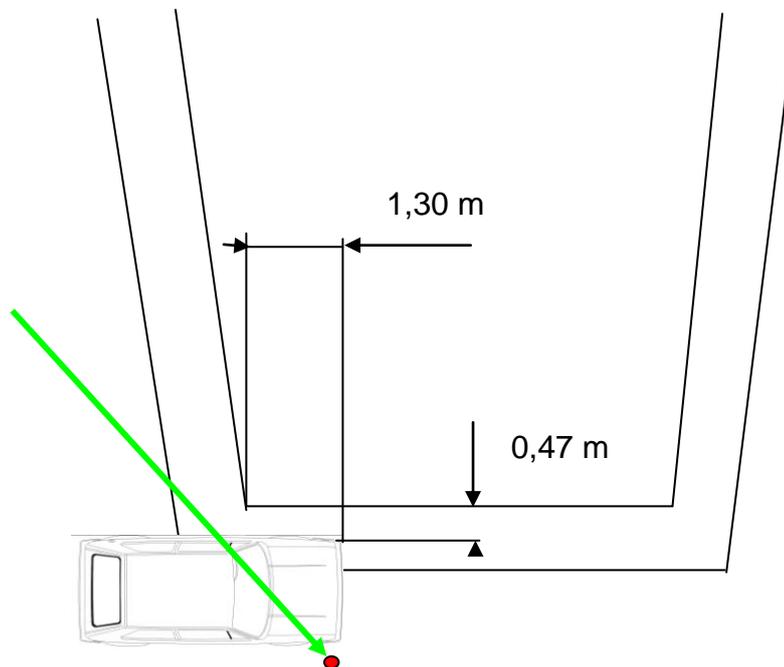
The projectile used for the experiment is a regular Russian HE projectile OF 482M 130 mm projectile with nose pointing as if the projectile was travelling from azimuth 271°. Point of impact is set as in reconstruction by Prof. Berko ZECEVIC, i-e the point of impact is at 2,65 m from south corner and at 5,60 m from north-east corner of NIK building in accordance with the files of investigative judge. The car was placed at 0,47 m and 1,30 m from the NIK building facade as in reconstruction by Prof. Berko ZECEVIC. Angle of fall was set at 62° by ourselves using our own clinometer. By doing this, the projectile is touching the GOLF Mk 1 right front aisle.

Note : *we have to point out that the car was placed at 0,47 m from the wall only because Prof. ZECEVIC did so.*

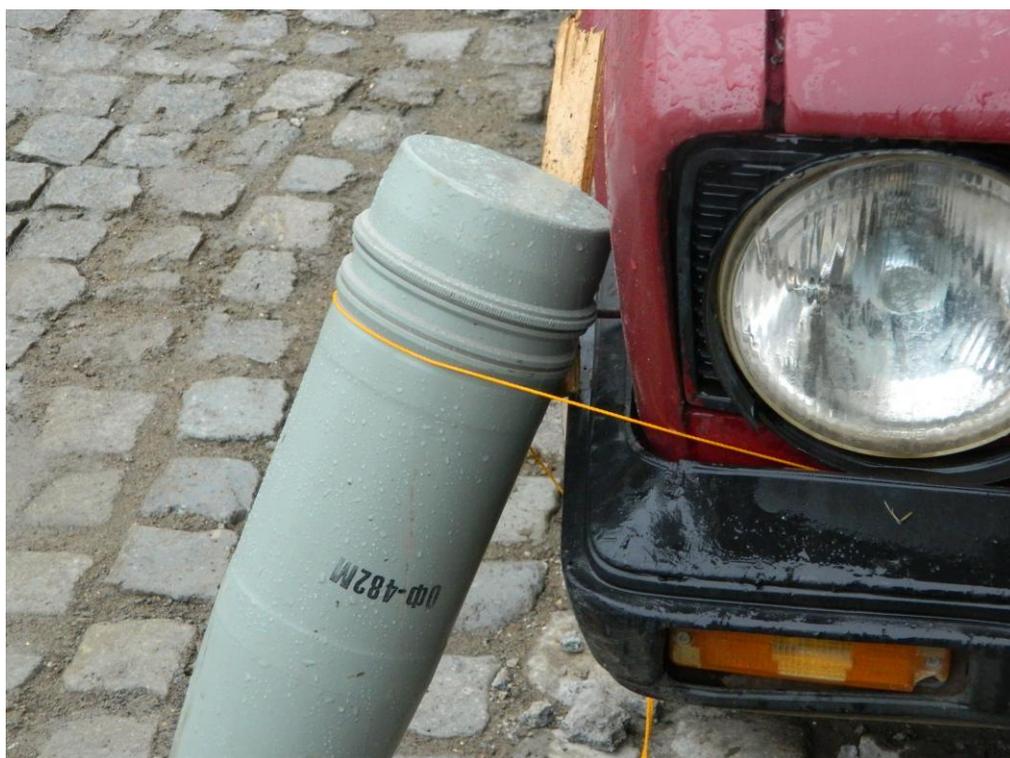
**Projectile placement (photo from front)
The projectile touches the aisle of the car**

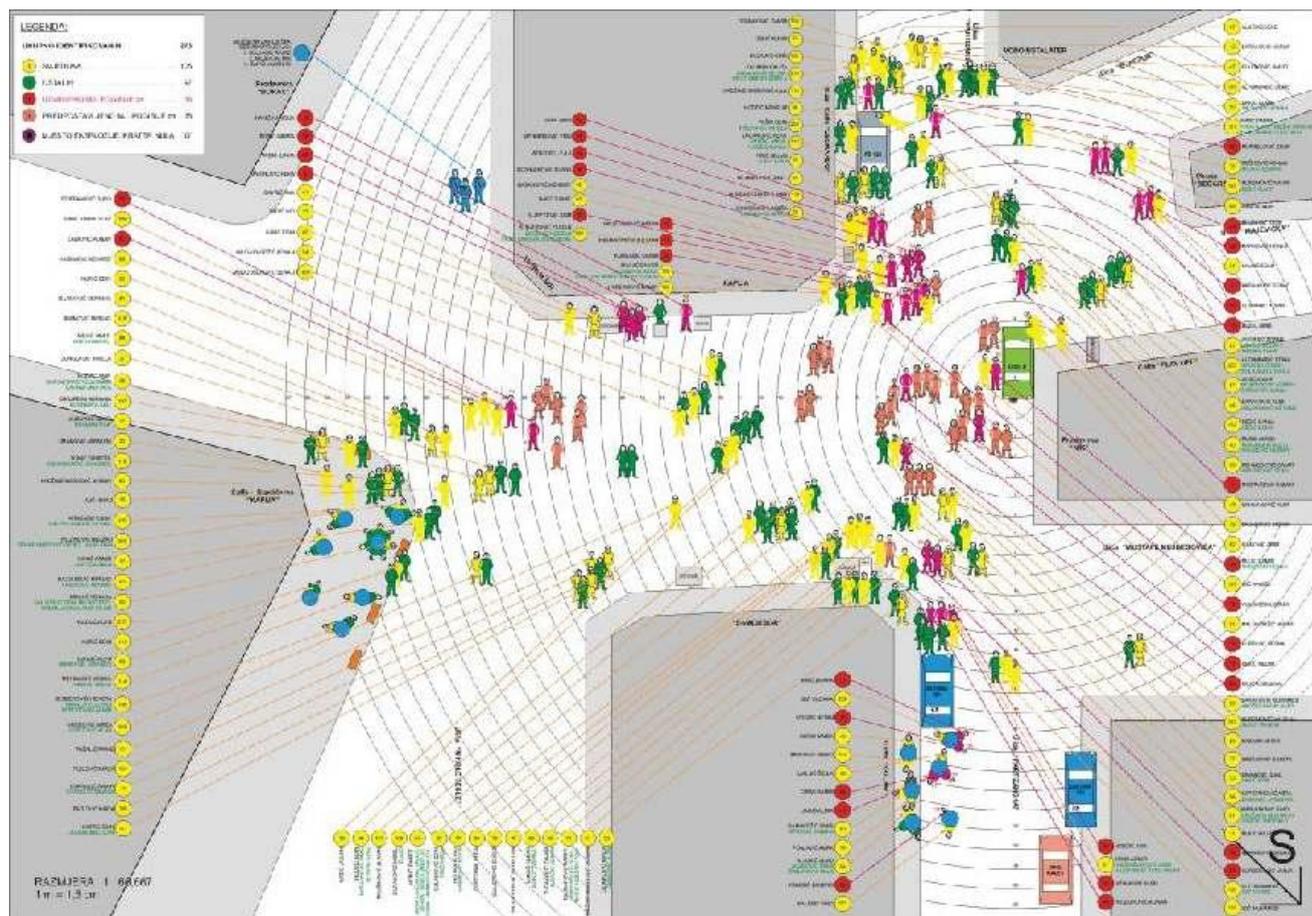
Wooden dolls were placed at locations where it is thought people died with a certain degree of certainty. They were numbered according to the numbers that were attributed to the victims. These locations were counter-validated by Israeli expert Joseph SHARON based on various data from videos, photos or witness statement.

Sketch of victims placement (only red figures are the ones who died and have a reliable placement at the moment of explosion)
