1. REPORT DATE April 2016			2. REPORT TYPE Technical report		3. DATES COVERED	
4. TITLE AND SUBTITLE Review of <u>Dr. Zecevic</u> expert opinion report conclusions regarding the causes and results of the explosion occurred at Kapiia square in the city of Tuzla on 25/05/1995					5a. CONTRACT NUMBER	
					5b. GRANT NUMBER	
					5c. PROGRAM ELEMENT NUMBER

6. AUTHOR(S) Sharon Joseph					5e. TASK NUMBER	
					5f. WORK UNIT NUMBER	
					8. PERFORMING ORGANIZATION REPORT NUMBER 32-16	
7. PERFORMING ORGANIZATION NAME(S) AND ADDRESS(ES) <u>Temech-Consultants</u> Tel-el 2516700 Israel					8. PERFORMING ORGANIZATION REPORT NUMBER 32-16

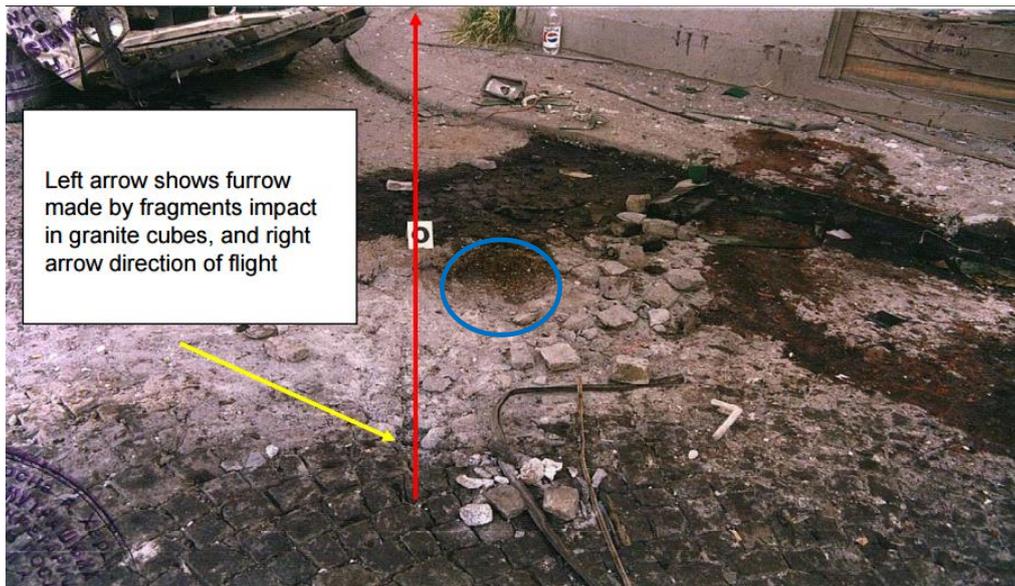
5. Contrary to the aforementioned, Dr. Zecevic determined the original direction of the fire by relying on the particular furrow in the ground, while determining that its source is the shrapnel from the shell, and that it could indicate the direction of shooting. However, in-depth study of that same furrow indicates that this **furrow does not derive from the center of the blast but it continues in parallel to the blast center**, as can be seen in the image.

It is probable that the furrow on which Dr. Zecevic based his determination is the result of cracking, crushing and separation of flagstones that were arranged in semi-circular shapes and which served as the paving surface of the road and sidewalk. Basing the determination on this furrow is erroneous and does not indicate the source of the fire.

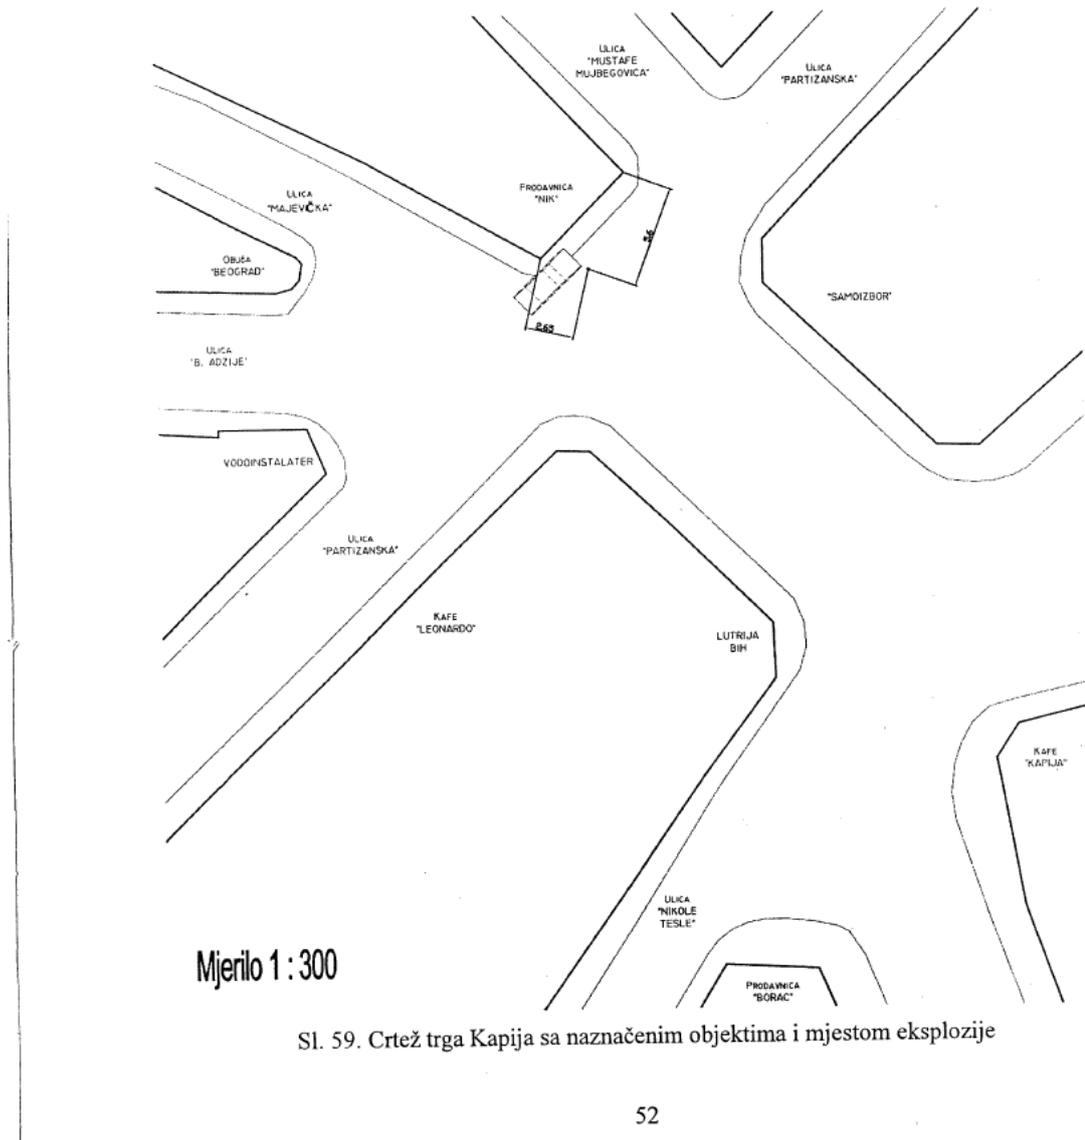
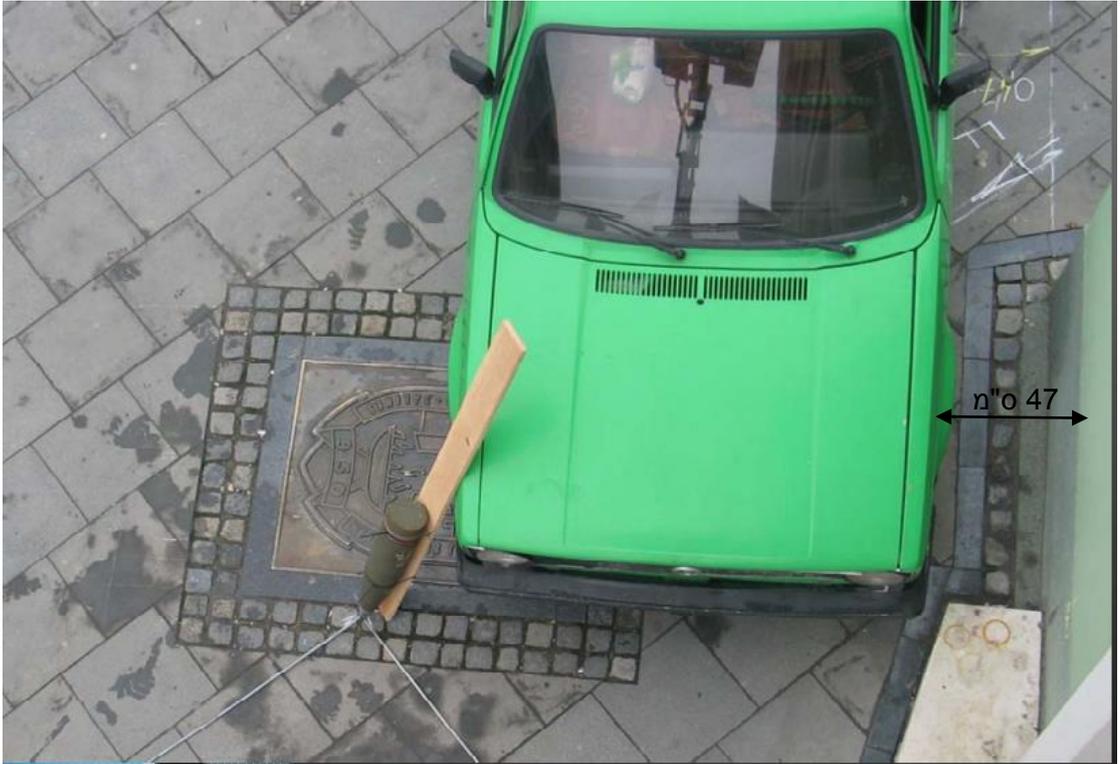
To validate the assertion concerning the direction and angle of firing the shell so as to suit his findings in the field, the prosecution's expert positioned the "Golf" vehicle at a distance of 47 cm from the building, while the front vehicle's bumper is 130 cm away from the corner of the building (page 62 of the original report). Dr. Zecevic determined that this location of the vehicle from the wall necessitates the vehicle being parked so that the two left wheels were on the sidewalk at the time of the explosion. The width of the "Golf" vehicle is 1.61 m, in other words, the vehicle was parked in such a way that almost half of it located on the sidewalk, while only part of it was on the road. The expert attached a diagram to his opinion backing up this assertion.

Distance of the vehicle from the wall of the “NIK” building according to the report of the prosecution’s expert

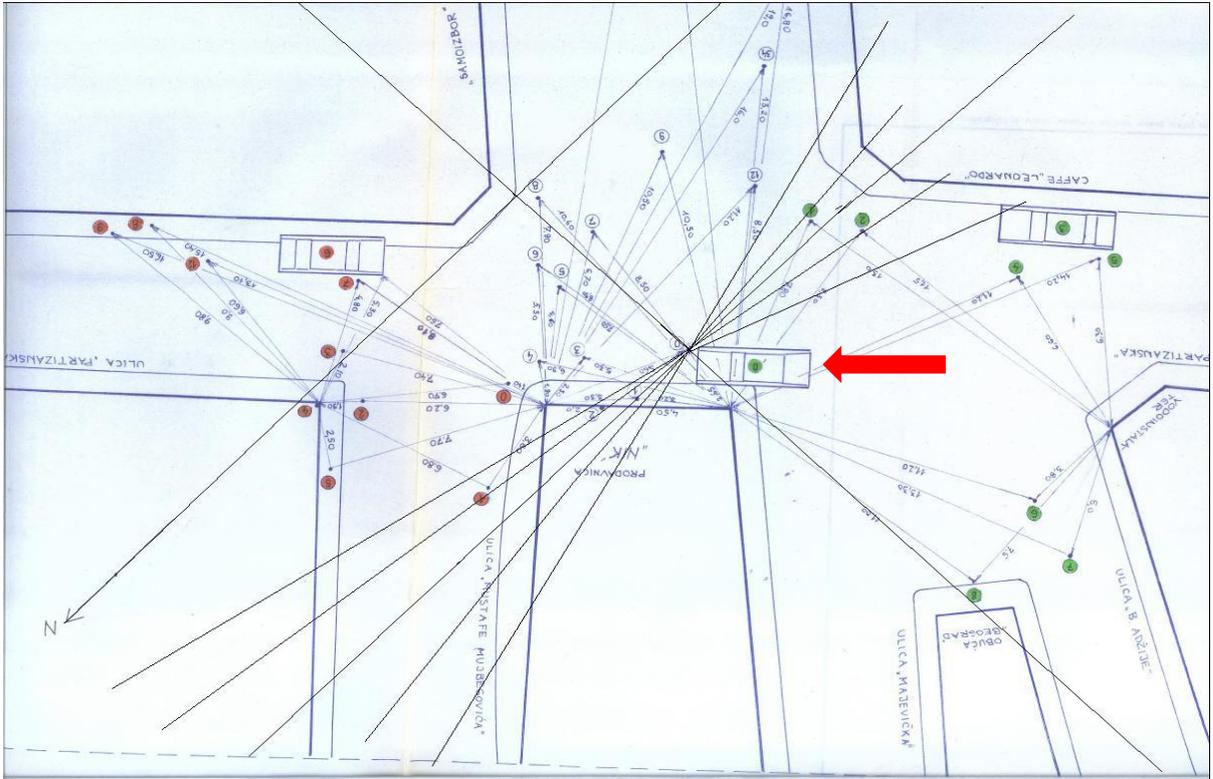
- 1) The original police diagram positioning the whole vehicle adjacent to the sidewalk

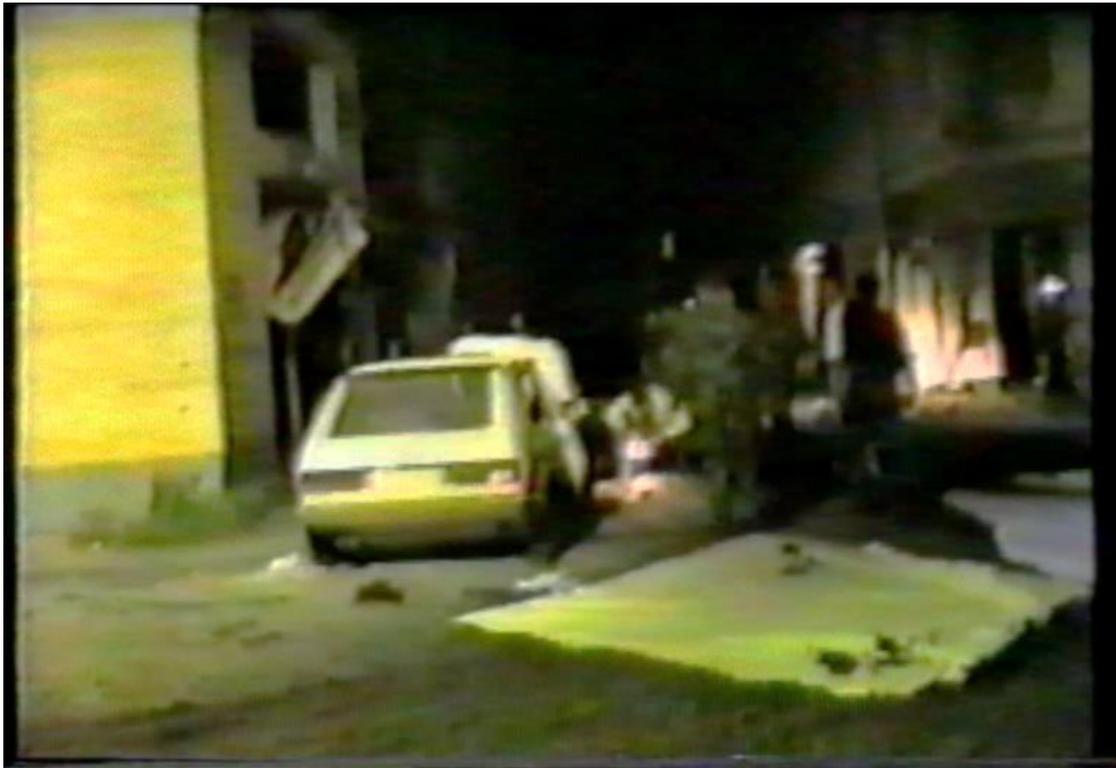
View from the rear towards the location of the vehicle prior to being moved – the wheels of the vehicle are adjacent to the sidewalk.

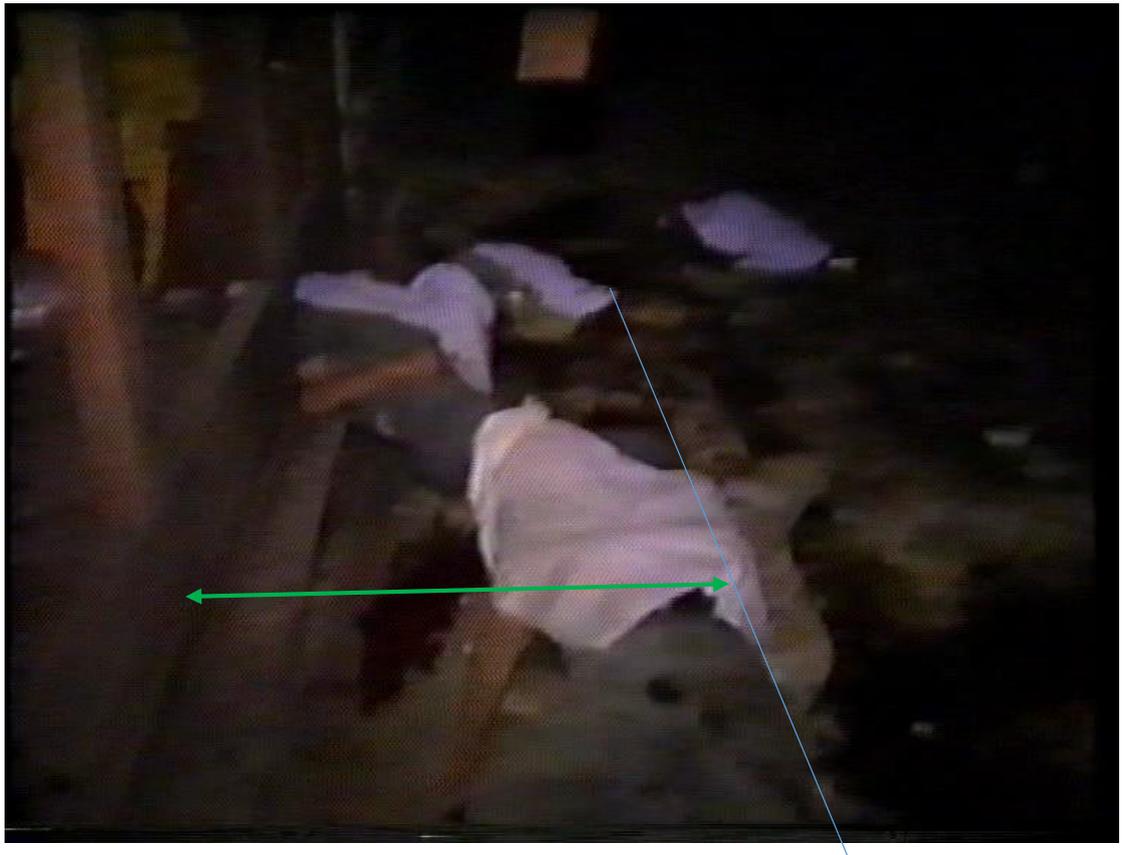
The sidewalk close to where the explosion occurred. The width of the sidewalk is about 1.1 to 1.2 m.

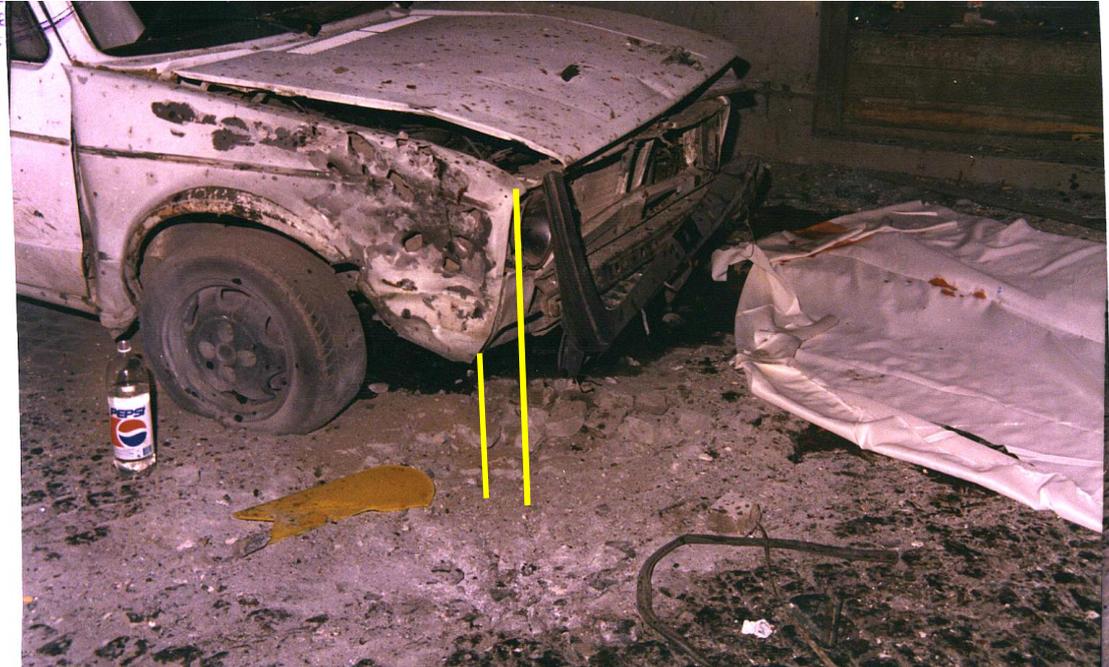
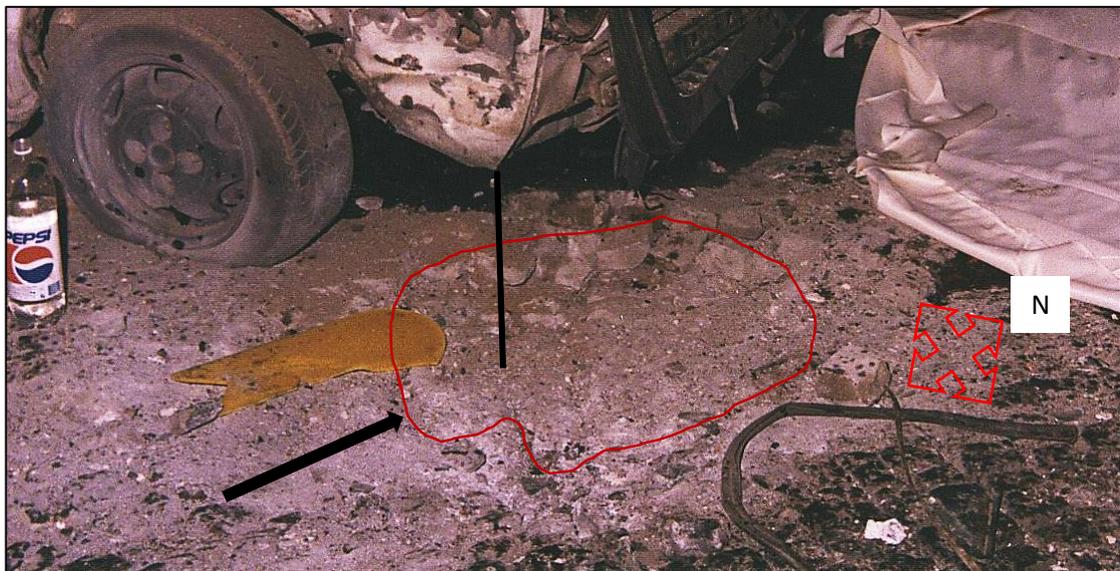
From the original photograph that was taken soon after the occurrence of the event, prior to moving the vehicle, it can be very clearly seen that the explosion crater is located at the front of the vehicle, and part of it is even under the body of the vehicle. You can discern that the eastern edges of the crater (marked by the arrow) only slightly protrude beyond the body of the vehicle.

- 1) According to measurements conducted by Dr. Zecevic and which were attached to the report that was submitted, the distance of the crater from the wall of the "NIK" building is 2.26 m. The diameter of the crater, according to the opinion of Dr. Zecevic, is 50 cm.
- 2) According to the opinion of the prosecution's expert, the shell exploded just 40 cm from the front right side of the vehicle. Assuming the point of impact of the shell was roughly at the center of the explosion, the edges of the crater were supposed to be found at a distance of 15 cm away from the side of the vehicle (40-25). This statement completely contradicts the photographs from the scene, in which it can be clearly seen that the edges of the explosion crater are found only a few centimeters outside the framework of the vehicle, while the rest of the area of the crater is under and at the front of the vehicle.

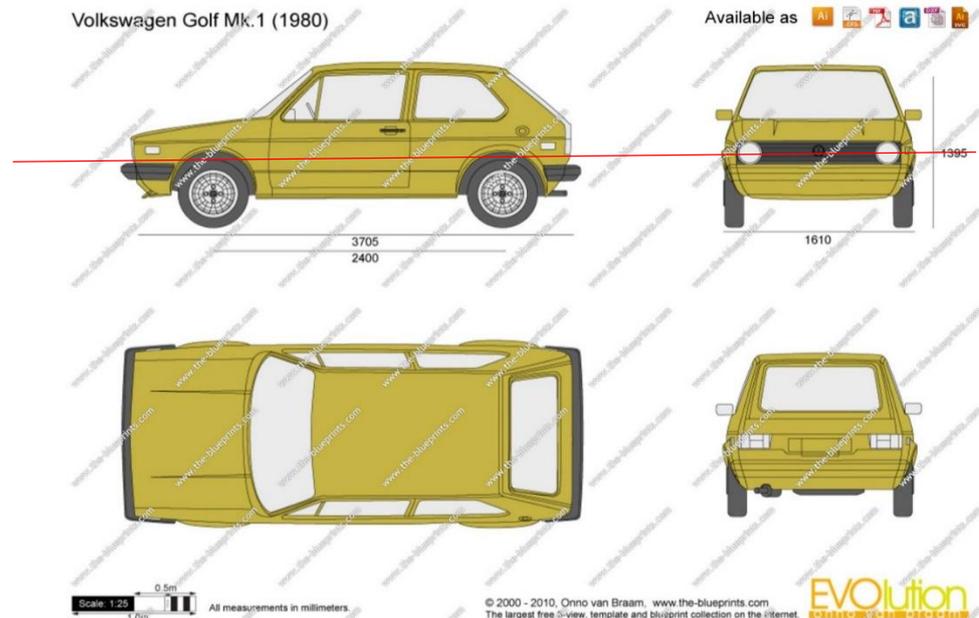
At the red line – the base of the shell found at an angle of 62 degrees

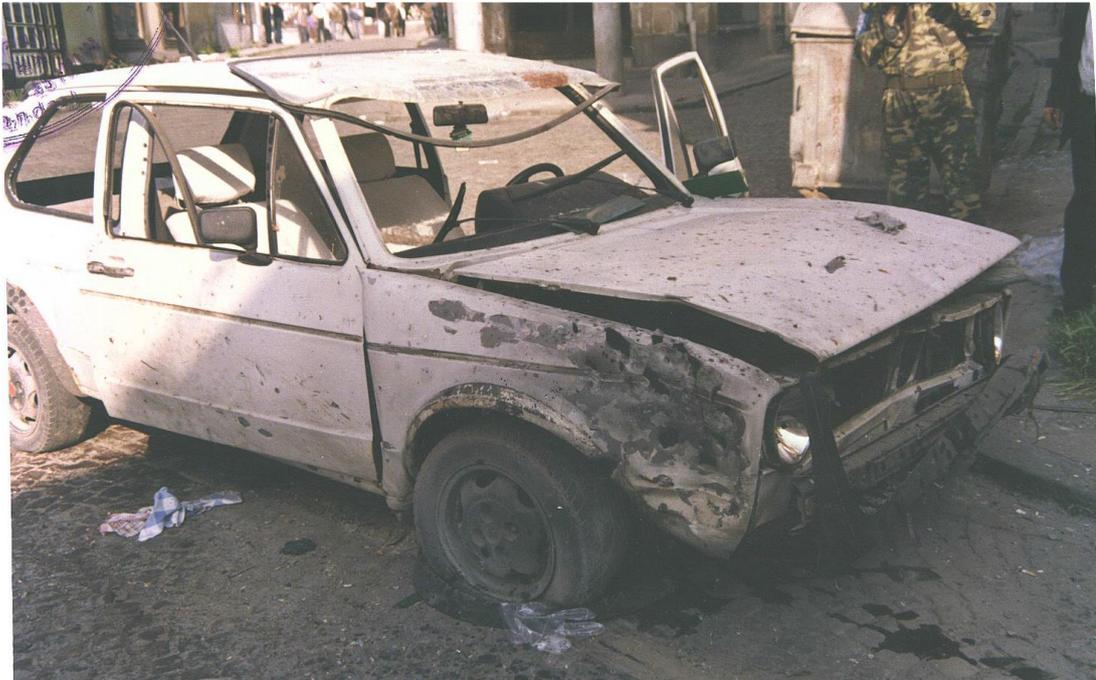
The vehicle from the Eastern direction

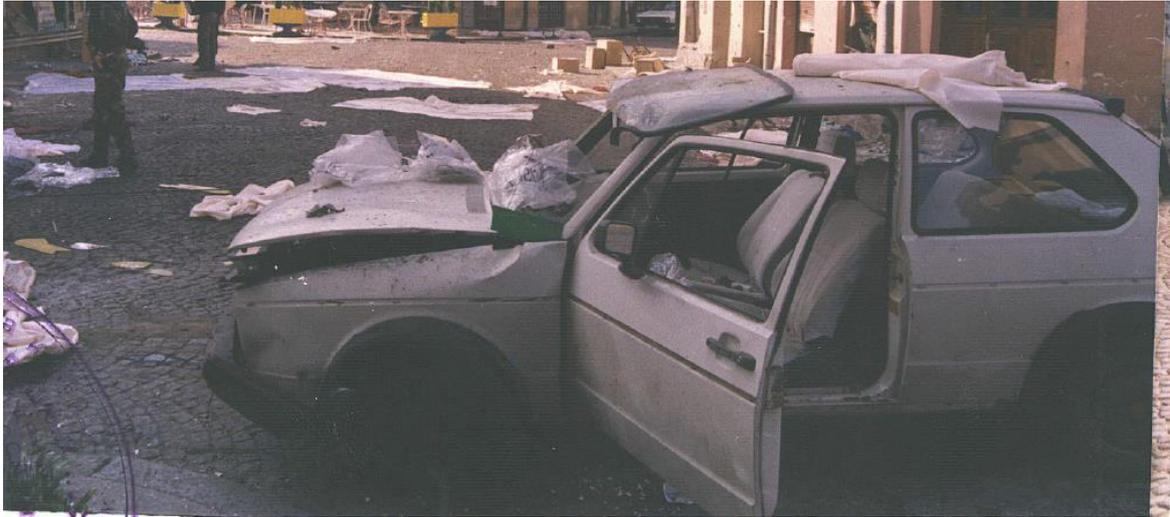
The vehicle from the driver's door direction. No effect of shockwave or pressure is apparent.

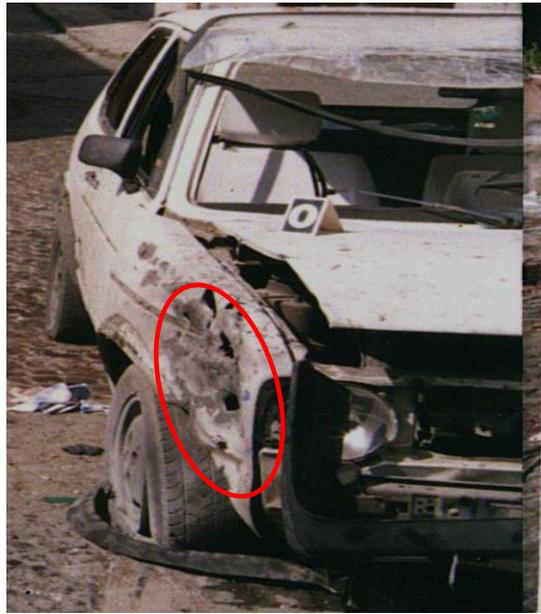
Denting was diagnosed in the side of the vehicle in an inwards direction in the lower part, as well as in the area of the blackening and shrapnel. The direction of the denting is diagonal and upward. This denting does not match the damage that should have happened to the side of the vehicle and additional assemblies, as a result of the direct effect of the explosion of the shell.

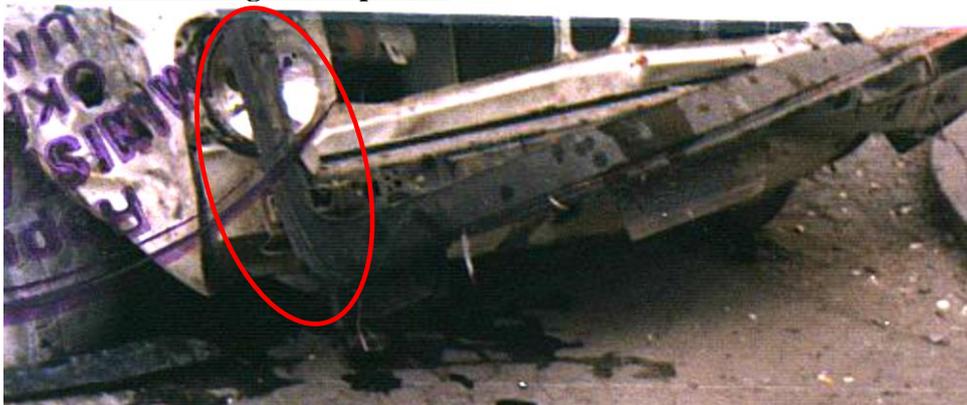
The fender the vehicle was torn from its place and distorted from **downwards in an upward direction and to the right**, indicating that the pressure applied to the fender came from the **direction of the ground upwards**.

According to the version of Dr. Zecevic, the shell exploded at an angle that should otherwise have caused the crushing of the fender while exerting explosion pressures and shrapnel in a **downward direction**, as it did in experiments performed, including without exception, crushing the fender and the side of the vehicle, downwards and inwards. The fact that at the “Tuzla” event the fender distorted upwards, without identification of the penetration of shrapnel/distortion/tearing of the fender as a result of the combination of results of the explosion of the shell indicates that the effect of the action is in an upward direction, that is, the pressure of the explosion and/or the effect of the crushing/blow moved from the bottom upwards.

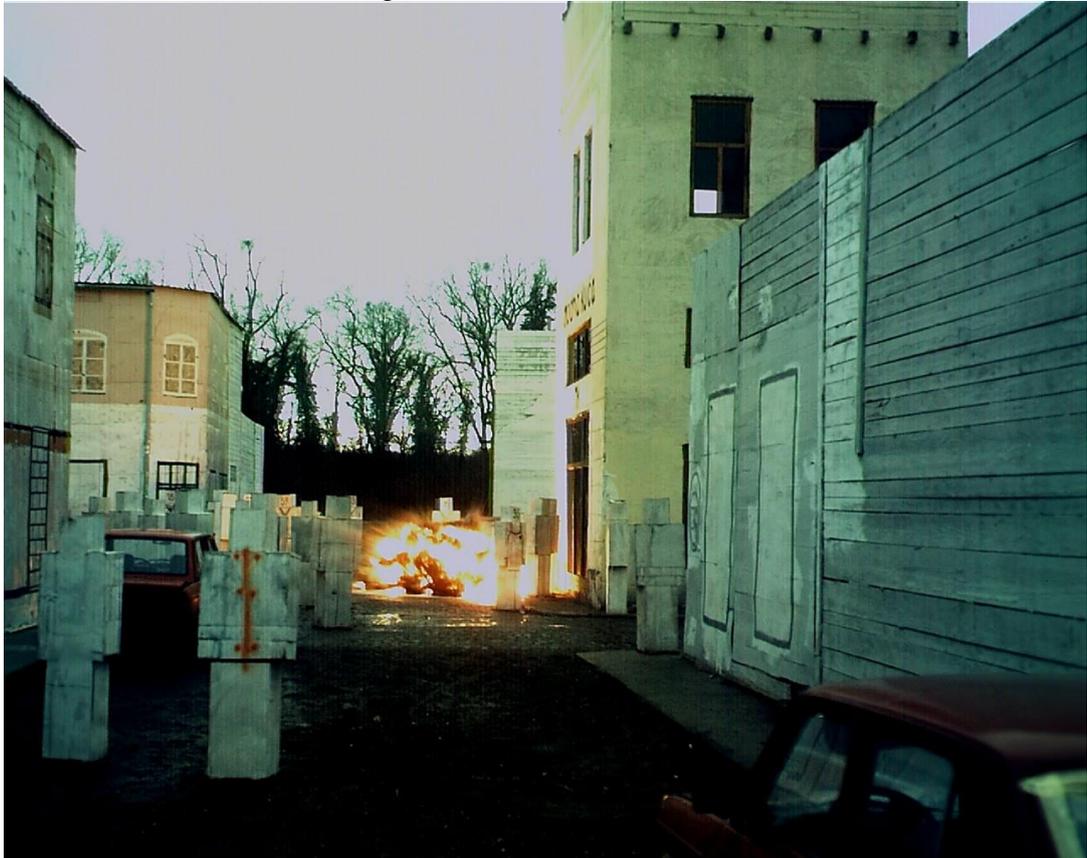
The minute of the shell explosion adjacent to the Golf vehicle – the photograph was taken from documentation of a rapid lens camera

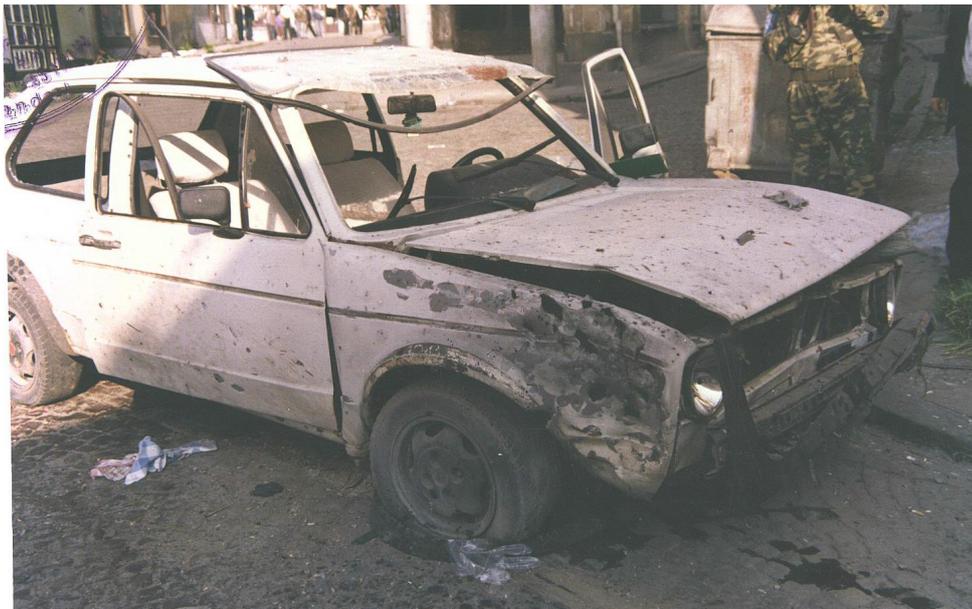
Damage to Golf vehicle at the Tuzla event – without the shockwave effect. See also details in Chapter D pp. 33-39 above.

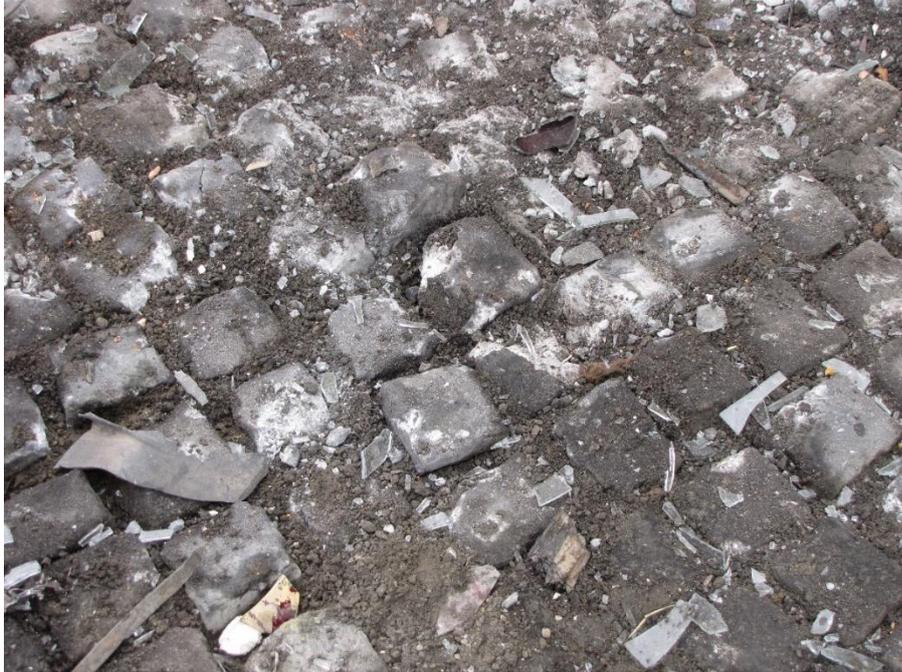
1. Explosion crater – the explosion crater created on the granite stones in the square that paved the road at the test site - was shallow. The reason for the creation of this configuration of the explosion center was the fact that, due to obvious circumstances, the impact element created when a projectile hits the road was not included in the test. Such an impact can cause a certain amount of penetration, albeit smaller, into the ground.

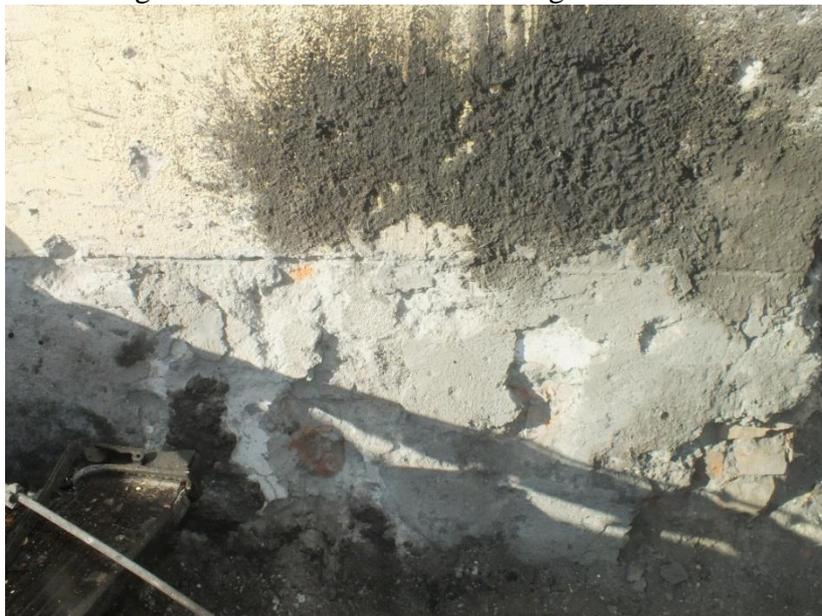
As a result of the shell explosion, debris of the bed found under the granite stones was repelled, some of it flung on the wall of the NIK building.

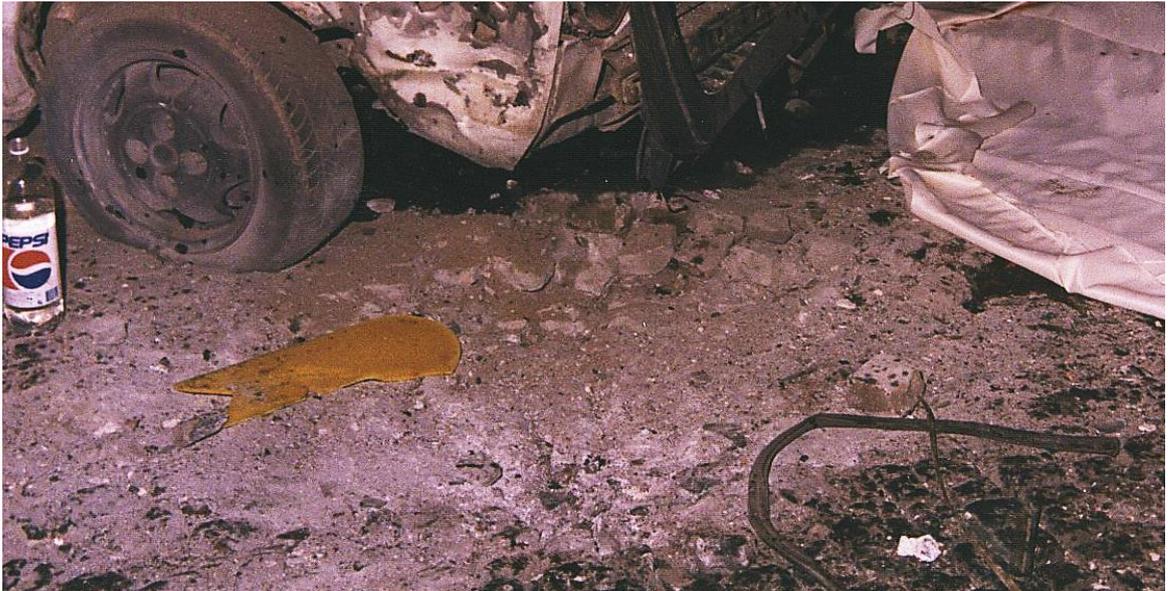
At the Kapija event, as described by Dr. Zecevic, the prosecution expert, the diameter of the explosion crater was 50 cm. However it can be deduced from analysis of the photos and video from the explosion location that the explosion crater was dug and widened by entities at the explosion site. In fact, for all intents and purposes it is impossible to determine with certainty its original size, although it is evident that the explosion crater was deeper and wider than that created in the test, as reflected in granite stones flung from their place to a location outside the explosion crater. The characteristics of this explosion crater indicate an explosion created at a point deeper than the road surface, spreading debris from base layer under the granite stones in the direction of the vehicle, and stone fragments in the direction of the NIK building.

Explosion crater before it was dug and changed

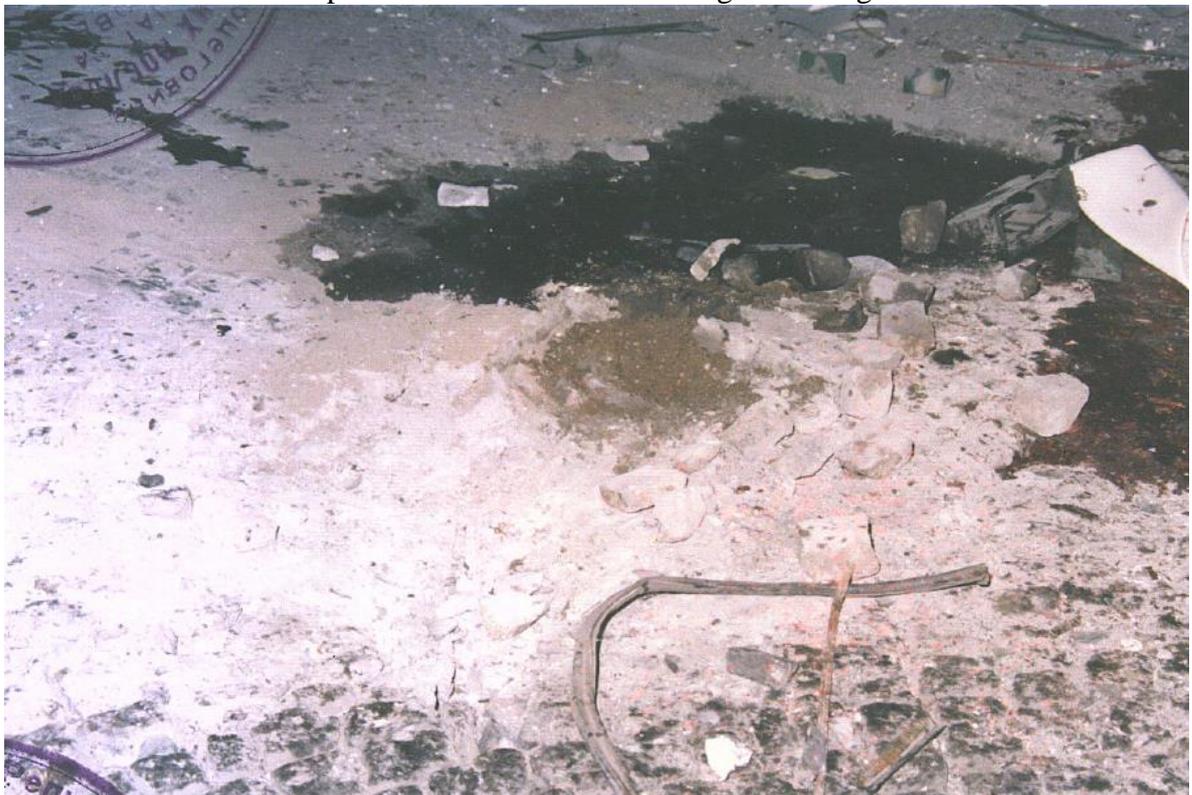
Explosion crater after it was dug

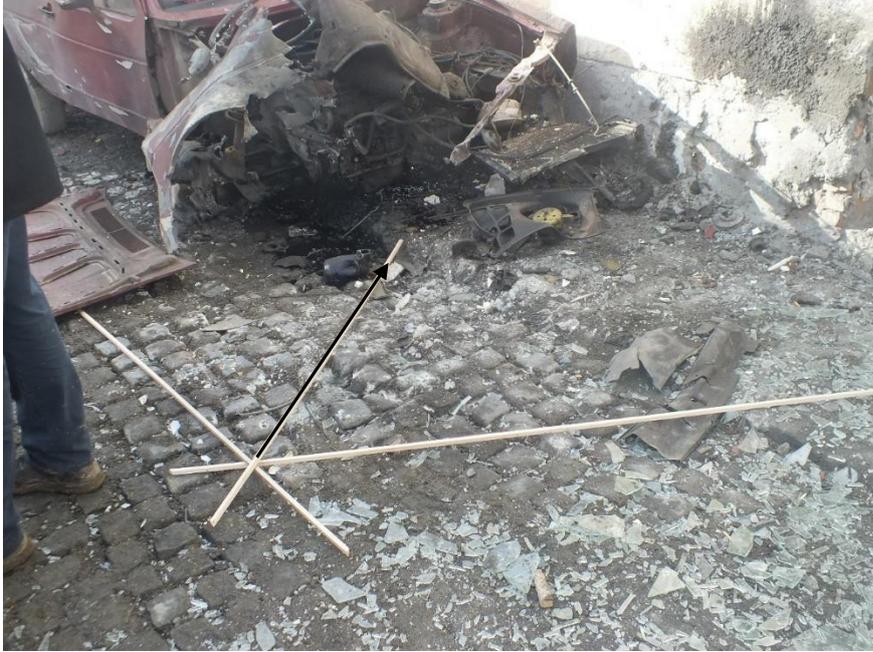
As a result of the explosion a fragmentation spread was created on the road - its vertex at the explosion crater and its sides opening towards the angle of the projectile tilt. In other words-drawing a straight line from the fragmentation spread vertex – the explosion crater crosses the spread triangle in its center so that it is possible to accurately determine the direction of the projectile.

Shape and direction of the ground fragmentation spray points to the West (test results)

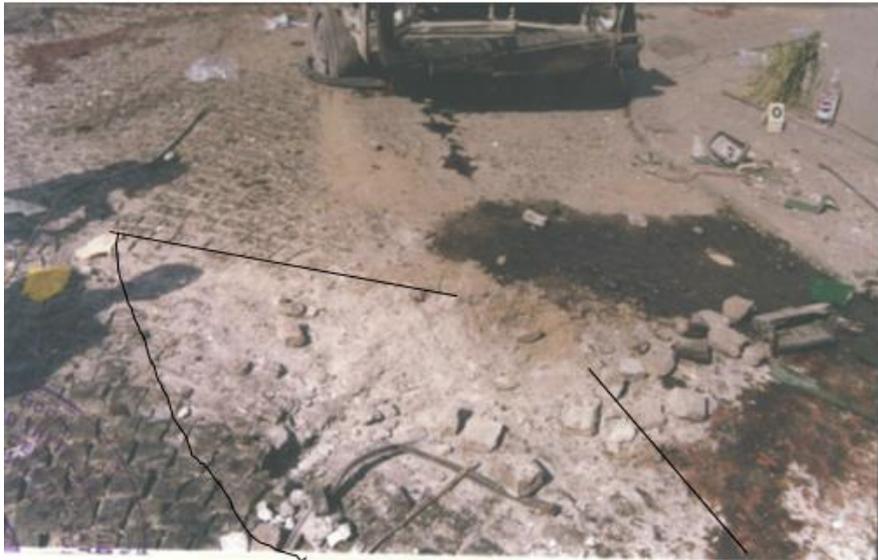
At the Kapija event the ground fragmentation spread was exactly in the opposite direction – towards the East

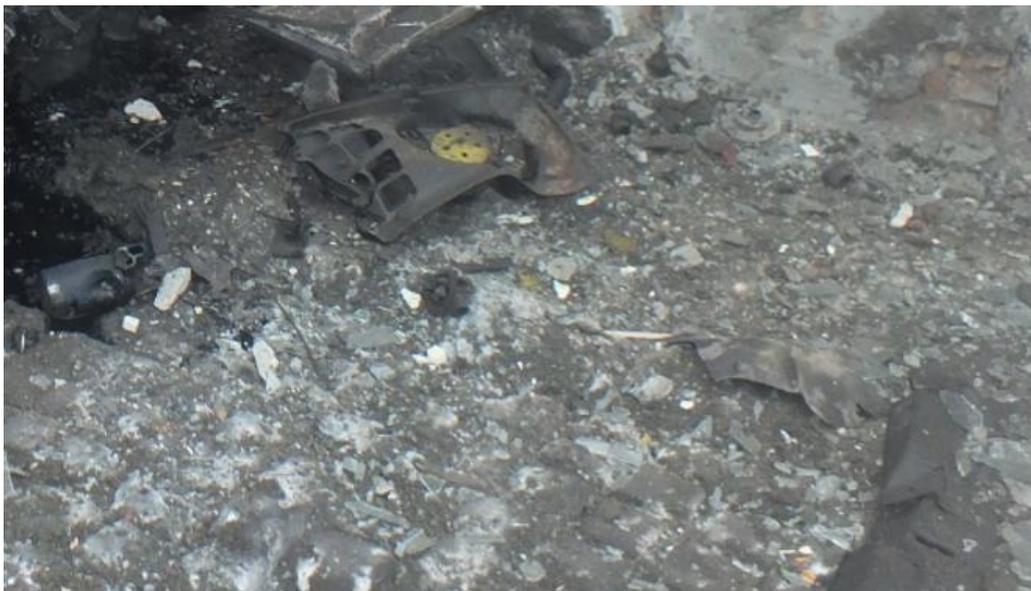
The sidewalk immediately after the explosion

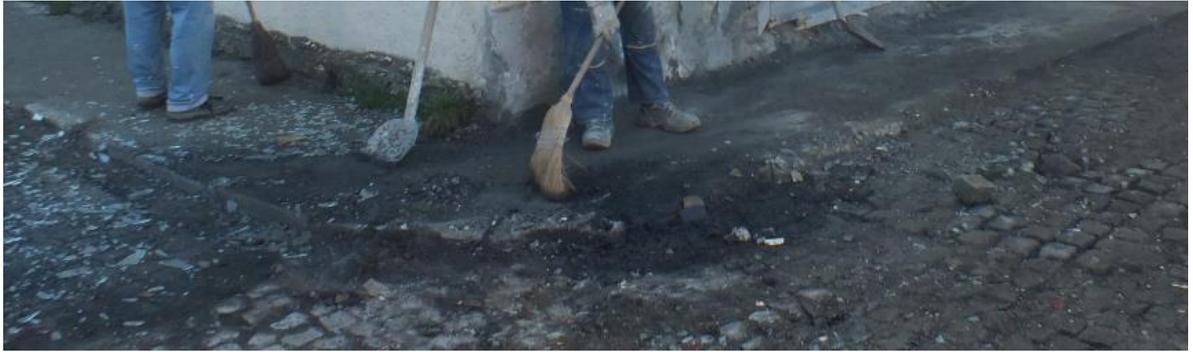
The curb stones found between the explosion crater and the NIK building shattered as a result of the test. In addition, deep and massive penetrating damage was found on the sidewalk surface.

The sidewalk after cleaning – heavy damage can be seen to the curb stones and to the surface of the sidewalk itself.

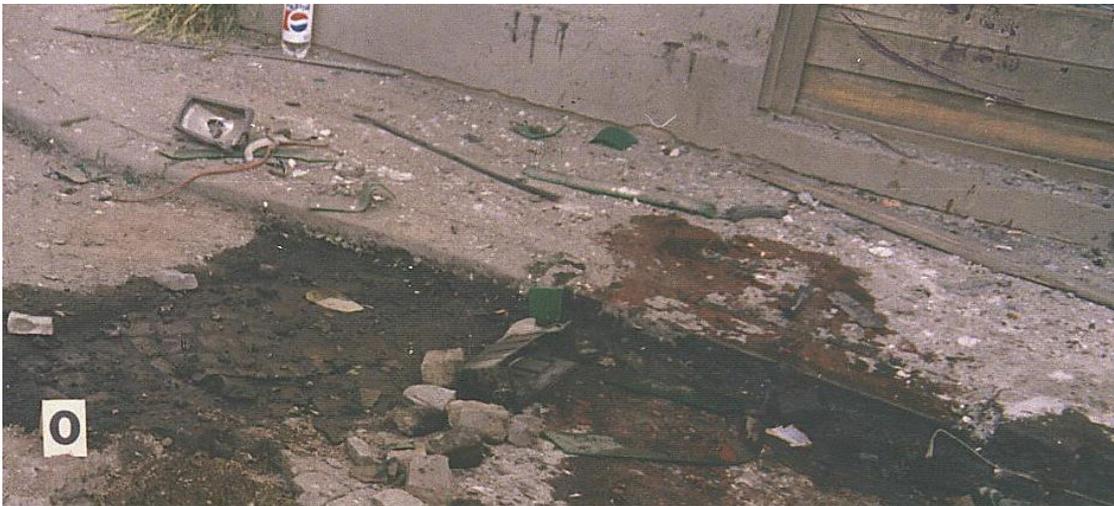
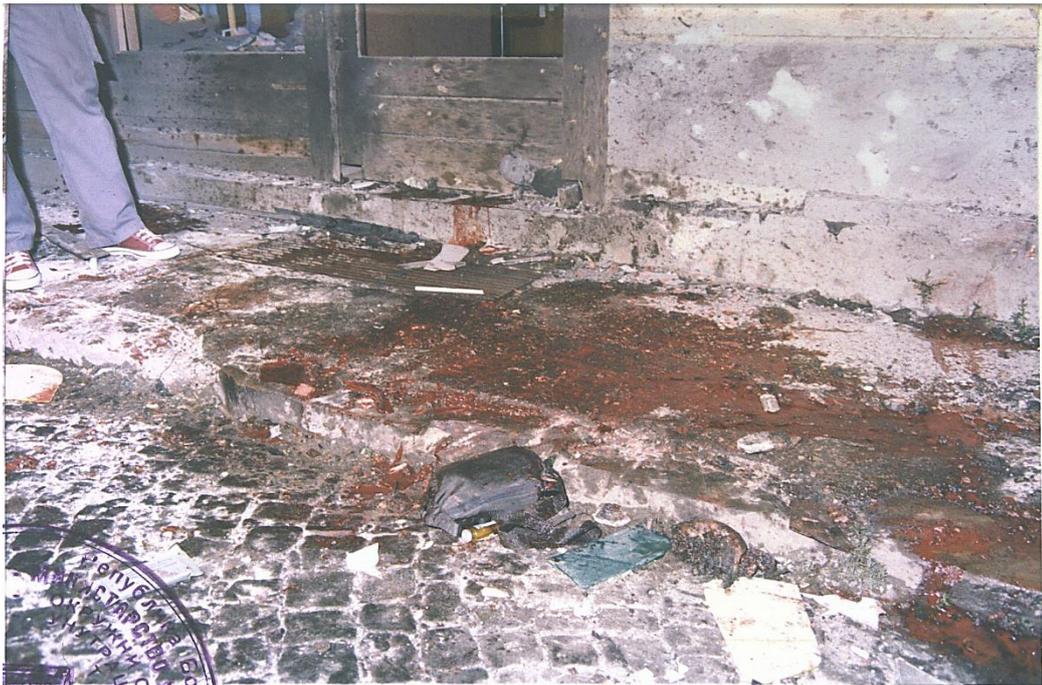
At the Tuzla event hardly any significant damage is evident on the sidewalk and the road in front of the NIK building opposite the explosion center.

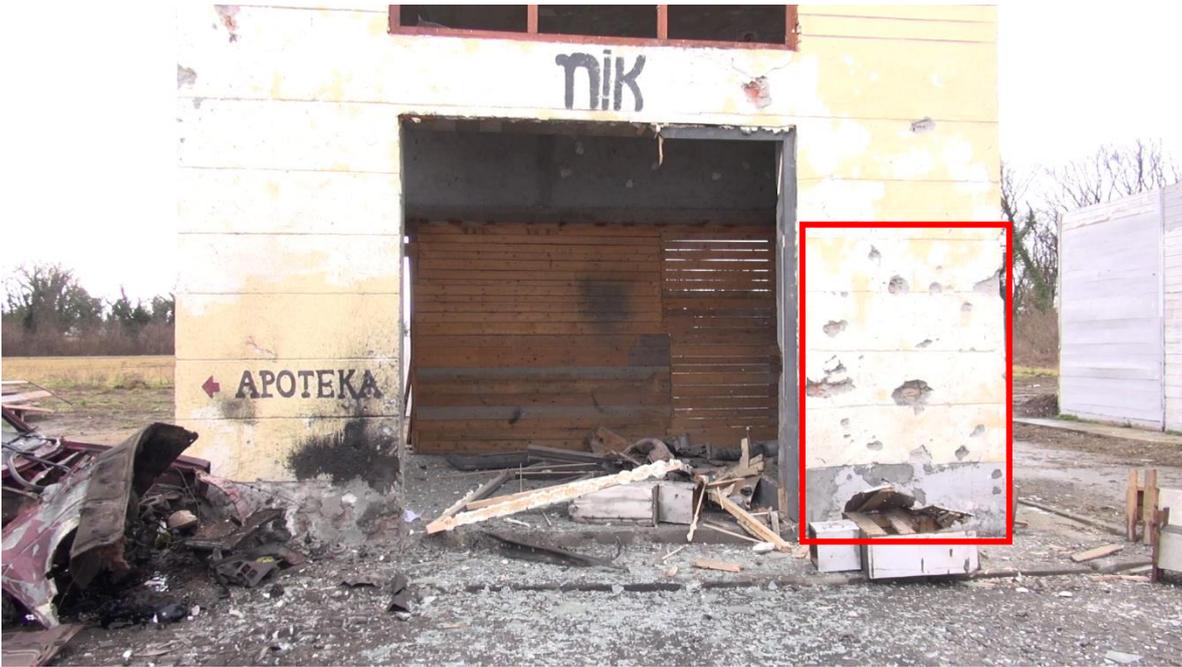
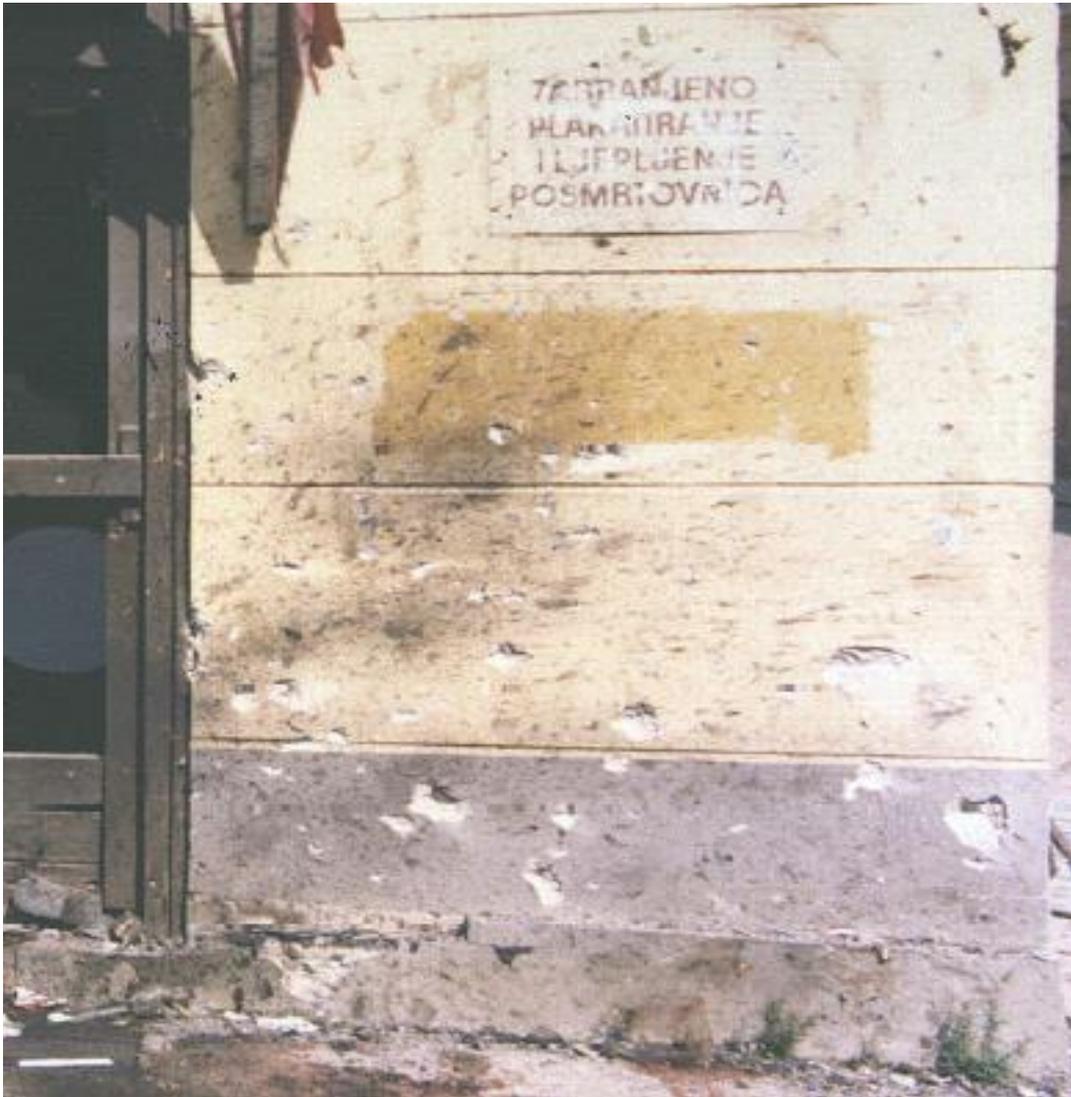
Two sites of fragmenting damage were found on the building's exterior walls. The first site - 17 places of fragmentation damage were found on the northern side of the NIK building façade, most of them up to about 2.50 meters height. Another fragment was found in the area between the store doorframe and the frames of the upper windows.

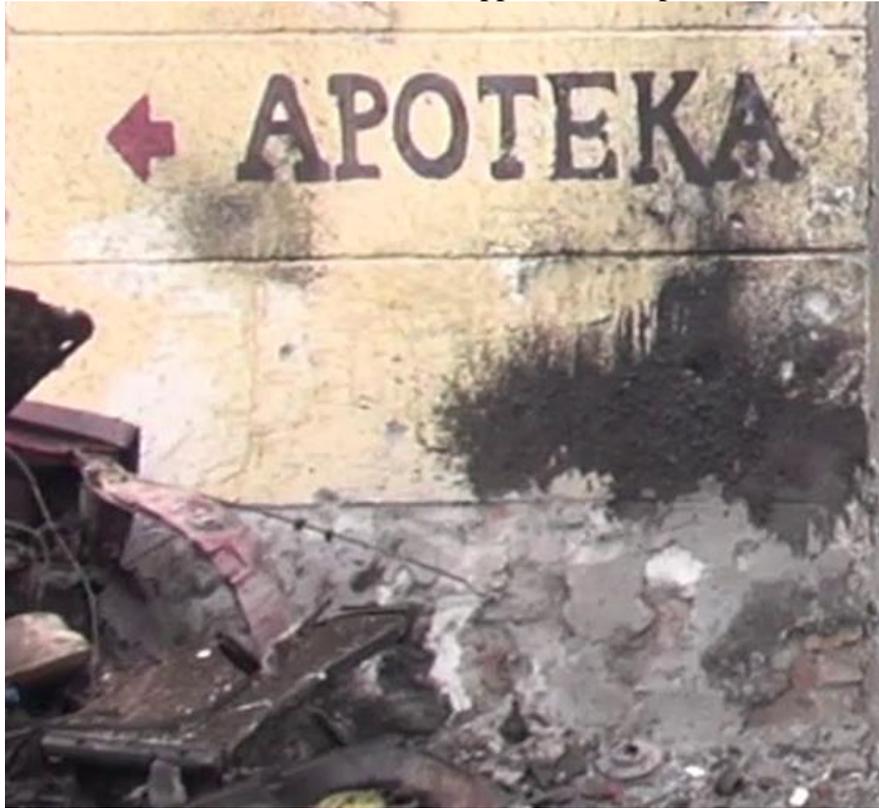
The second – along the southern wall of the NIK building façade, 2 points of fragmentation damage were found – at the bottom of the wall opposite the explosion area.

Part of the façade wall found adjacent to the explosion center – test result

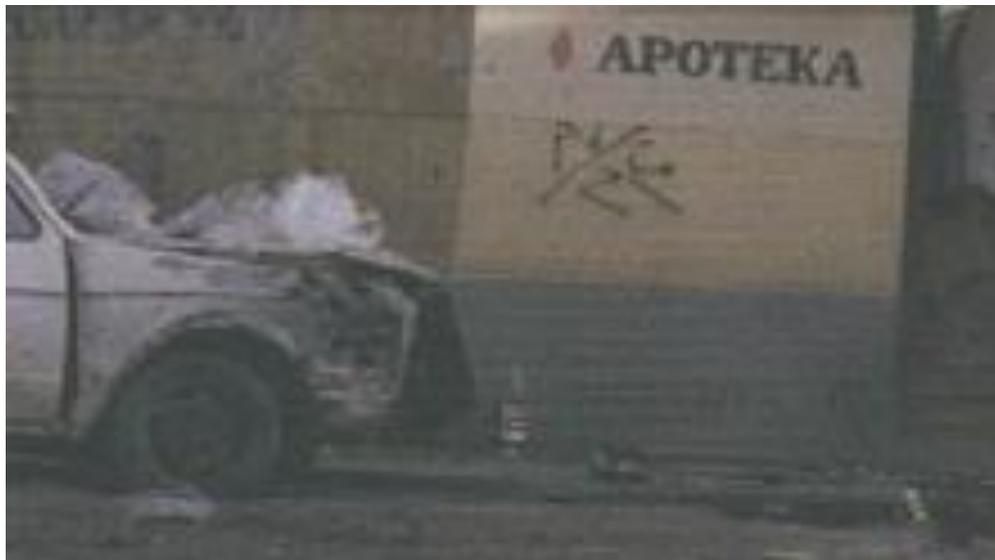
The same part – Kapija event - fragmentation damage and explosion pressure are not evident
