1. REPORT DATE April 2016			2. REPORT TYPE Technical report		3. DATES COVERED	
4. TITLE AND SUBTITLE Review of <u>Dr. Zecevic</u> expert opinion report conclusions regarding the causes and results of the explosion occurred at Kapiia square in the city of Tuzla on 25/05/1995					5a. CONTRACT NUMBER	
					5b. GRANT NUMBER	
					5c. PROGRAM ELEMENT NUMBER

6. AUTHOR(S) Sharon Joseph					5e. TASK NUMBER	
					5f. WORK UNIT NUMBER	
					8. PERFORMING ORGANIZATION REPORT NUMBER 32-16	
7. PERFORMING ORGANIZATION NAME(S) AND ADDRESS(ES) <u>Temech-Consultants</u> Tel-el 2516700 Israel					8. PERFORMING ORGANIZATION REPORT NUMBER 32-16

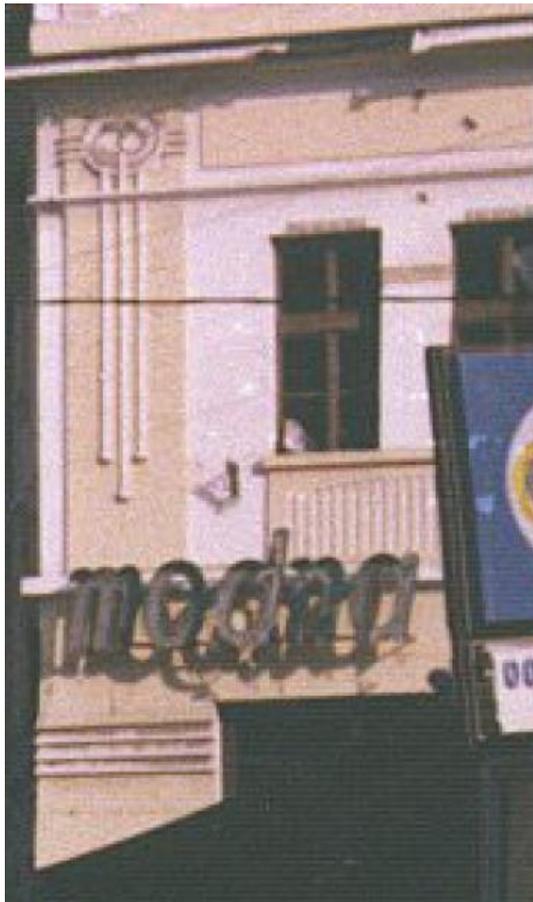
On the upper part of the wall, at a height between 3.20-6.00 meters, 8 fragmens were found, most of them in a straight line about 0.5 meters from the southern side of the building

At the Kapija event - fragmentation damages were not found on the side of the building, only 4 places of fragmentation damage at the center of the building façade, at a height of about 10 m.

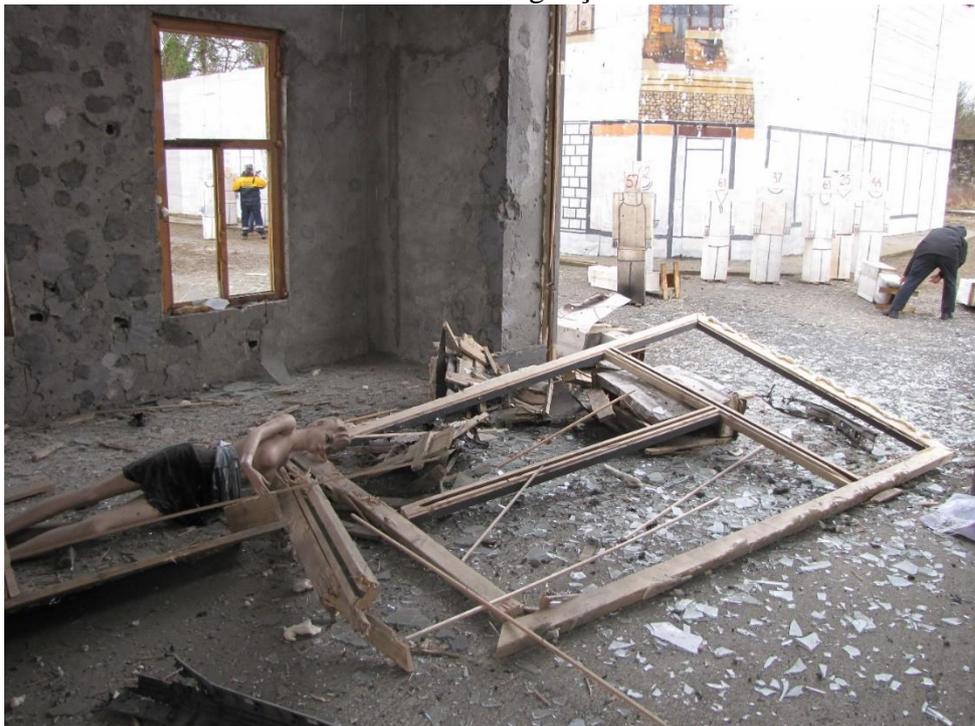
Here as well, there is a fundamental difference between the test results and the Tuzla event. In the test, general destruction was caused to the storefront and to the items in the store, with the items displayed at the front of the store repelled backwards into the store, broken and shattered. However in the Tuzla event fundamental damage was not evident to the shop window – the wooden frame remained in its place, slightly covered with soot, the mannequins remained standing, and no damage was evident on the mannequins clothing. Minor damage was caused to the storefront sunshade found above the clothing store.

Test results

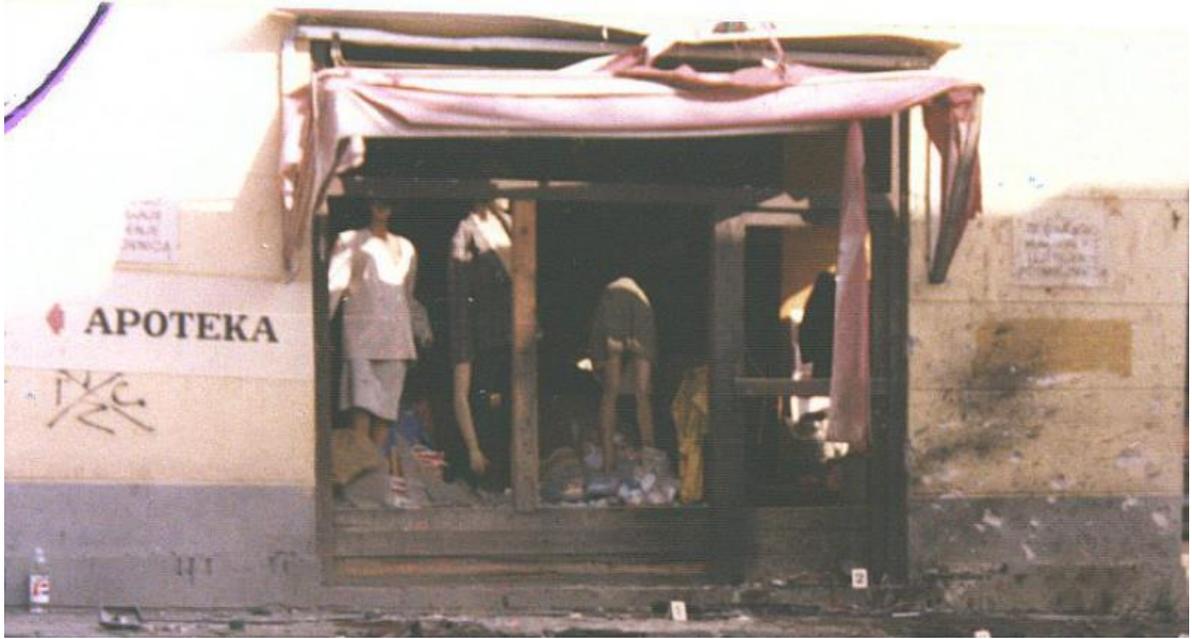
Façade of clothing store – NIK building in Kapija square – after the explosion

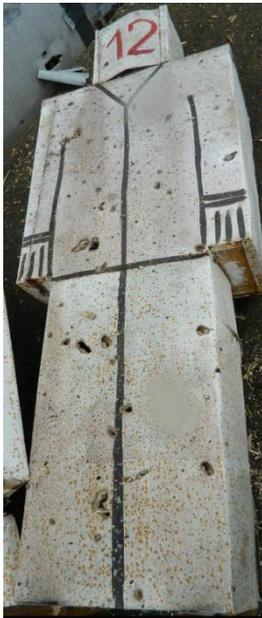
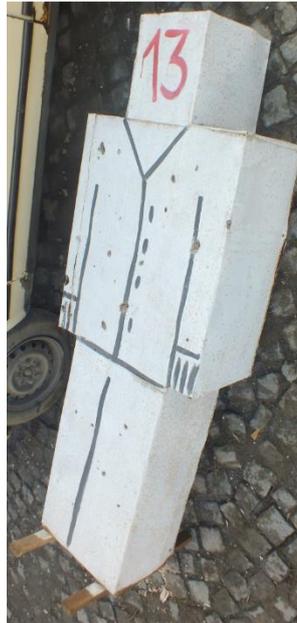
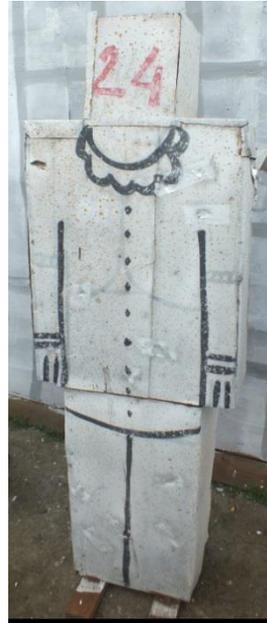
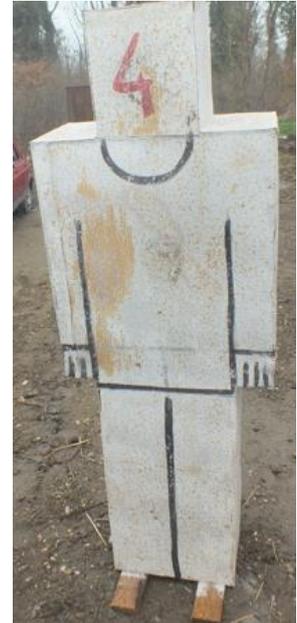
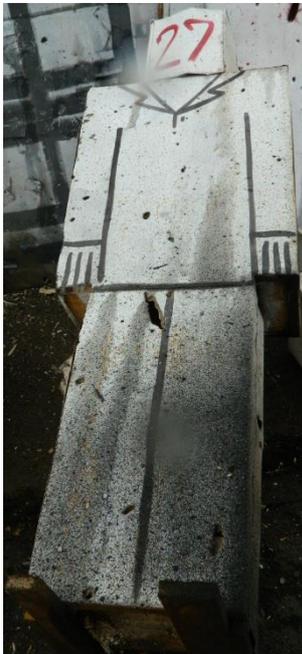
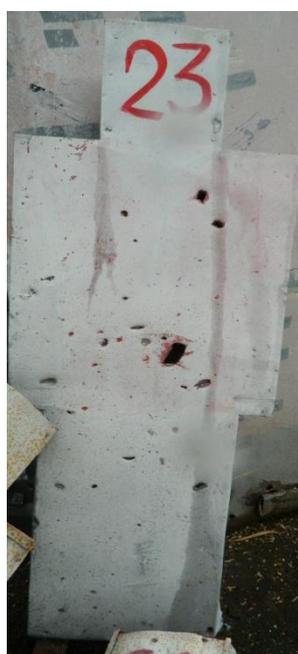
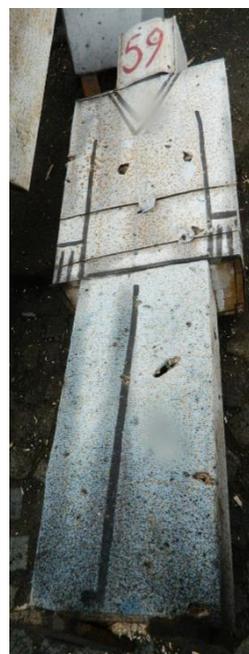
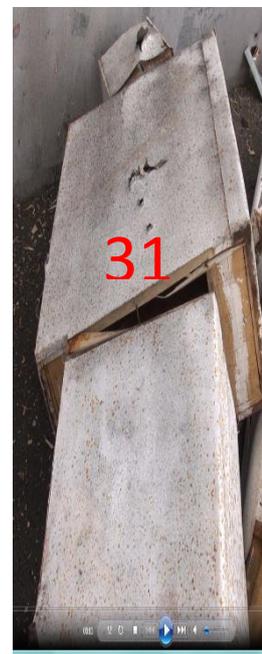
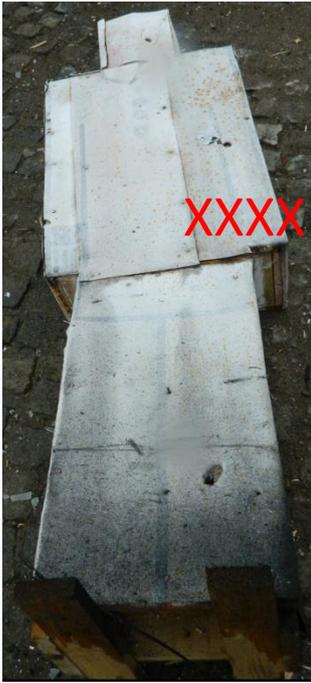
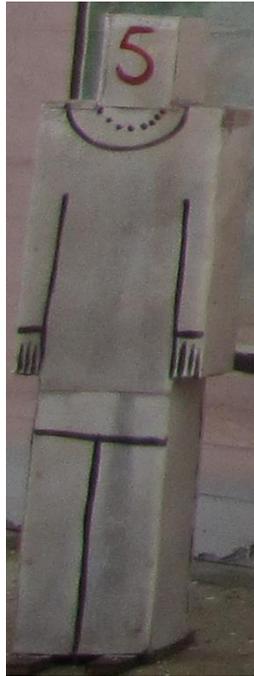
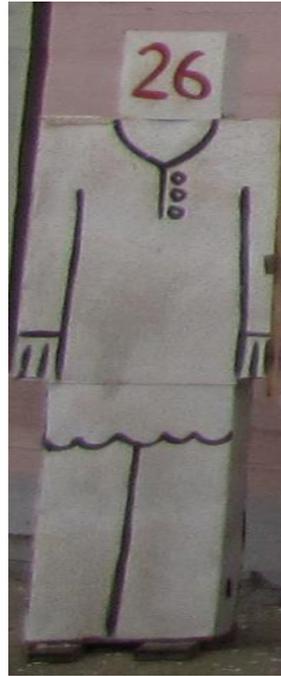
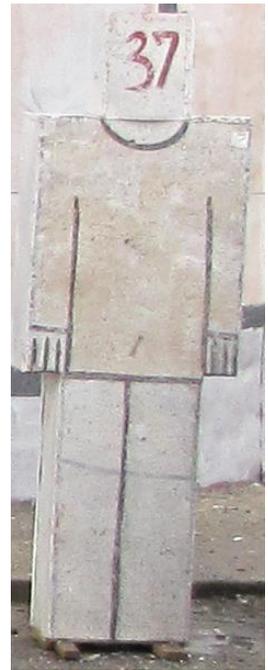
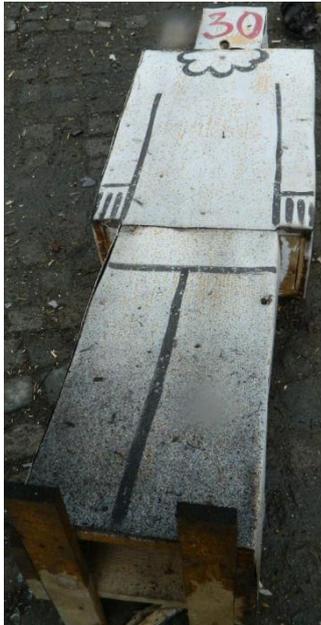
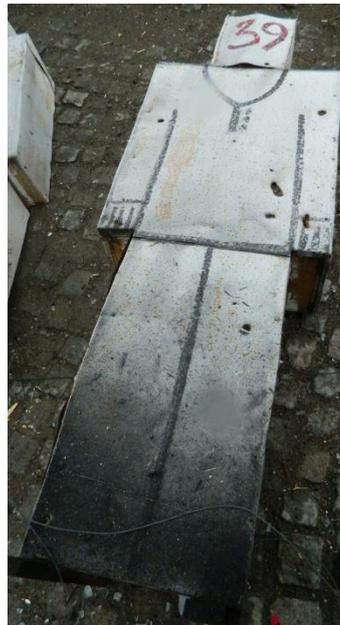
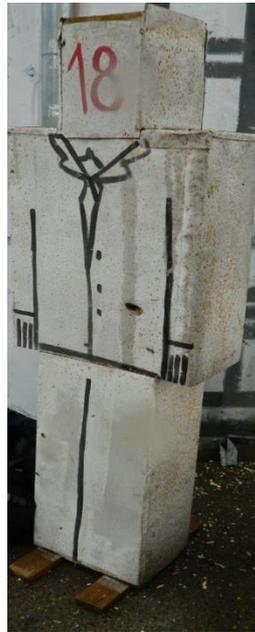
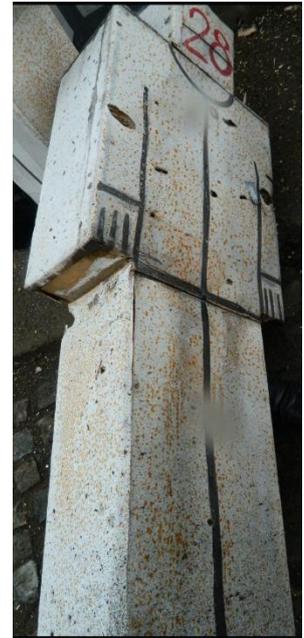
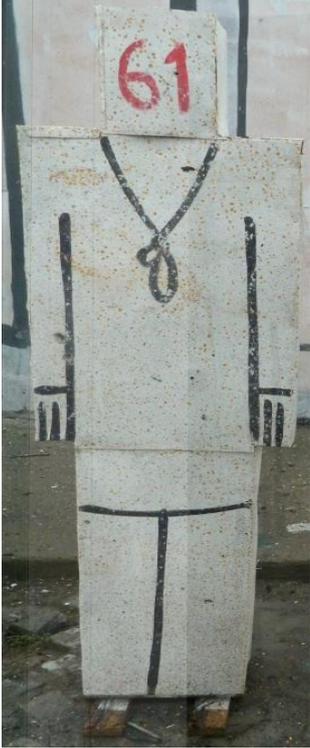
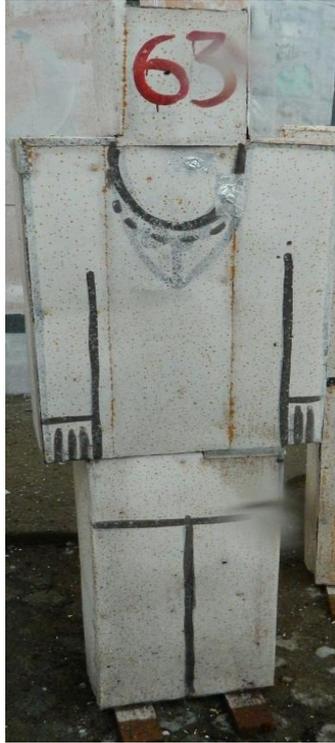
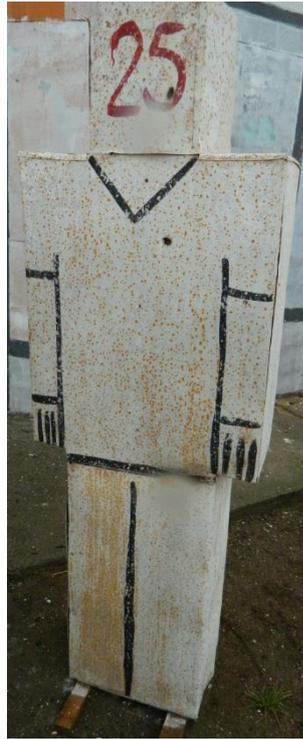
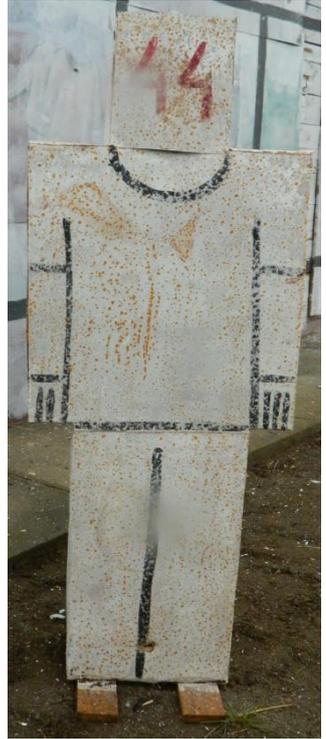
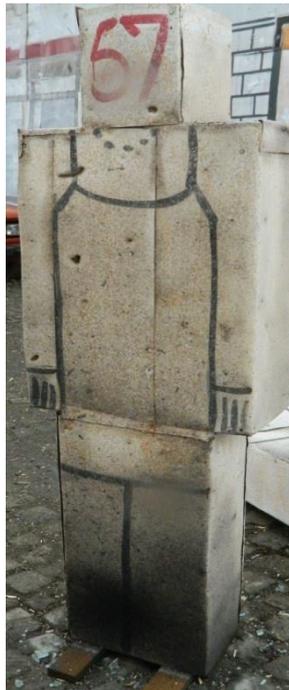
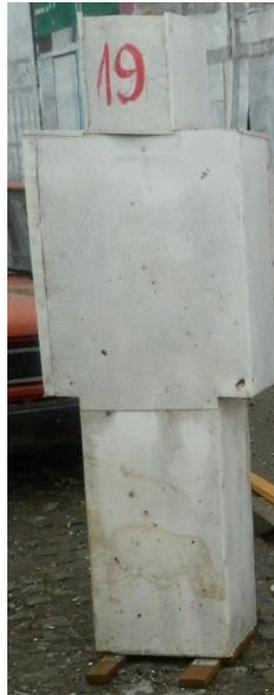
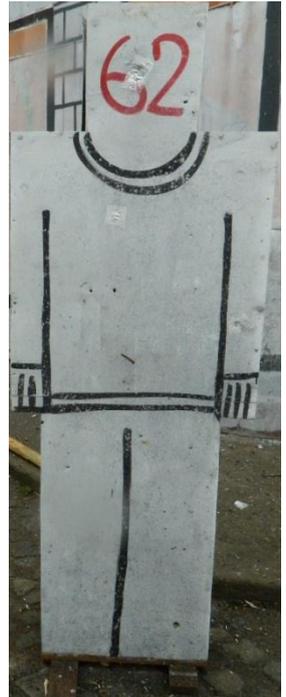
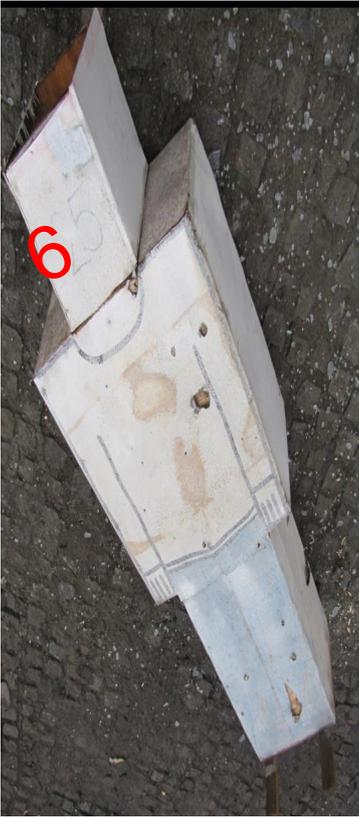
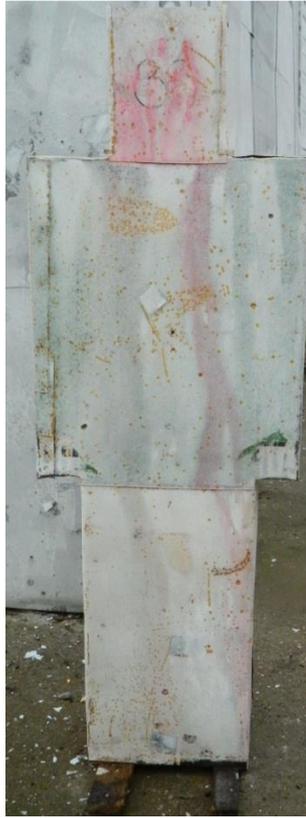
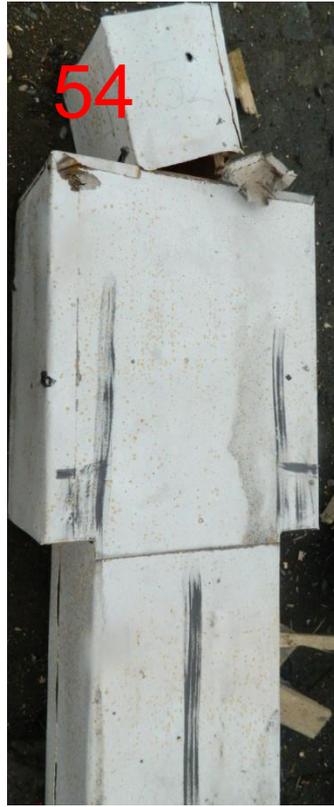
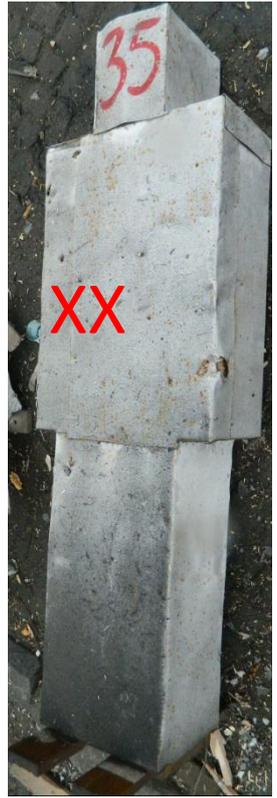
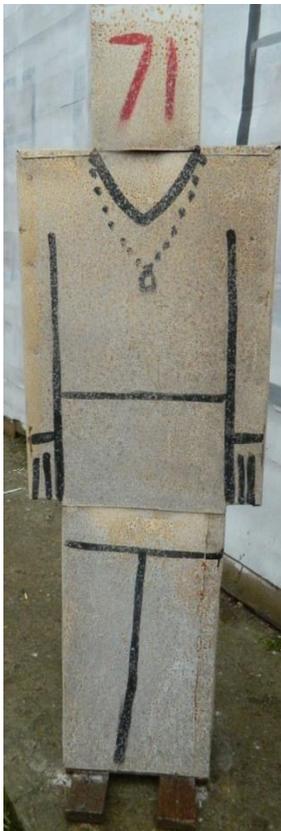
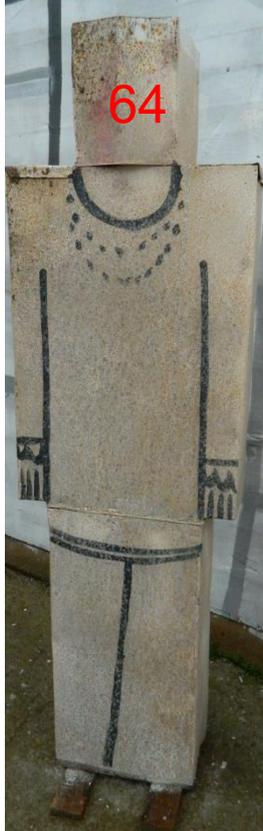
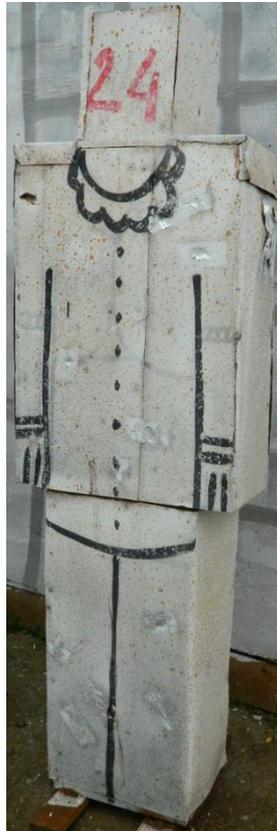
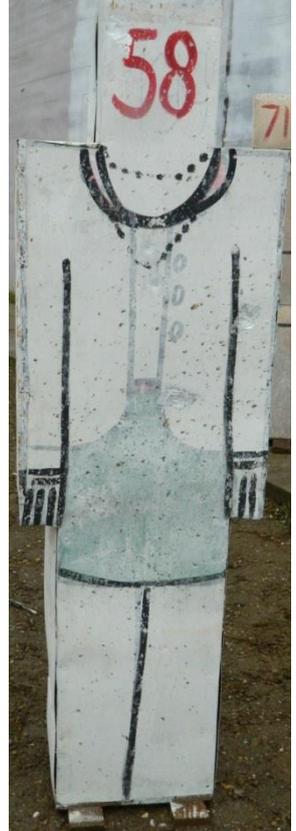
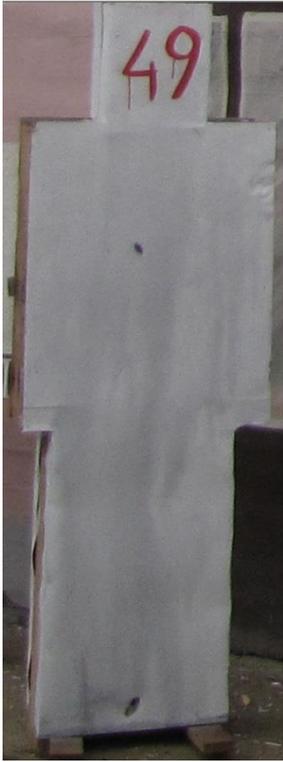
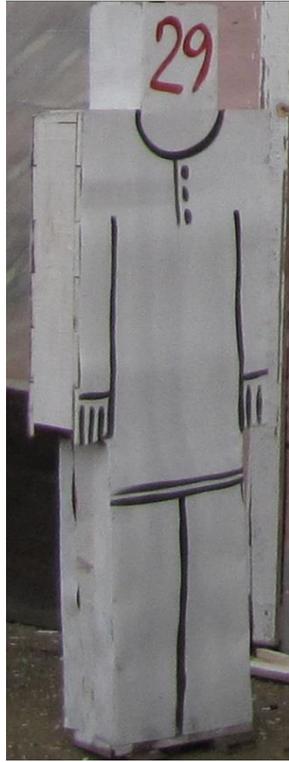
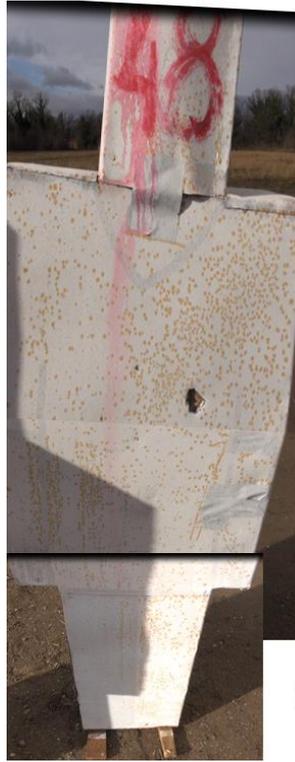
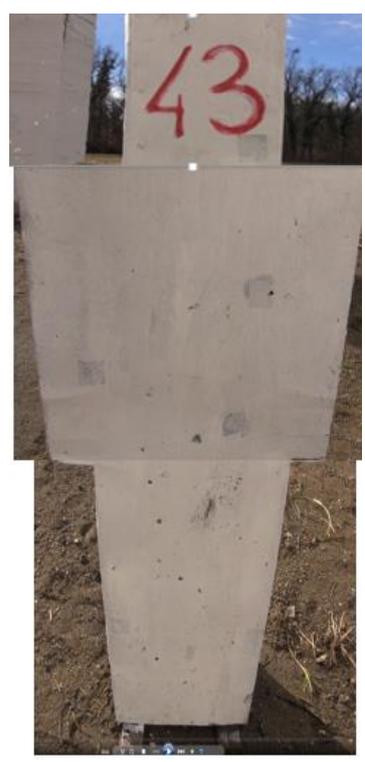
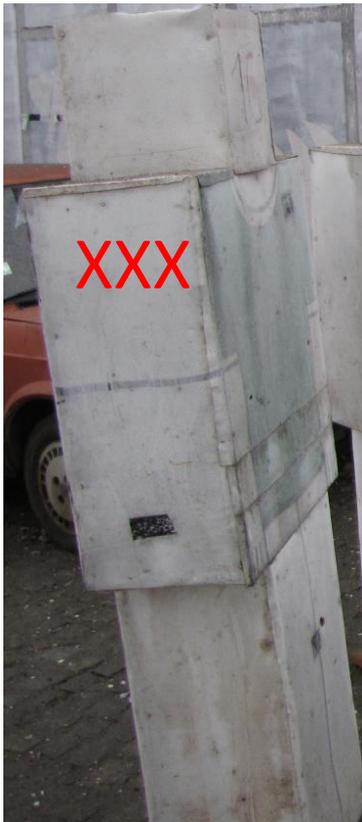
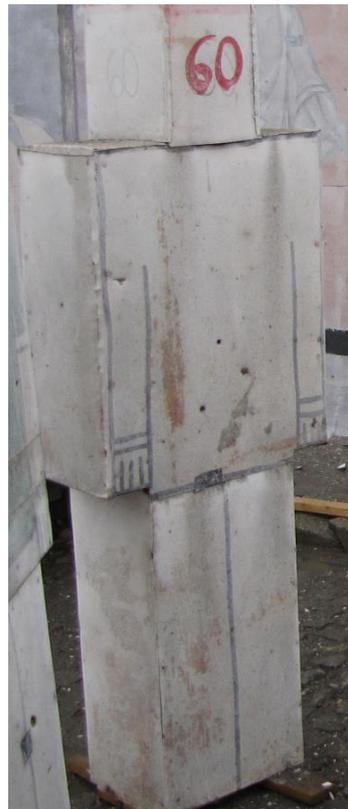
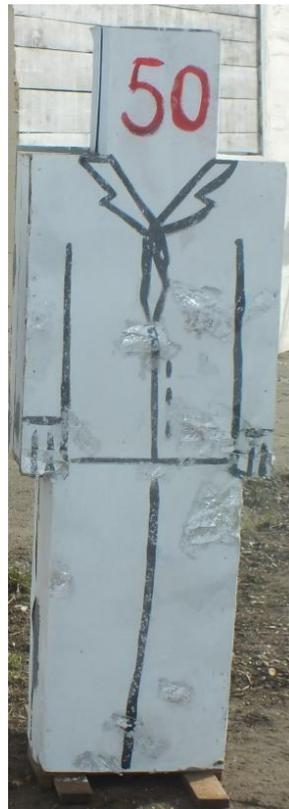
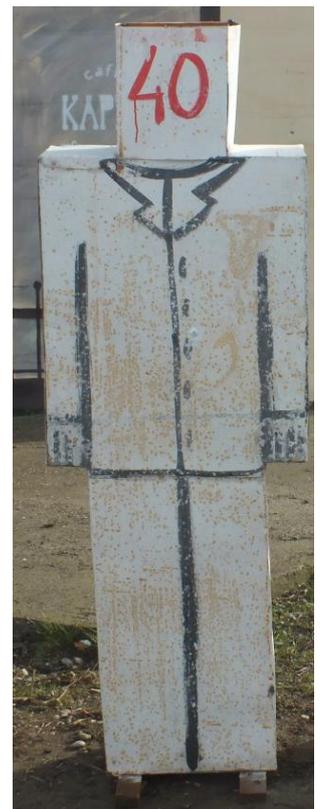
The first – photos of human figures, each figure after it was hit, in addition to a table detailing the main effects found with respect to every human figure.

In 4 figures – (xxxx, xxx, 31 and 35) fractures were found, caused from the impact of the blast wave.

11 figures – 27% did not sustain any damage.

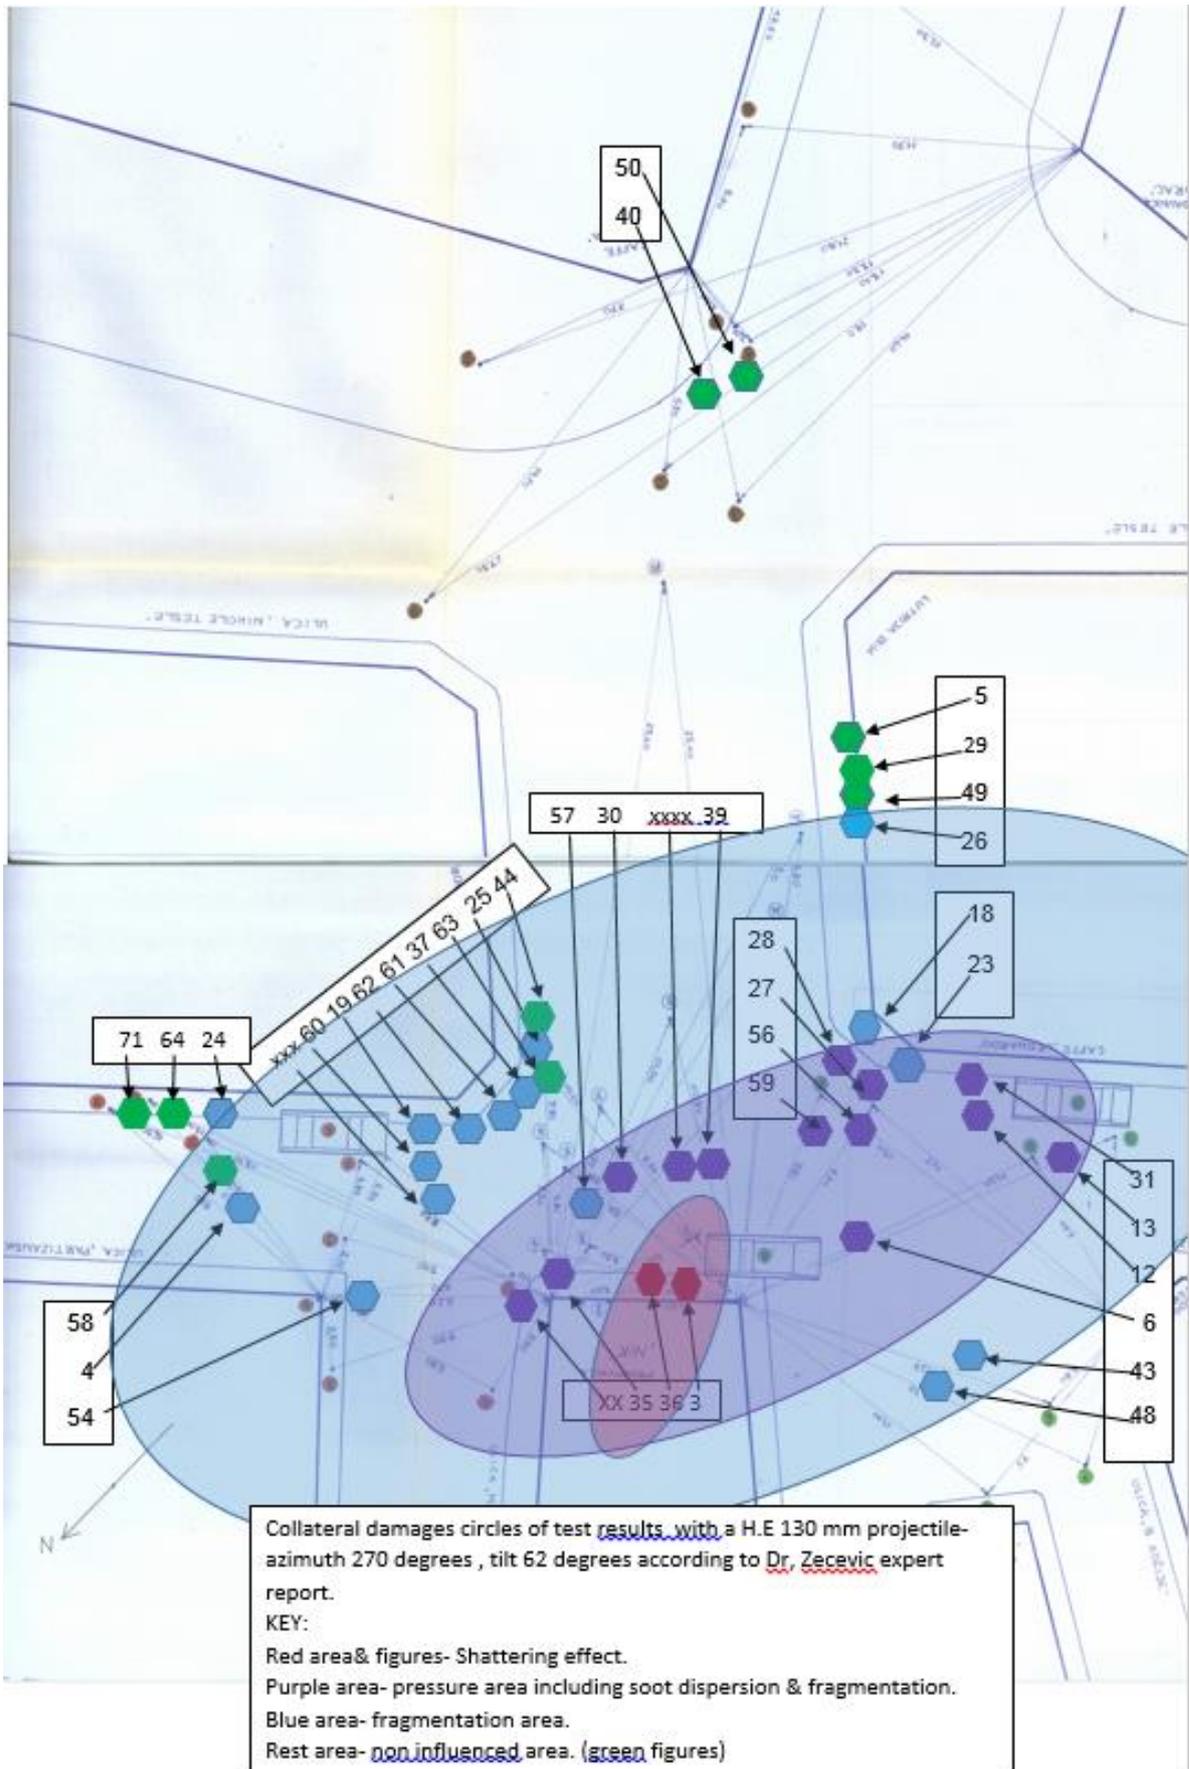
Analysis of the damage enables to draw a diagram of destruction/damage circles according to the level of damage caused the human figures.

The damage diagram allows for a visual examination of projectile effects according to the position determined by Dr. Zecevic.

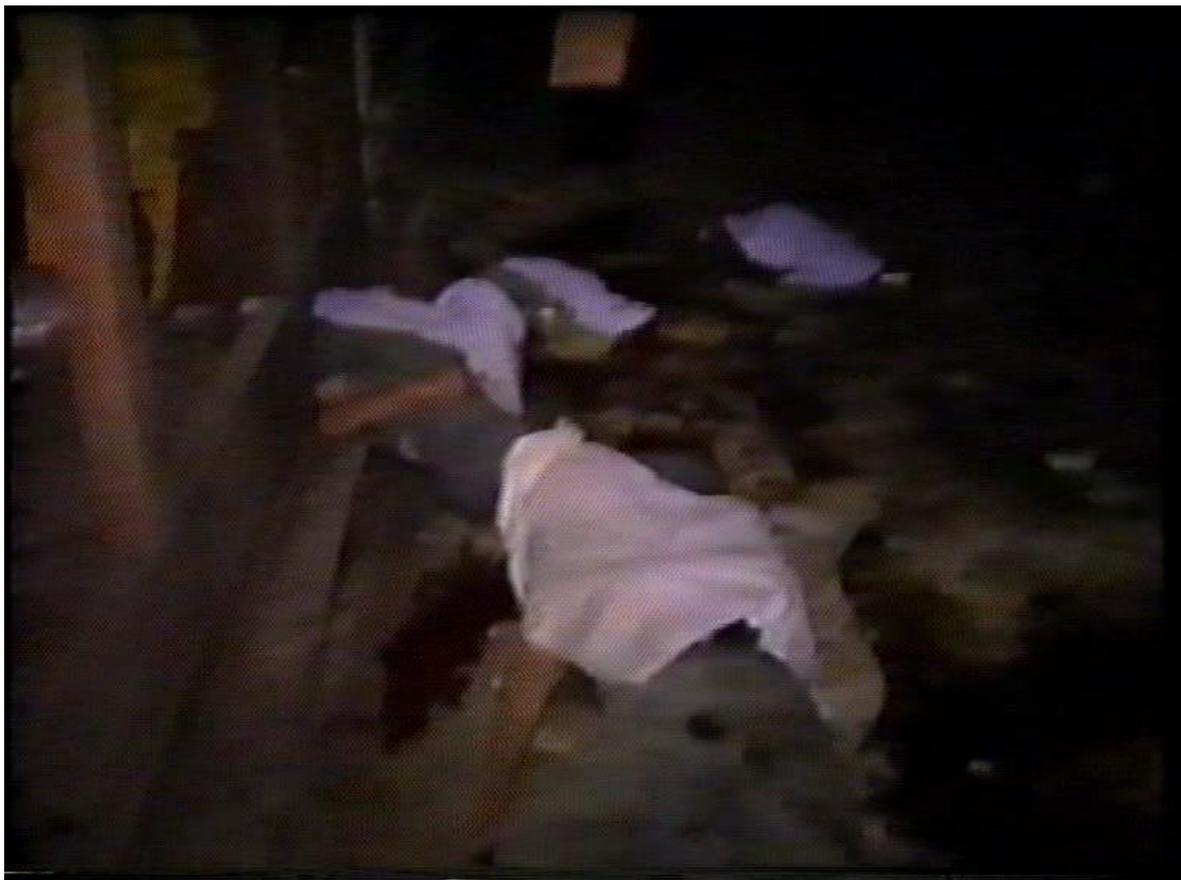
There is special significance to the comparison between the results of the explosion on victims No. 3 (Hasanovic Senad) and No. 36 (Alispahic Admir), two policemen who, at the time of the explosion, stood in front of the NIK building, very near the Golf vehicle.

As a result of the explosion the 2 policemen were killed and their bodies remained on the sidewalk in front of the building, as shown in the photo.

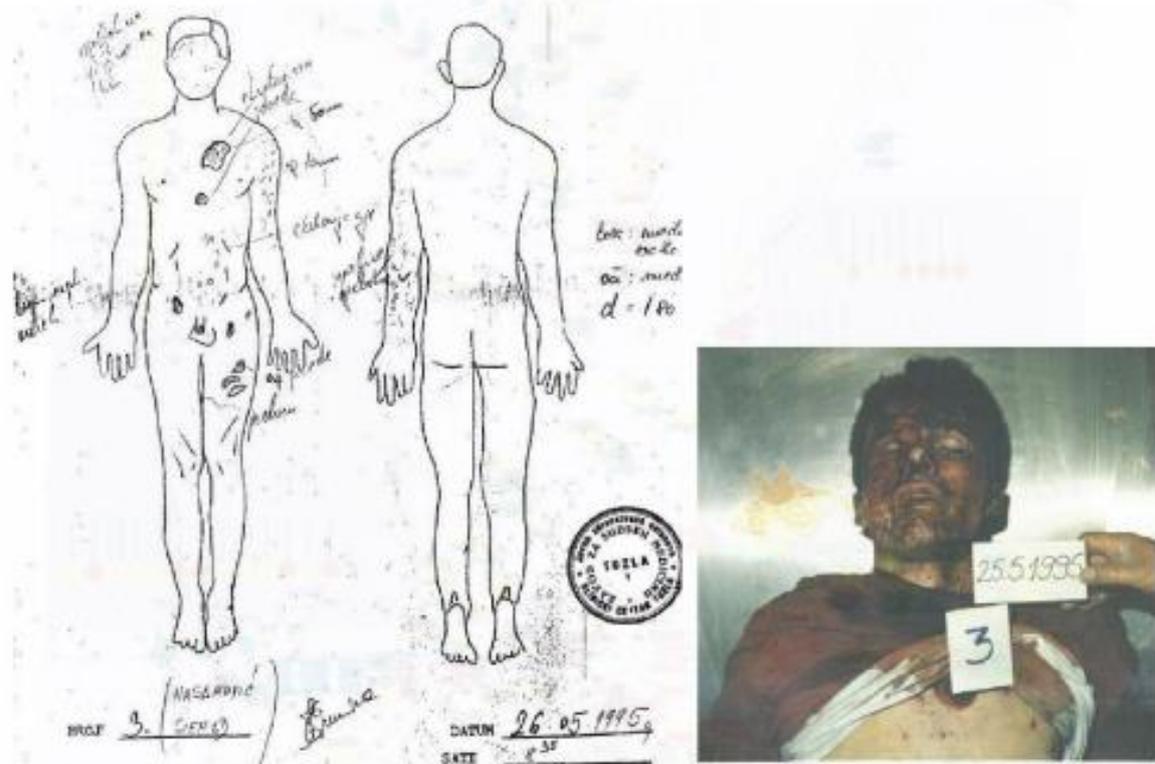
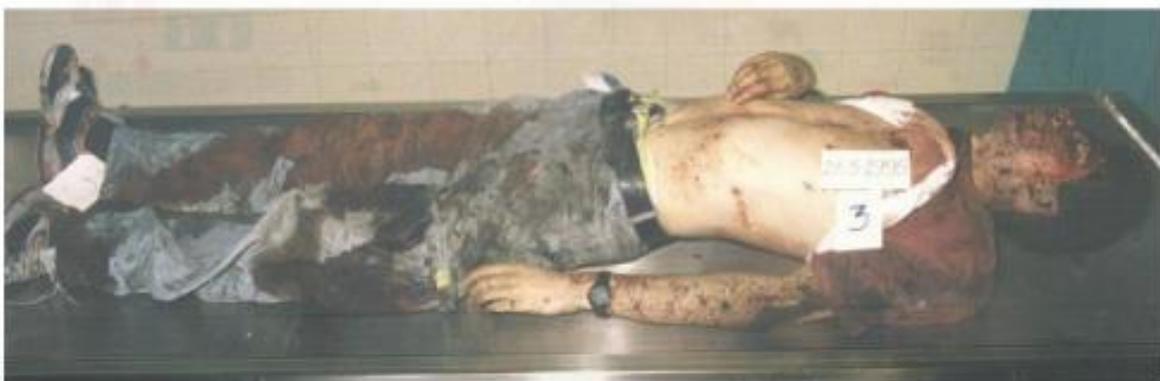
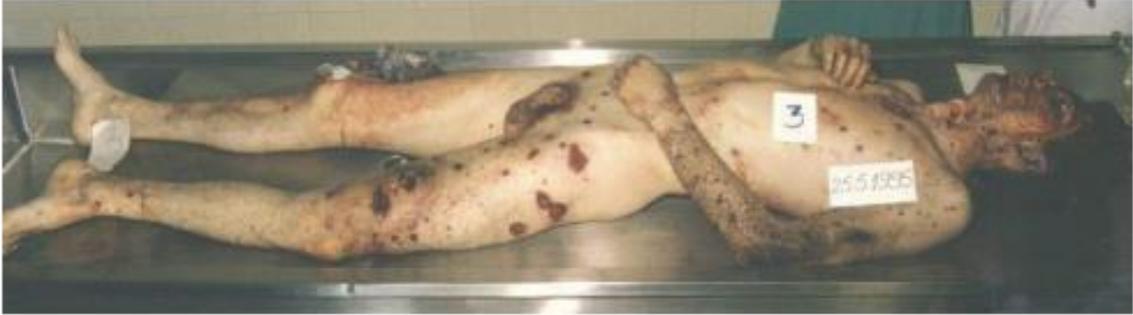
3. Senad Hasanović, son of Meša,

In the description of the injuries were ascertained defects of the skin of the outside left [art of upper body, left arm and left leg that continues in depth with multiple fractures of the left femur. Injuries are visible on the schematic display and photographic documentation.

On the body of this person there are clearly visible injuries which are located on the front and left lateral side of the body. Injuries stretch from the shins all the way up to the head. In addition, injuries to the head and neck that are visible from the photographs are not described in the record, nor were they drawn in the schematic display of injuries.

In the area of the left upper arm and in the region of the left elbow is clearly a massive deposit of soot which again points to the great proximity to Center of Explosion. Soot is visible in the photograph also in the region of the left sleeve of the t-shirt.

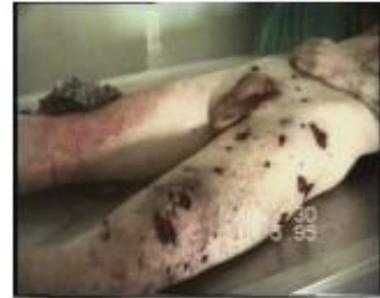
The trousers give an impression that over the left trouser leg there are also deposits of soot. Soot is visible in the area of the front side of the left thigh, as the previous one, and the photograph that was extracted from the video.

Based on previously conducted analysis of video that was made immediately after the critical event, it was found that this person was in the left front part of the car "Golf" at the entrance to the store "Nik", together with Admir Alispahić. It follows that he was located about 2.5 to 3 meters from explosion site. It is completely obvious that such violations do not correspond to injuries caused by 130mm artillery projectile explosion which explodes at 2-3 meters from the injured person.

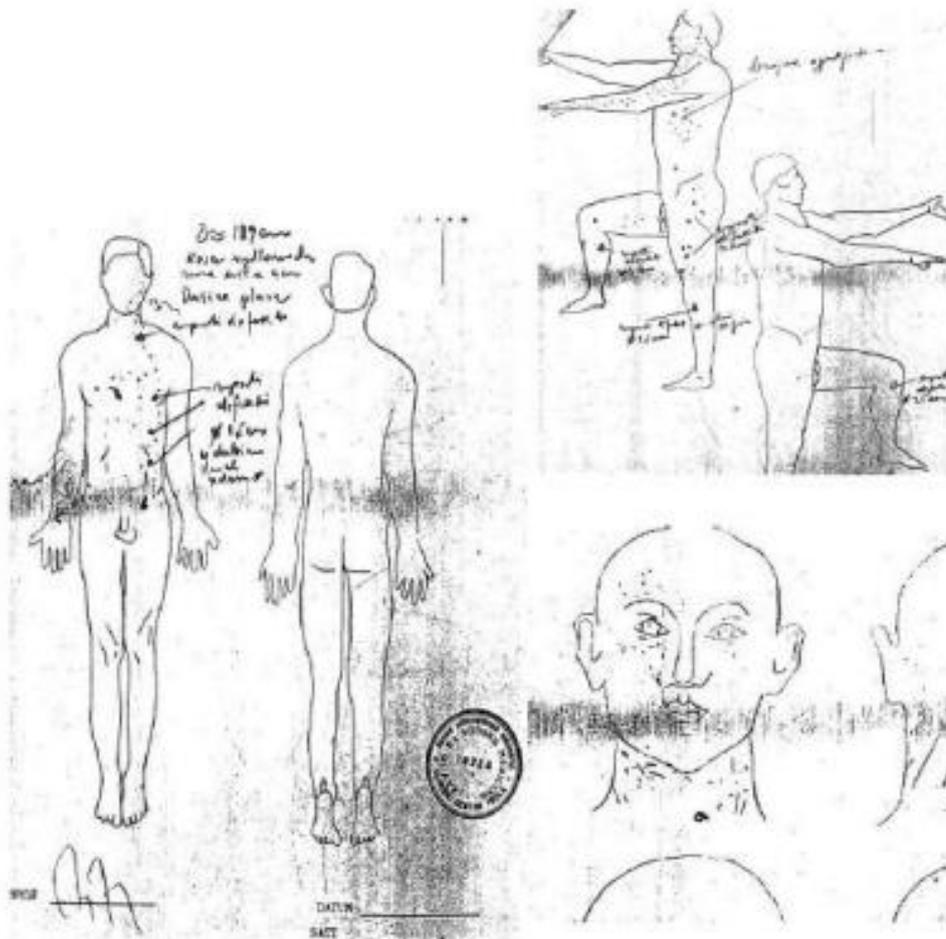
36. ALISPAHIĆ ADMIR, son of Alija, born in 1971 from Tuzla

External inspection of the body of this person found the following injuries: injuries described as numerous small defects located on the left side of the trunk, the limbs and the inside of the right foot.

Schematic display of the recorded injuries and photographic documentation made during the performance of the external inspection were submitted for this individual.

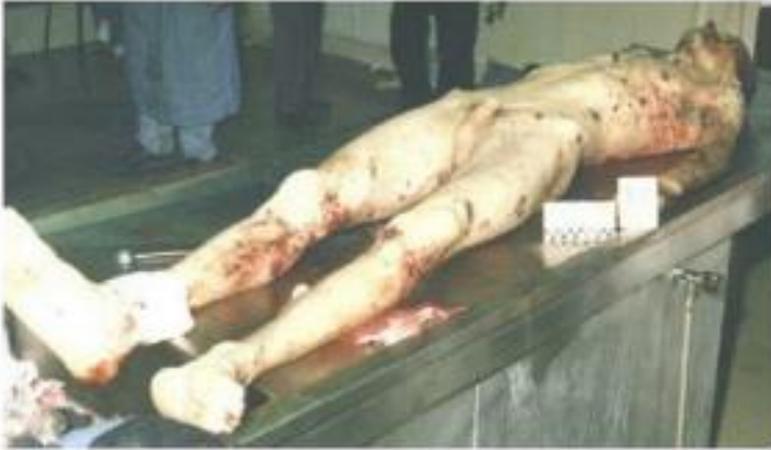
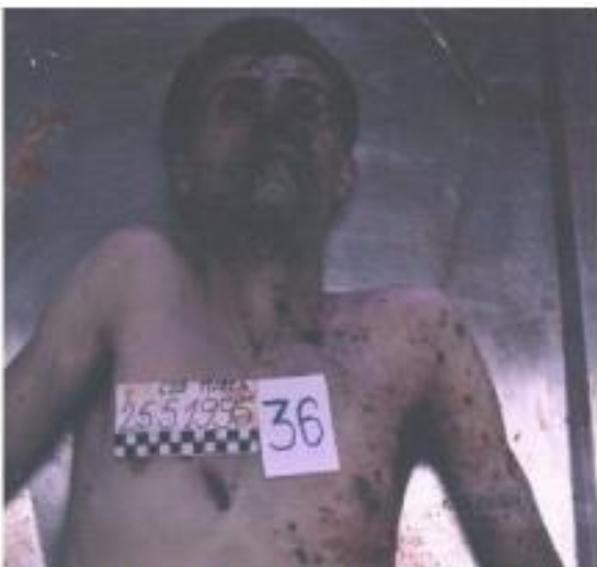
Small defects listed in the records on external

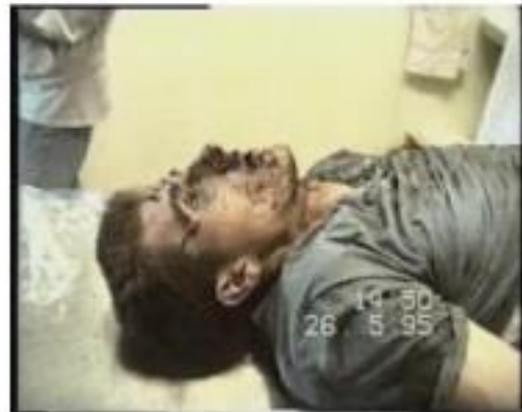
On the photo which is extracted from the video, it is obvious that this person at the moment of the event was wearing short-sleeve T-shirt so it is apparent that the soot in this case also was located on the uncovered parts of the body.

The photos showing this body show visible soot located on the front side of the face and in the region of the left upper extremity. These deposits of soot are not described in the report on the external inspection of the dead body and were not found in the chart.

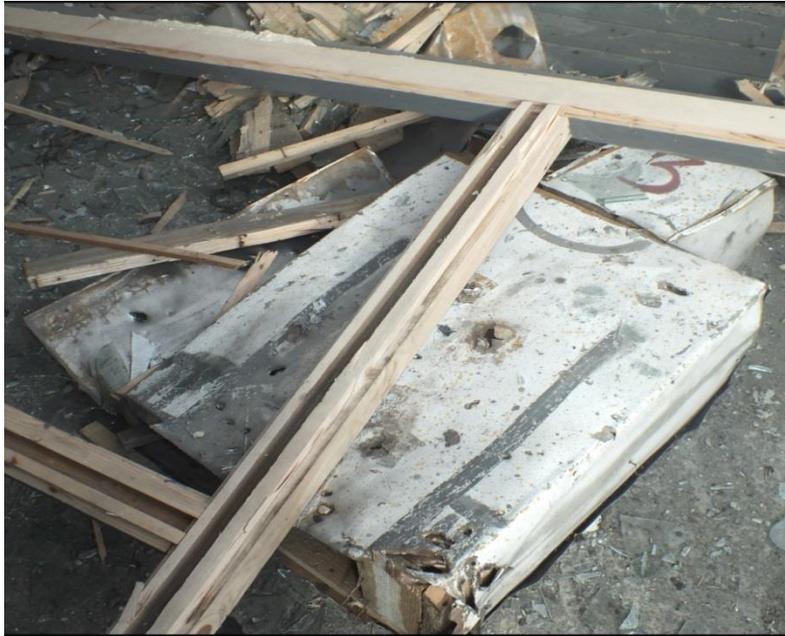
Remains of human figure no. 3

The "legs" of the human figures were completely shattered. The chest area sustained significant injuries as reflected in a massive breaking of the wooden human figures. Extensive soot was found on human figure no. 3.

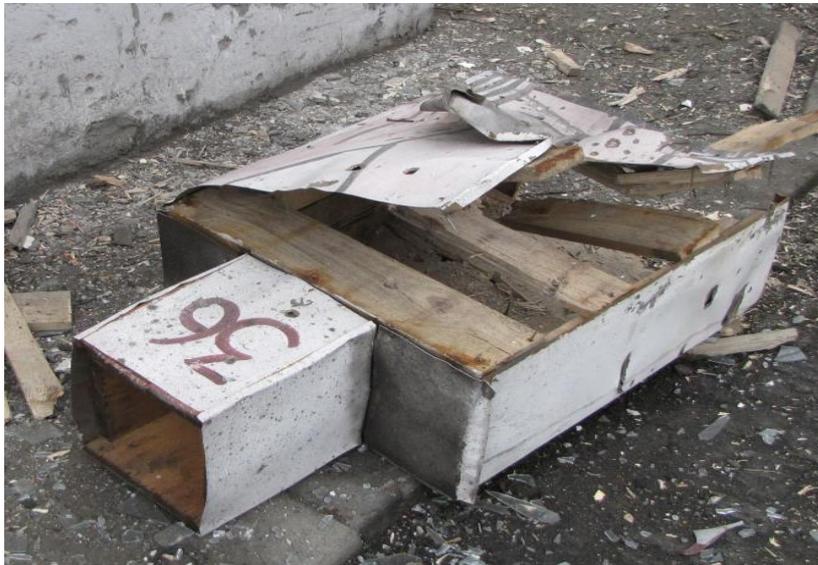
Remains of human figure no. 36

These 2 victims were located very close to the explosion site (2-3 meters), as determined in Dr. Zecevic's opinion.

There appears to be a fundamental difference between the two scenarios. In the test the human figures were exposed to a very strong shattering effect of the explosives of the 130 mm projectile. On the other hand, in the original event it is evident that the victims were injured from a weapon with a much weaker explosive effect that produces smaller and more numerous fragmentation (like the explosion effect of a hand grenade or something similar), that contains explosives with a negative oxygen balance, such as TNT and that produces extensive soot darkening. Otherwise, **the explosion center was farther than the location claimed.**

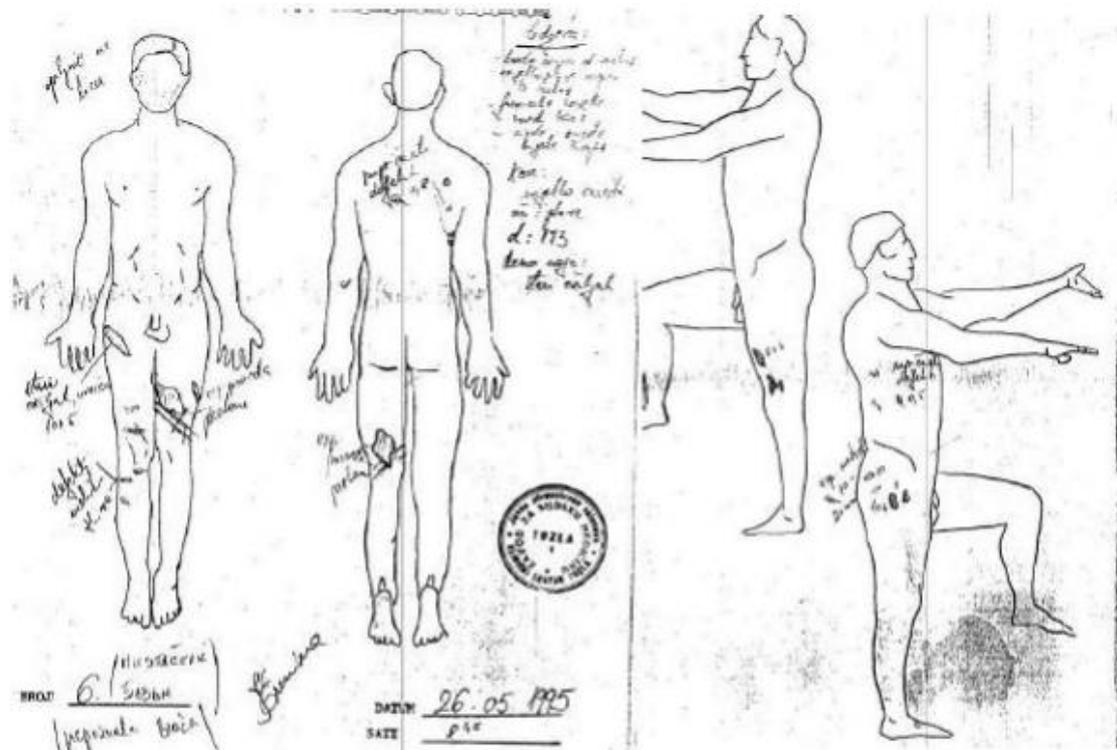
No. 6 – soot darkening on the face and right pant leg

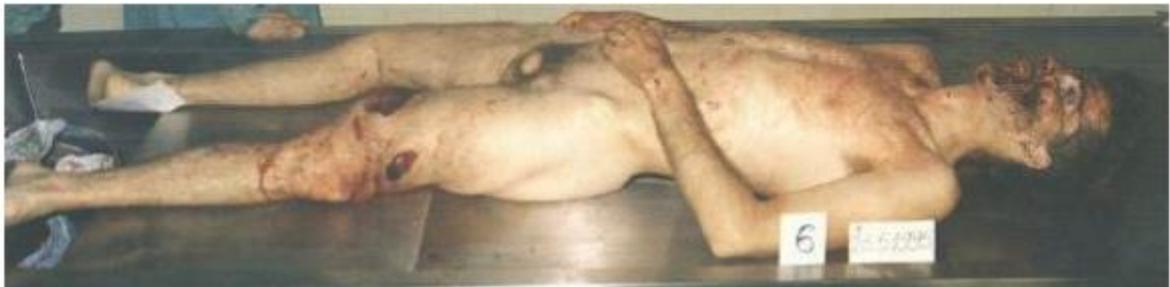
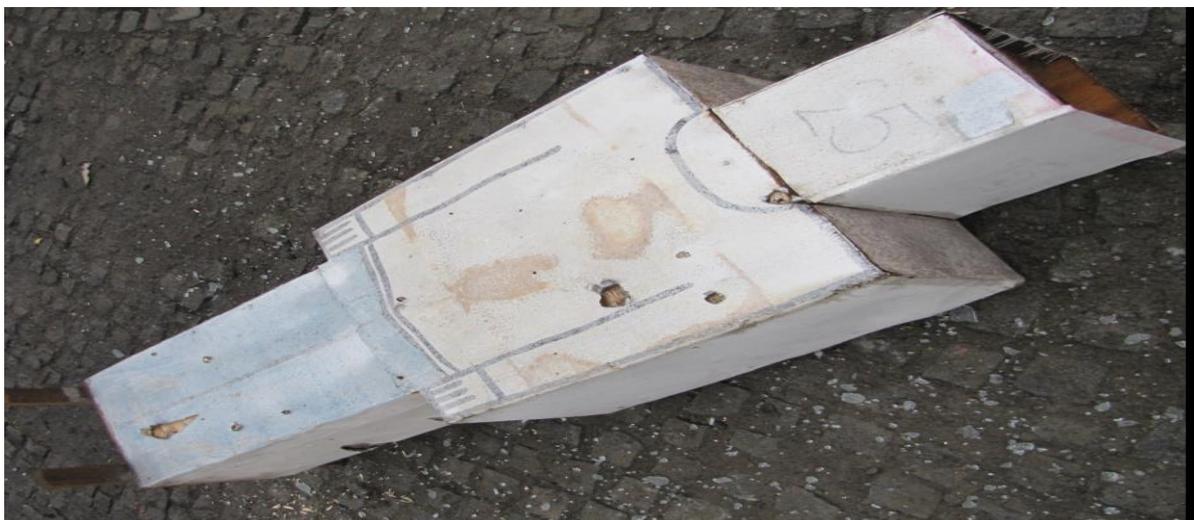
Fragmentation in the upper part, in the lower part – no soot darkening

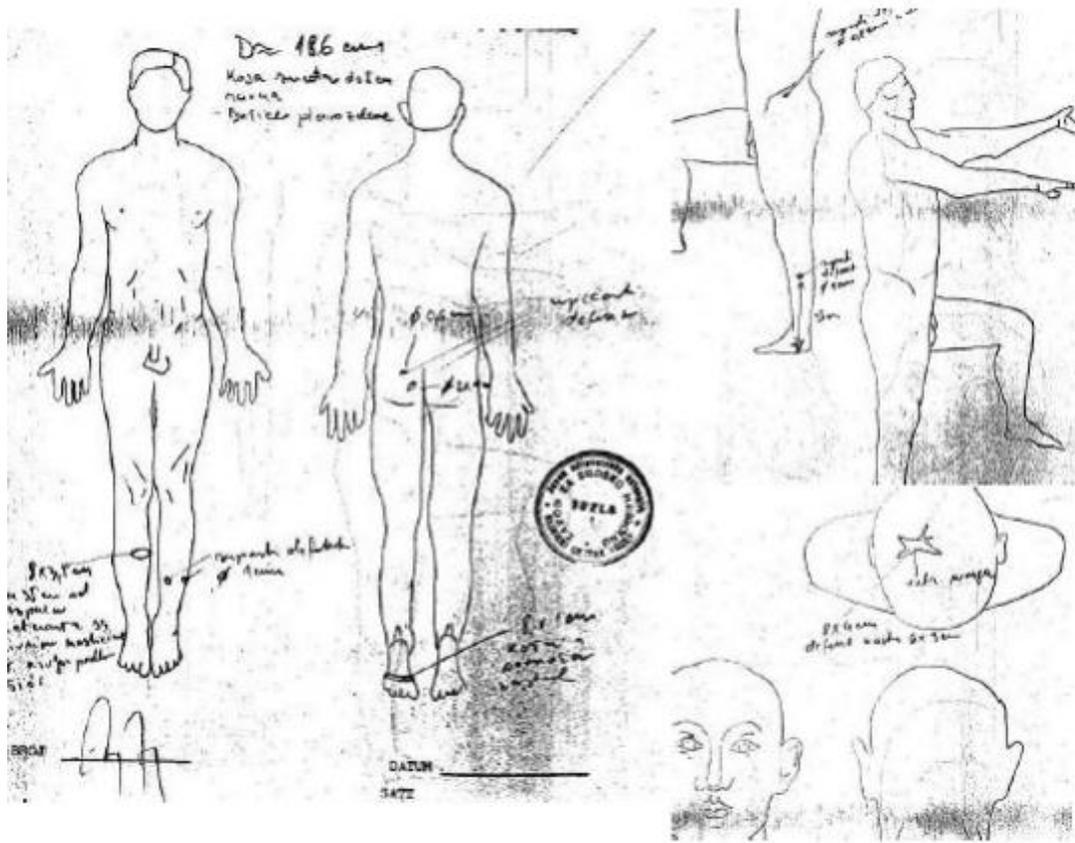
No. 12 – little fragmentation
