1. REPORT DATE April 2016			2. REPORT TYPE Technical report		3. DATES COVERED	
4. TITLE AND SUBTITLE Review of <u>Dr. Zecevic</u> expert opinion report conclusions regarding the causes and results of the explosion occurred at Kapiia square in the city of Tuzla on 25/05/1995					5a. CONTRACT NUMBER	
					5b. GRANT NUMBER	
					5c. PROGRAM ELEMENT NUMBER

6. AUTHOR(S) Sharon Joseph					5e. TASK NUMBER	
					5f. WORK UNIT NUMBER	
					8. PERFORMING ORGANIZATION REPORT NUMBER 32-16	
7. PERFORMING ORGANIZATION NAME(S) AND ADDRESS(ES) <u>Temech-Consultants</u> Tel-el 2516700 Israel					8. PERFORMING ORGANIZATION REPORT NUMBER 32-16

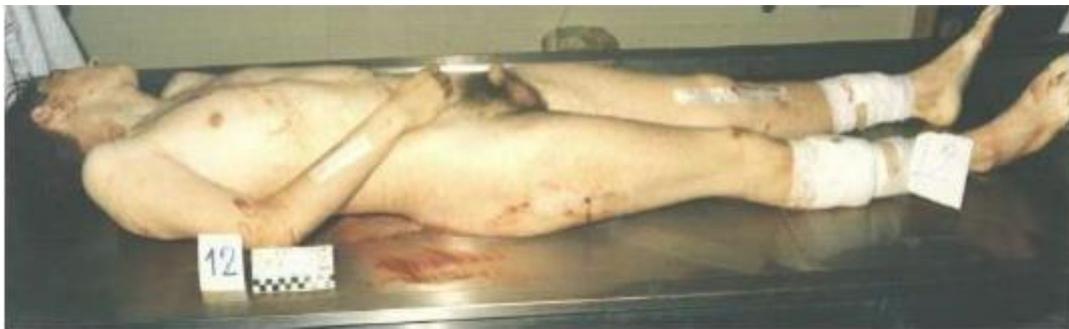
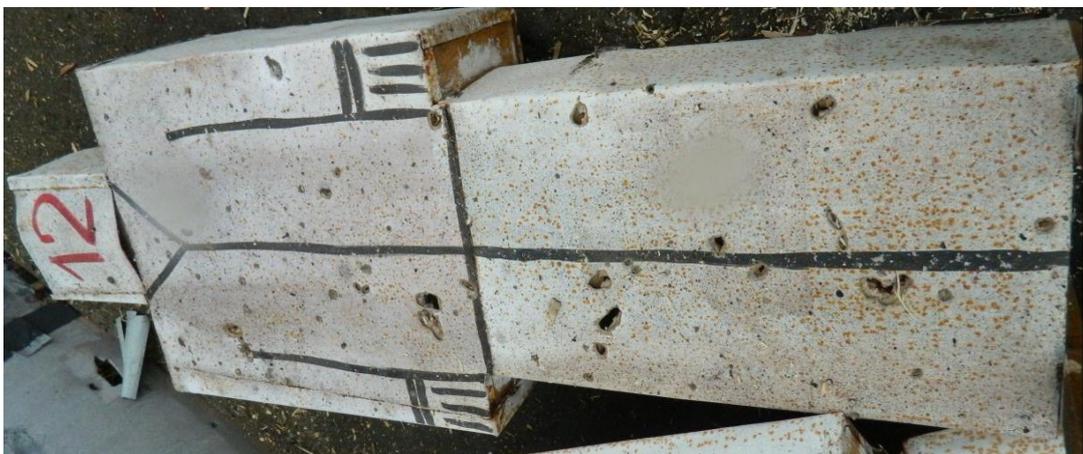
Massive fragmentation on the entire surface of the human figure

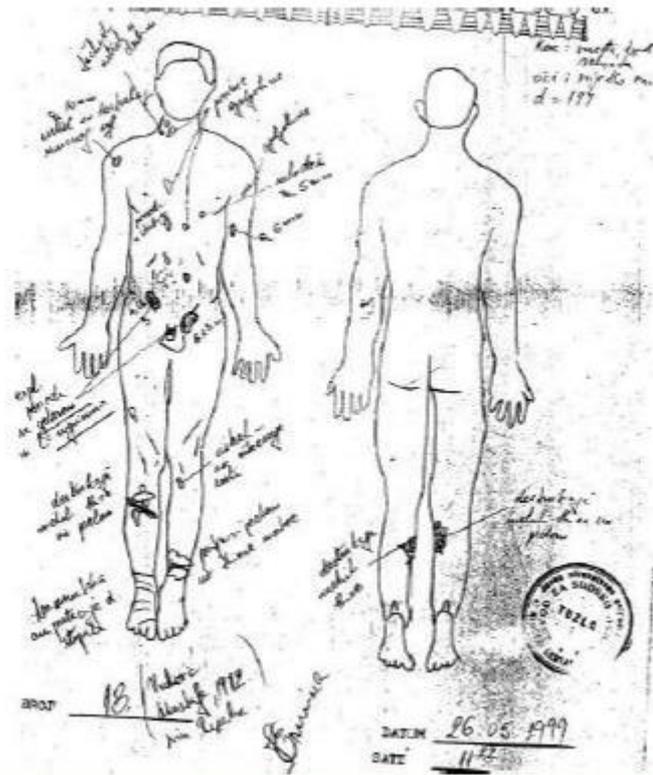
No. 18 – extensive fragmentation spread over the victim’s entire body

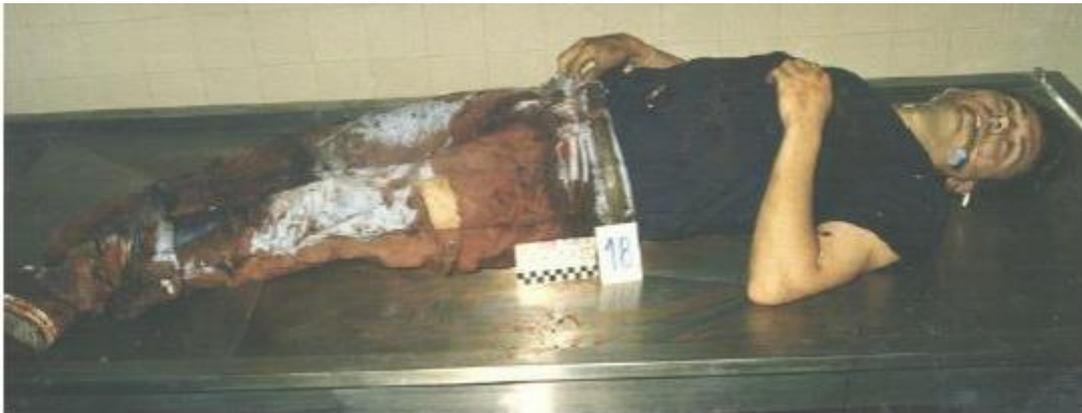
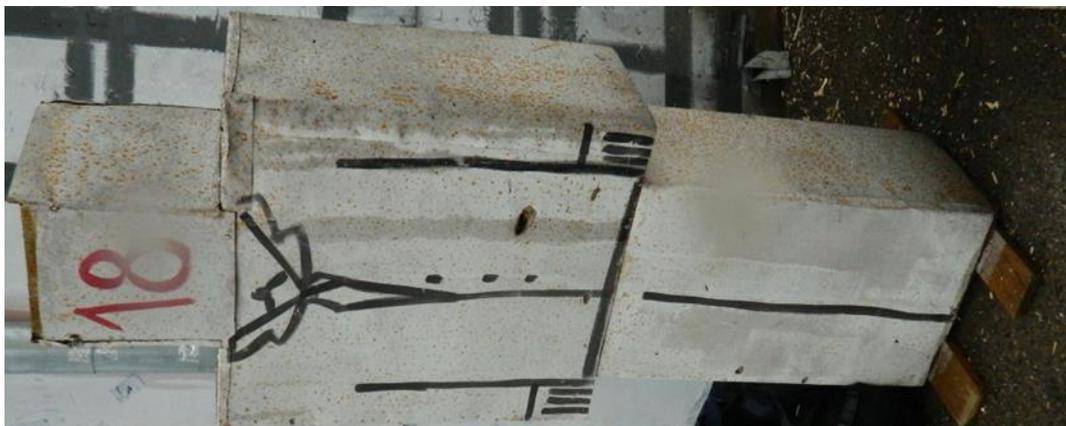
Single fragment in the abdomen area

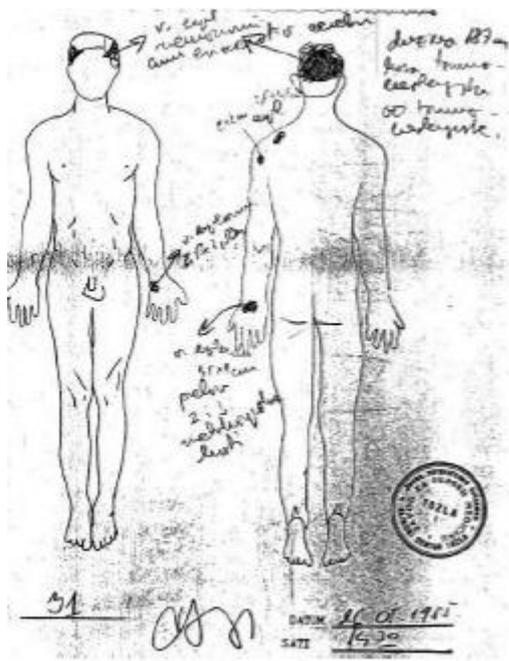
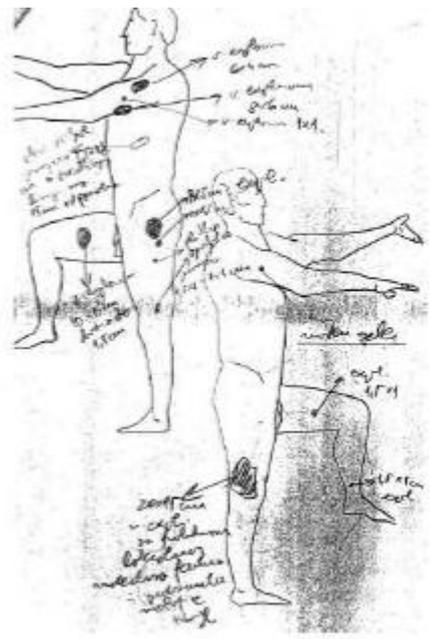
No. 31 – no soot darkening, fragmentation on several of the victim’s organs

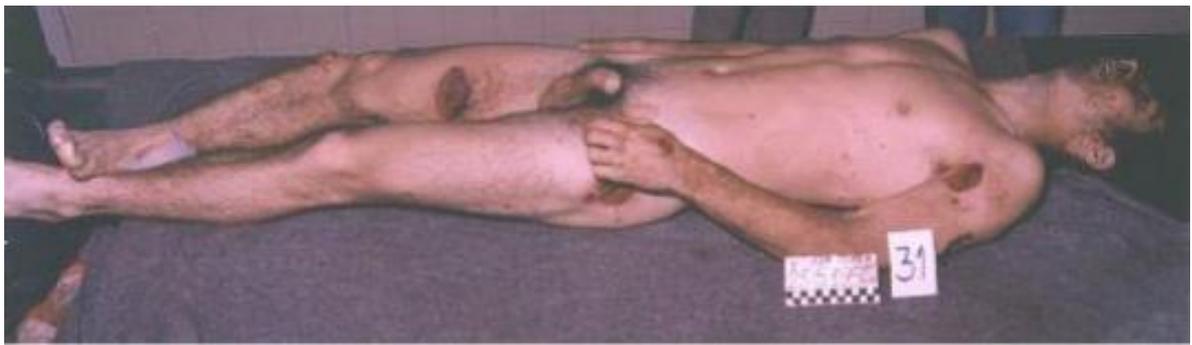
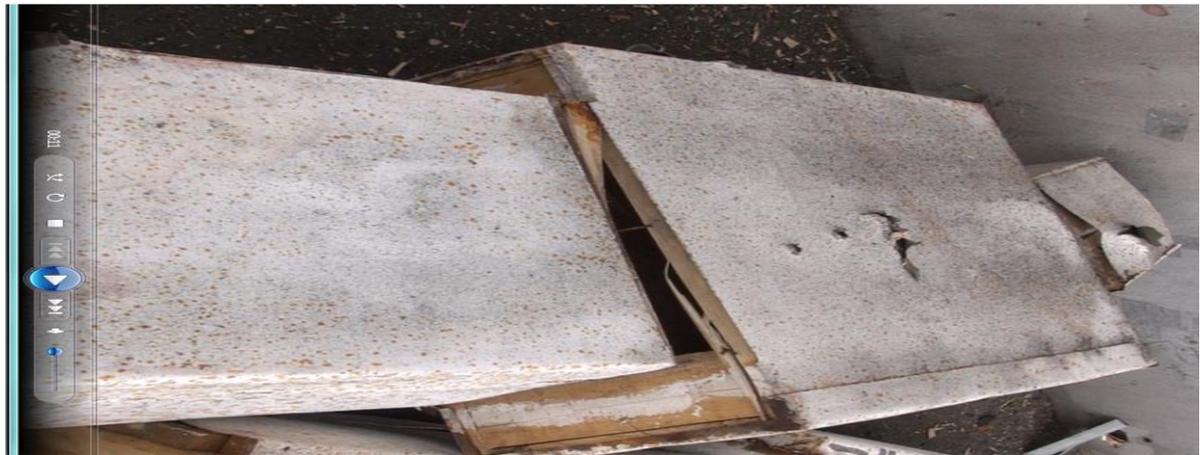
Strong shockwave effect on the human figure, massive soot darkening on the upper part, penetration wounds in the chest area.

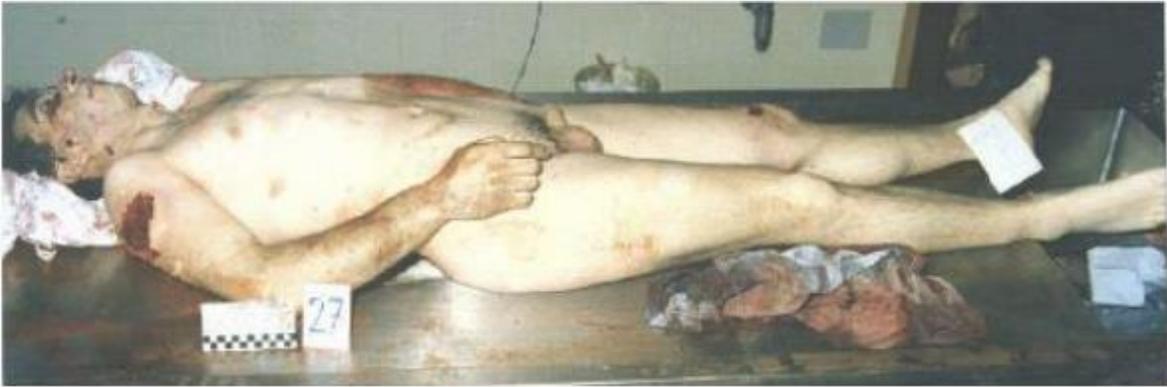
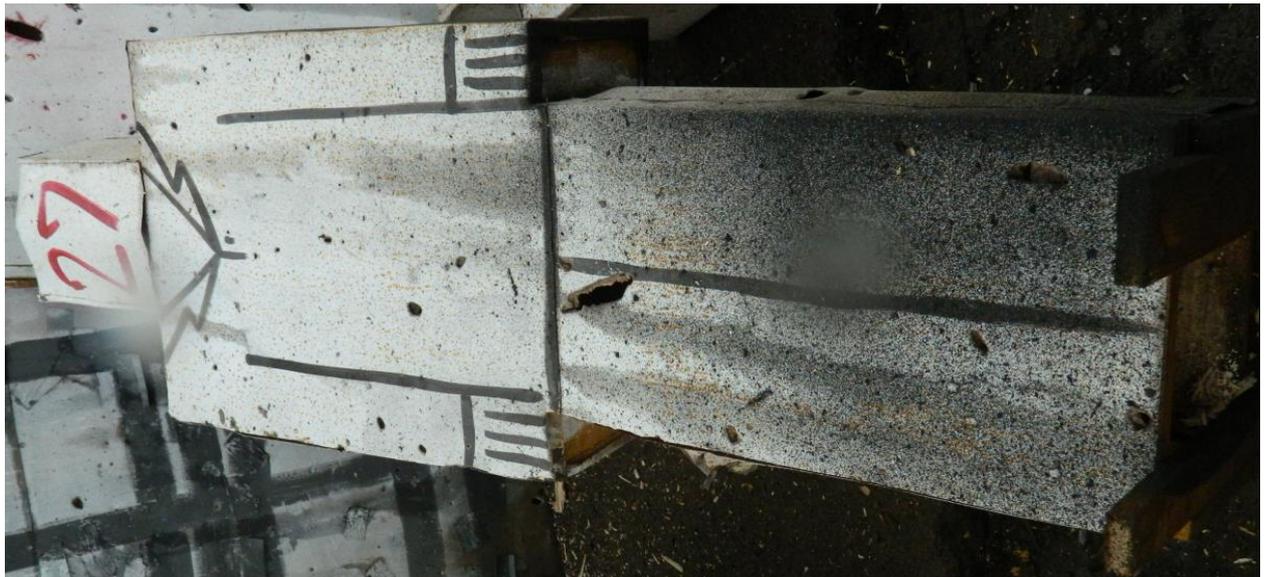
Strong shockwave effect on the human figure, massive soot darkening on the lower part of the body and extensive fragment penetration on the entire area of the human figure.

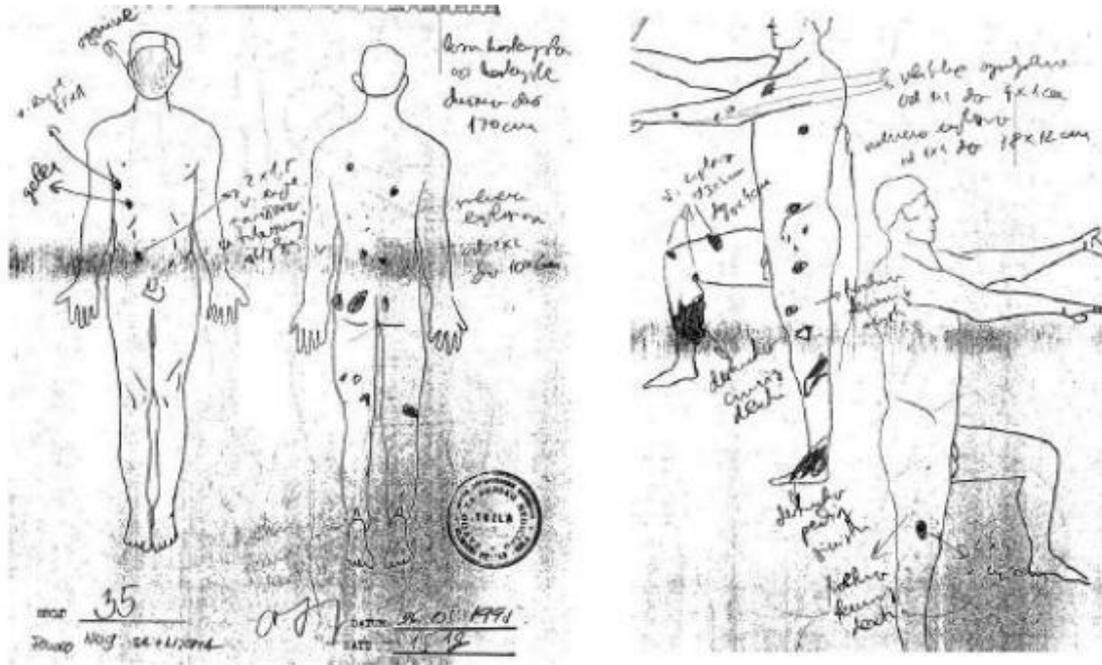
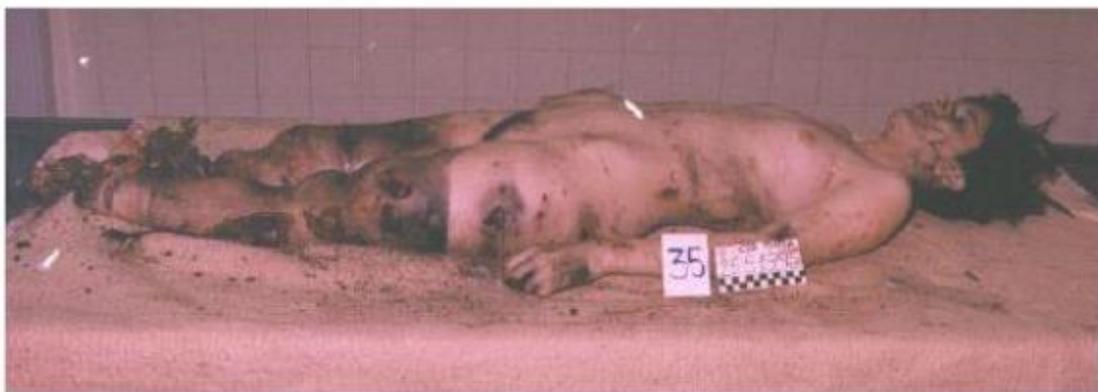
No. 35 – soot darkening on all unclothed areas and massive fragmentation on the legs

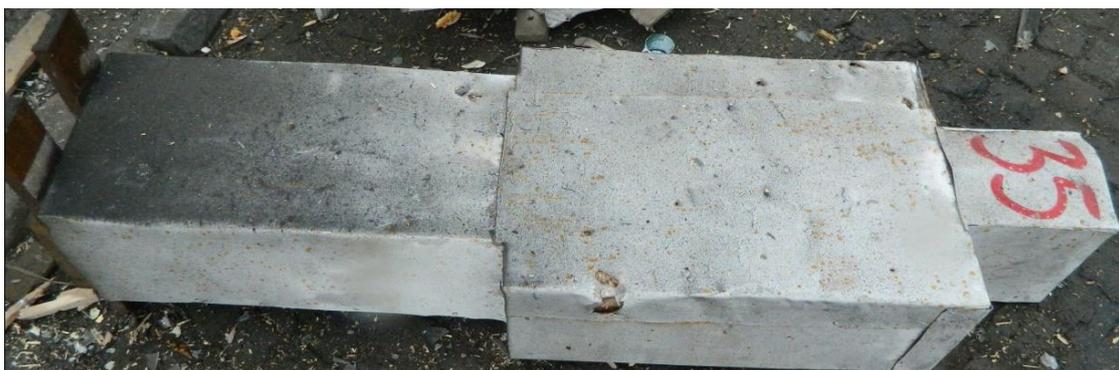
Soot darkening – little and small fragmentation in upper part

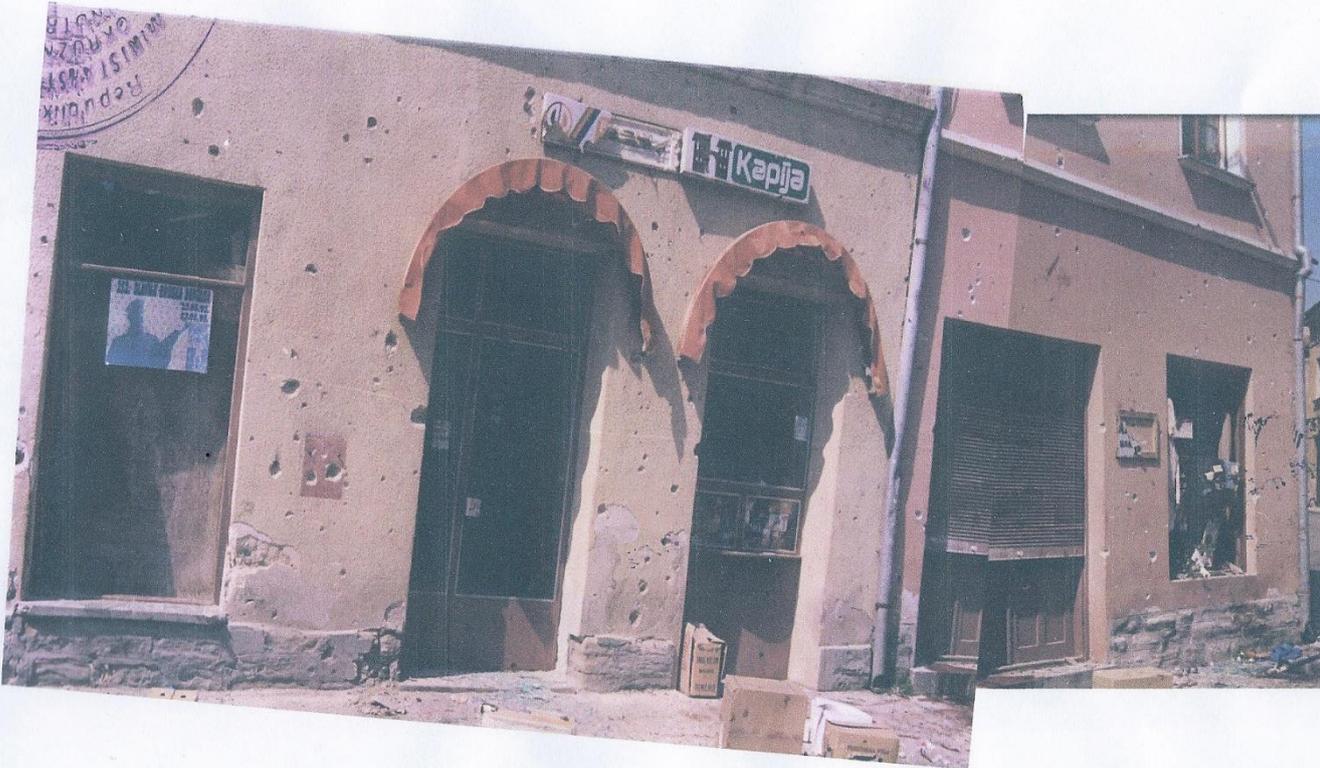
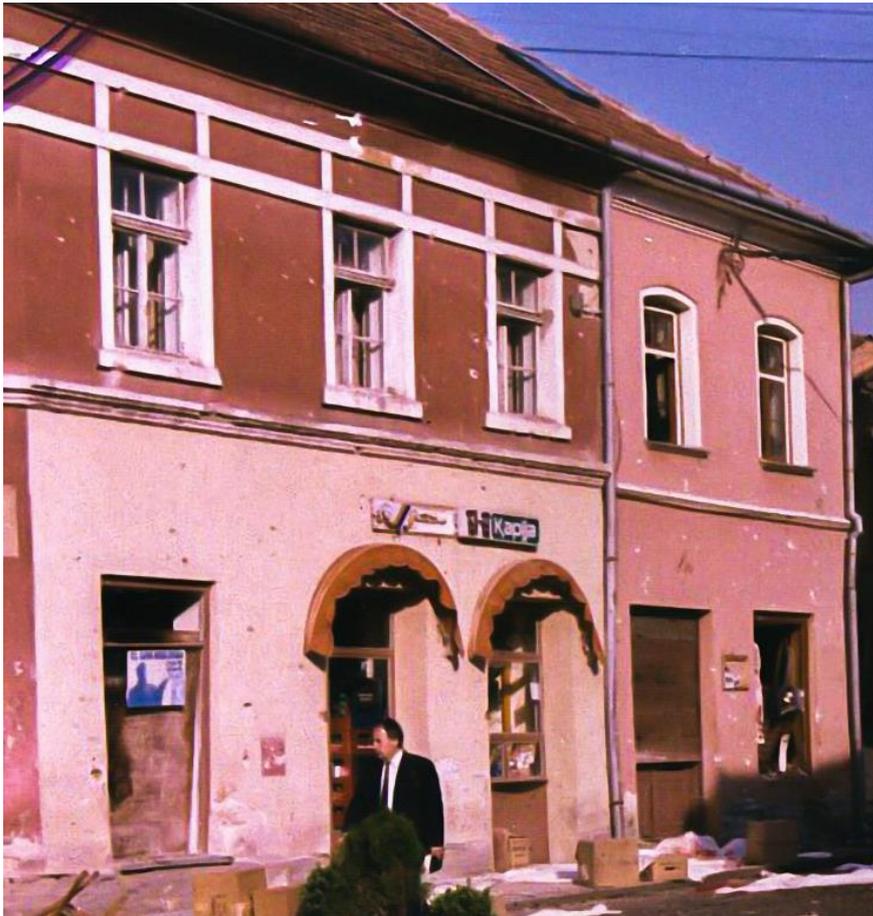
Northeast façade – the building façade suffered massive fragmentation on the entire area, with the fragmentation particularly concentrated in the lower part of the wall. The photos show that most of the fragmentation is found up to a height of about 3 m., with most of the fragmentation concentrated in the lower part of the wall.

There is fragmentation damage in the upper part of the wall, however there is less and it is spread over the entire upper part of the wall.

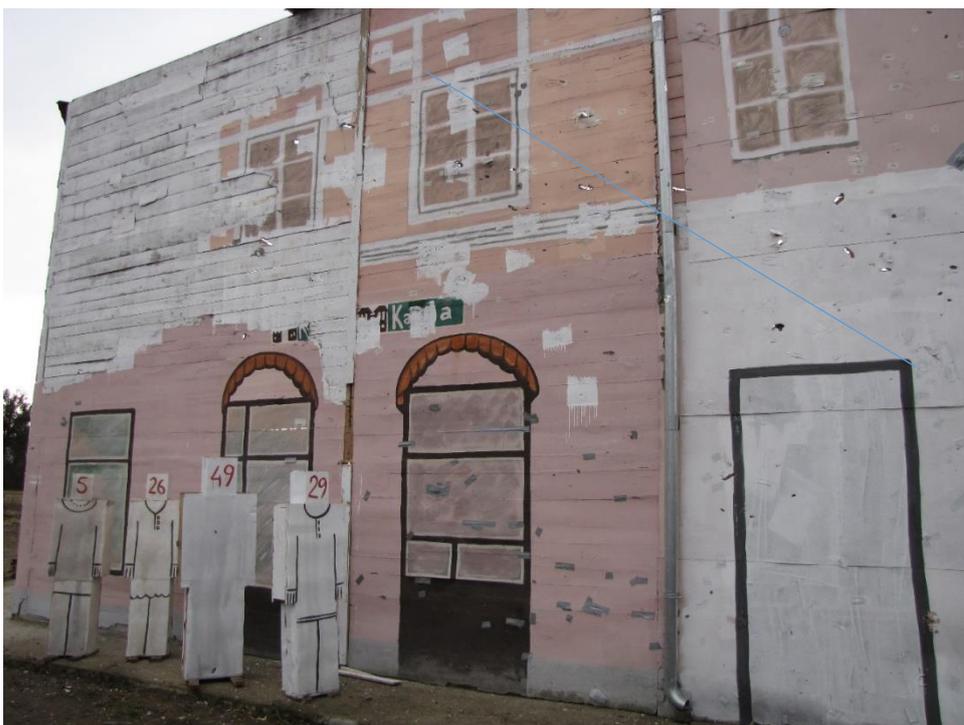
In the test fragmentation reached a maximum range of 16 m on the northeast wall at a height of 1.80 m. In the upper part of the building wall a diagonal fragment was found at an angle of about 60 degrees that ends at a distance of about 20 m, where it rises above the roof of the building.

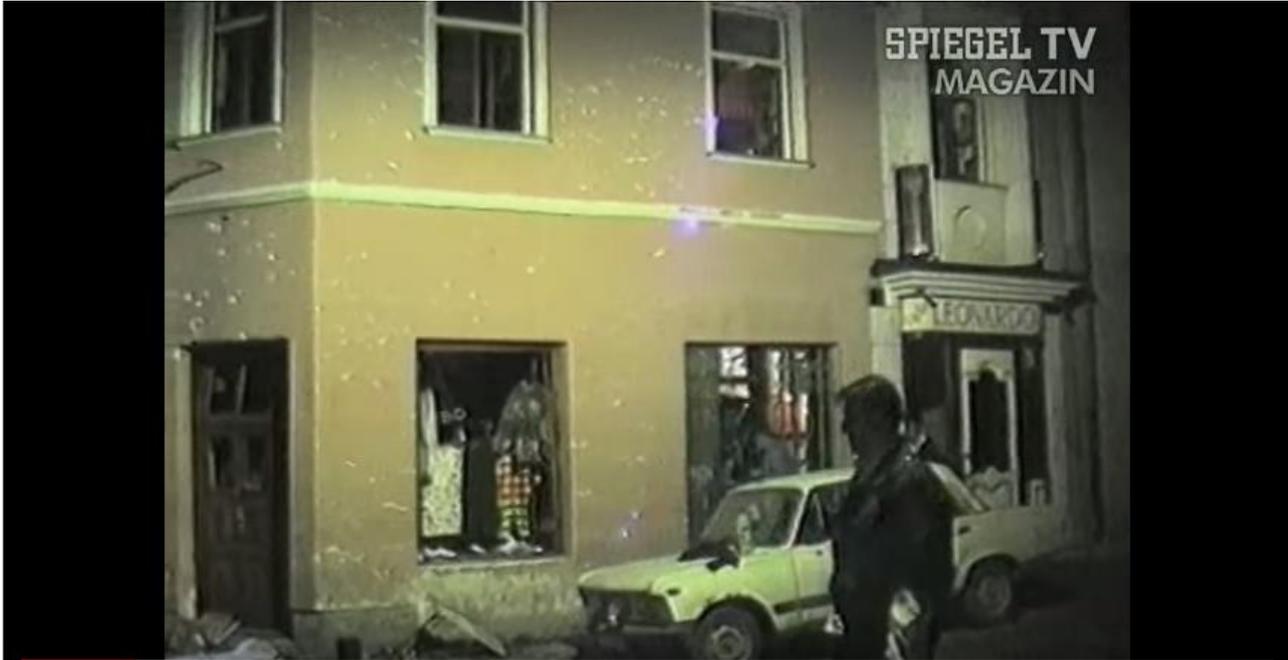
B. Corner of Kapija building and the west wall

The Tuzla event – extensive fragmentation was concentrated in the upper part above the door, and on the Northwest wall on the second floor, up to a distance of about 12 m from the explosion center.

On the bottom part there is something resembling elongated scratches on the wall ending opposite the front of the vehicle, at a distance of about 11 m from the claimed explosion crater. Next to it, on the wooden door, there are relatively many fragments spread on the area of the door.

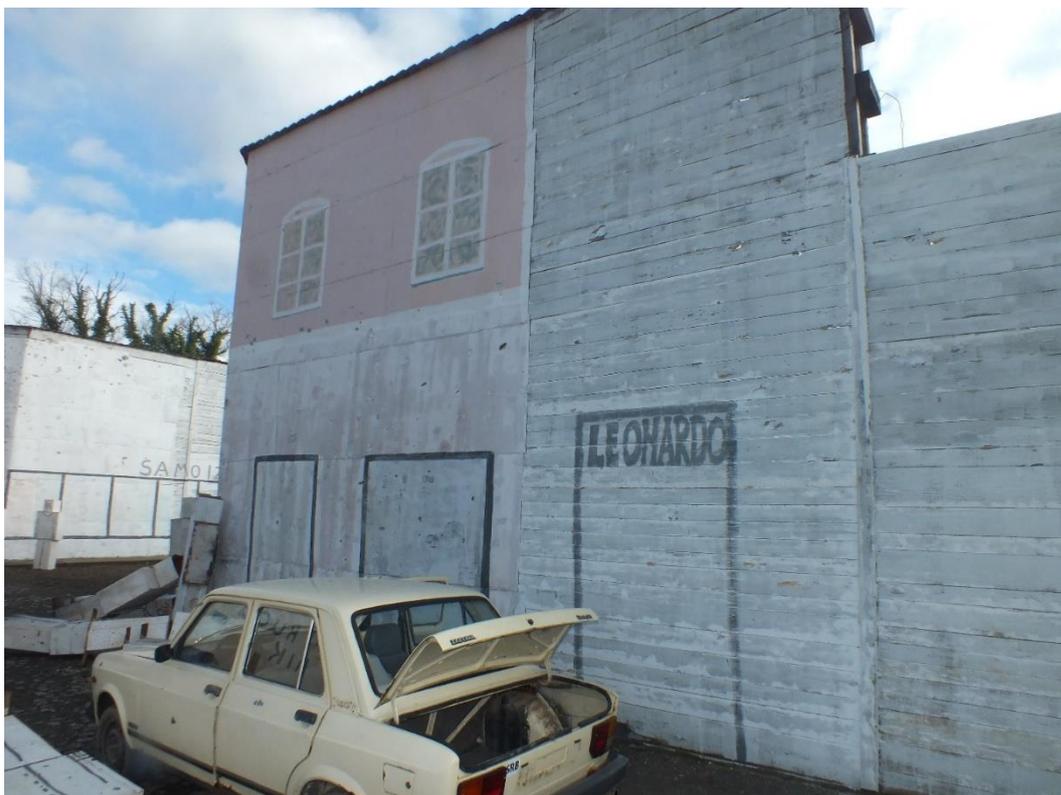
In the experiment – few fragments – most of them concentrated at a height of up to 3 m

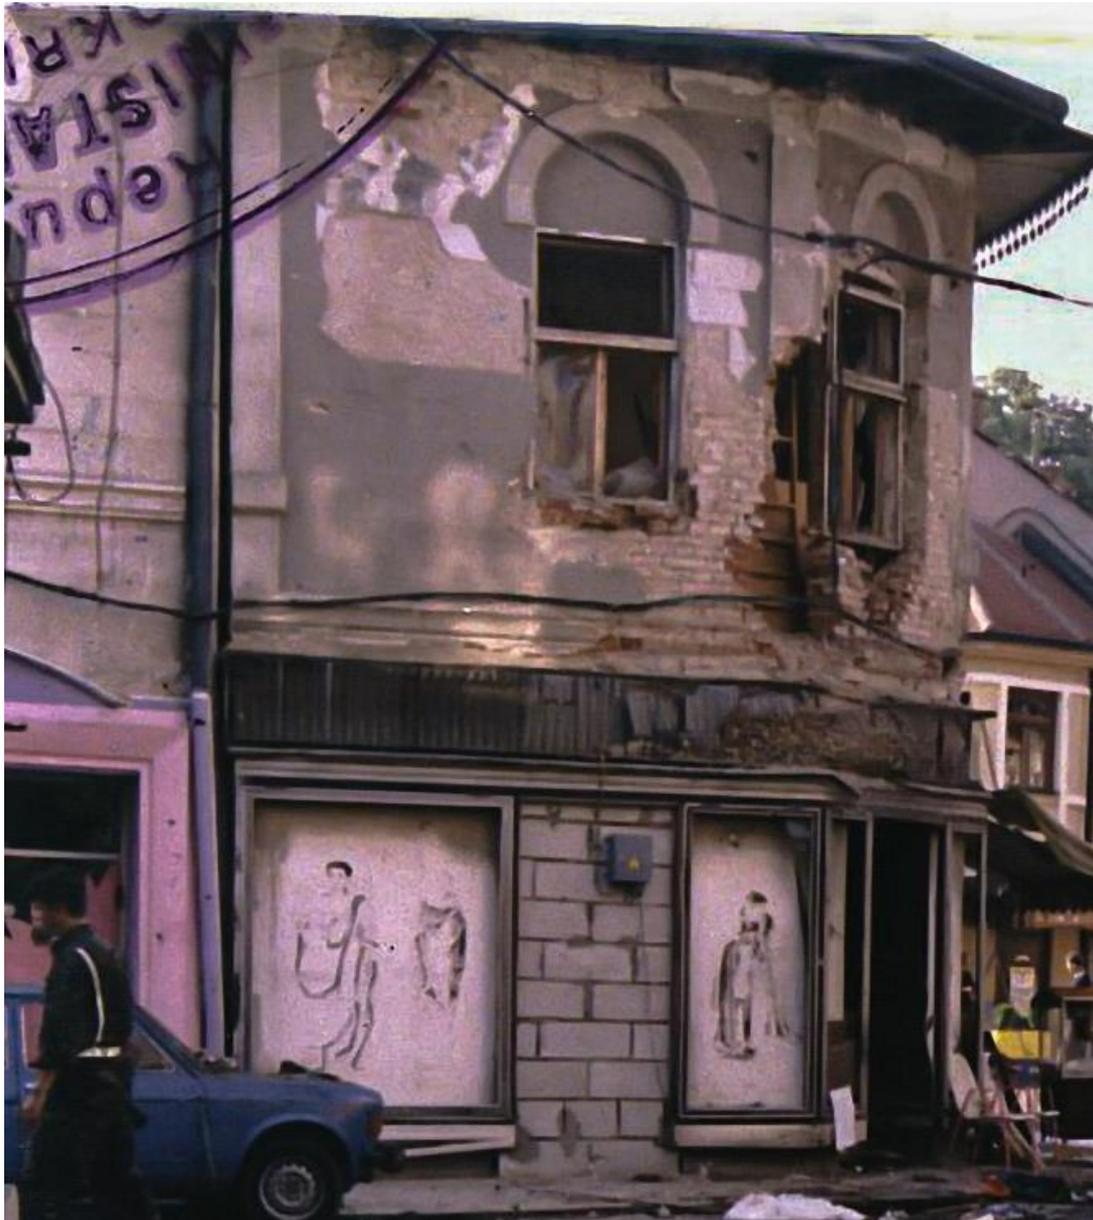
West corner of the building – Kapija event

West corner - one of the most significant differences between the original event and the test was found in this area. While in the Tuzla event there was a high concentration of fragments in the lower part, and this was also where the highest number of victims was found, **in the test the large number of fragments was concentrated in the upper part of the wall**, while fragmentation in the lower part was relatively small. This difference in the location of the fragmentation spread is of great significance with respect to the positioning the shell. Furthermore, it is evident that this fundamental difference unequivocally indicates that there is no congruence between the position of the shell according to Dr Zecevic and the results of the explosion in Tuzla.

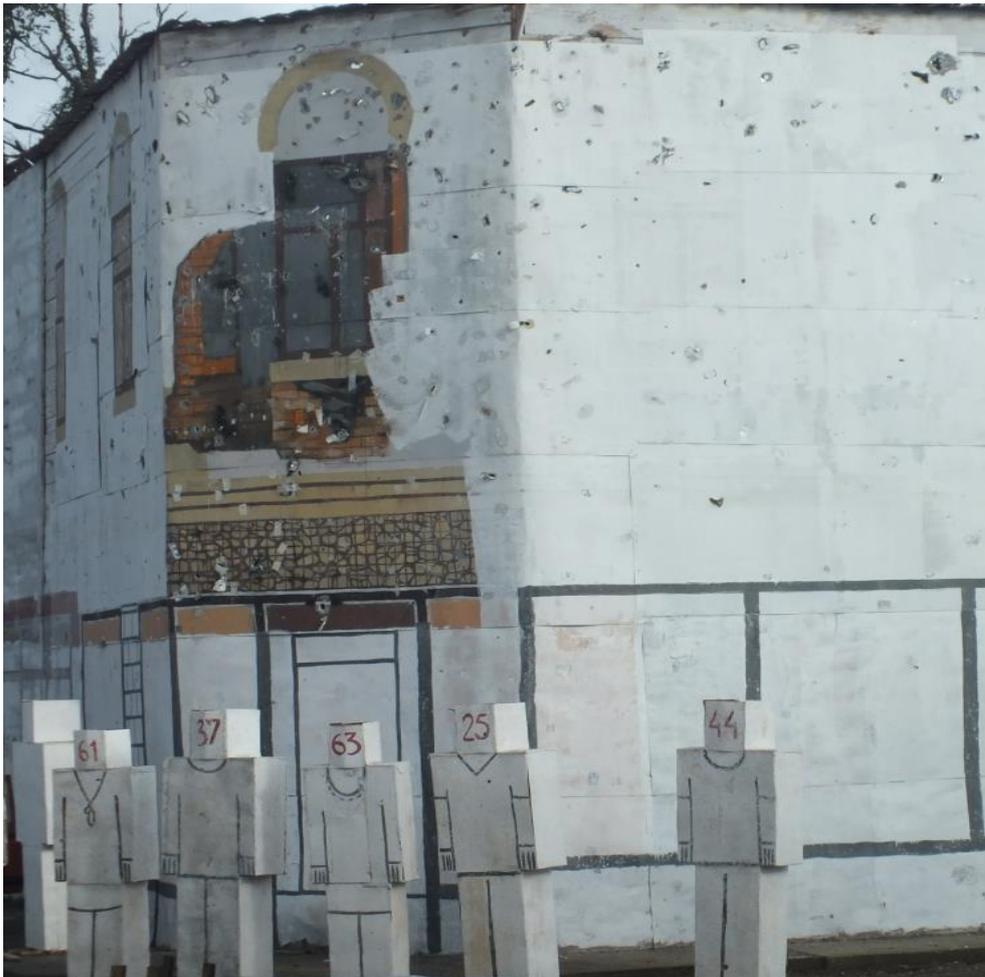
Samizbor West corner- test results- most fragment hits are on the upper part

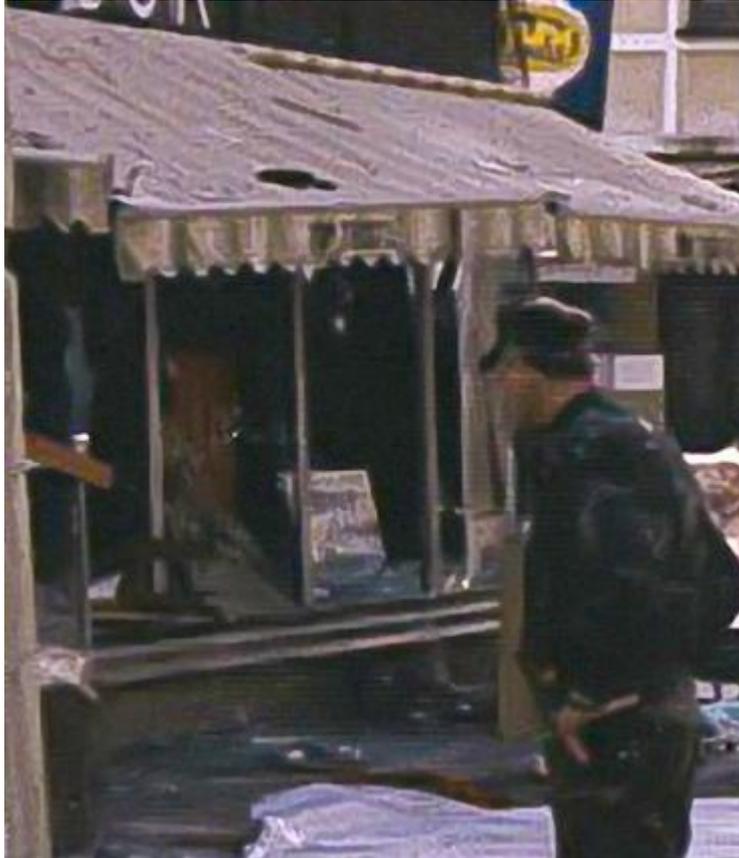
Notice the large amount of fragmentation that created holes in the store window sunshade and shattering of the glasses

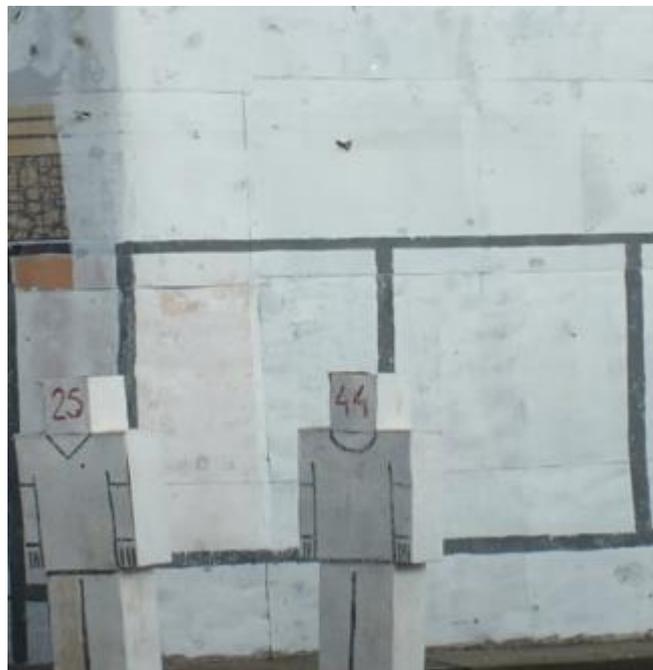
Samoizbor – Southeast façade – test – no fragmentation

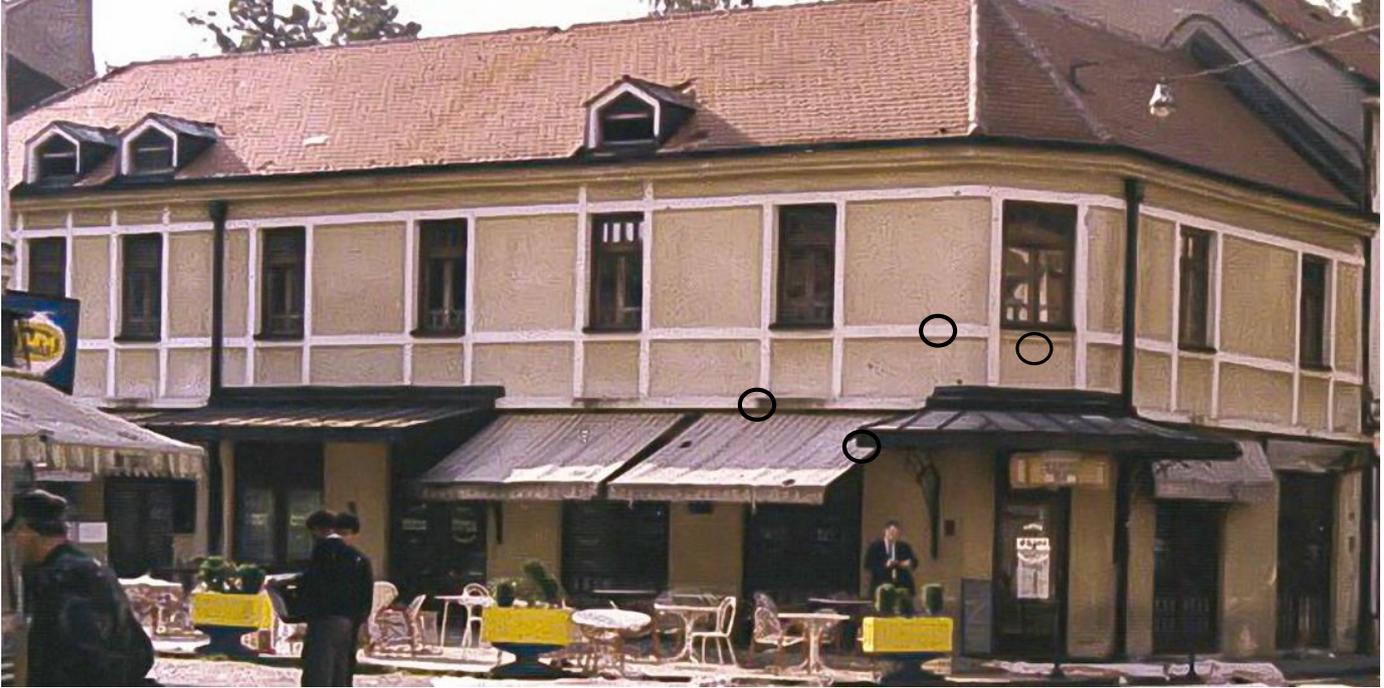
Photos of the original event do not allow for in-depth examination of the number of fragments that damaged the building and the location of the damage. Several places of fragment of damage can be shown in the photo..

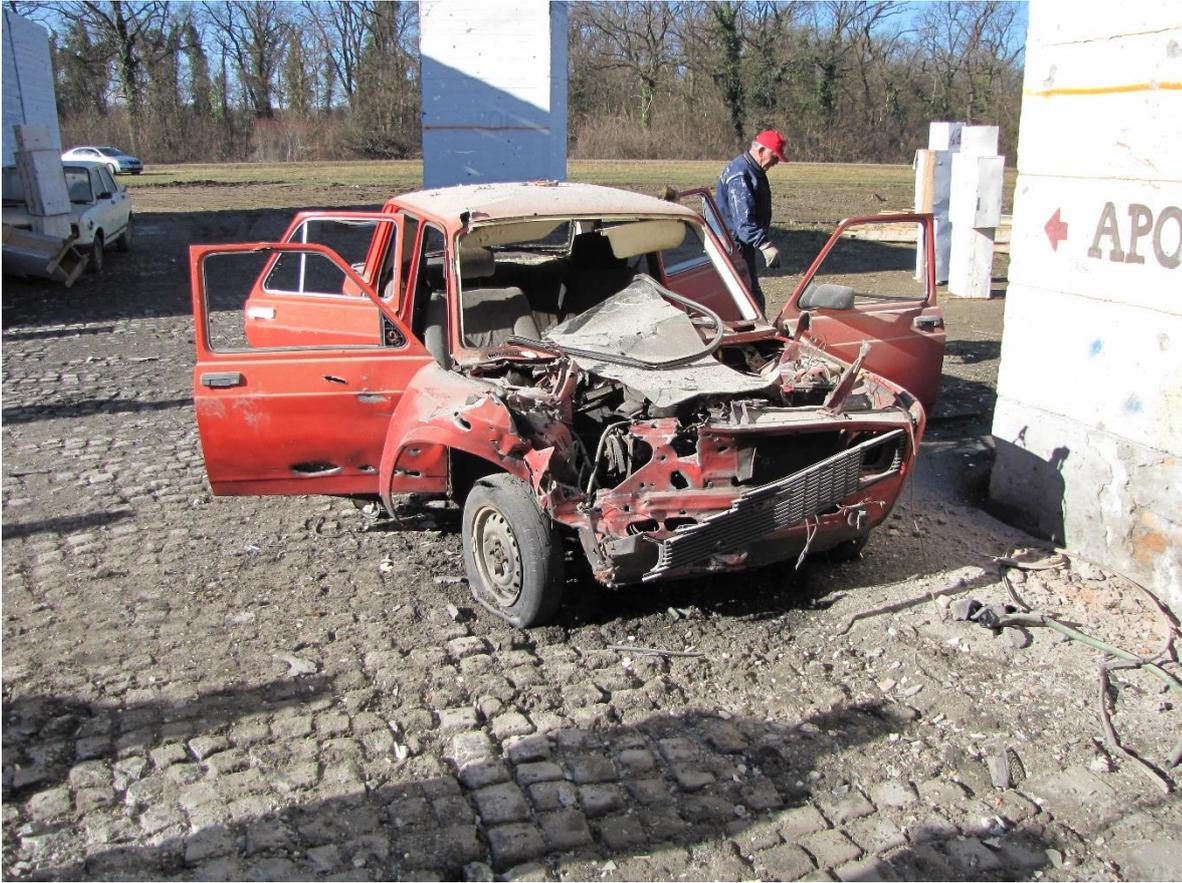
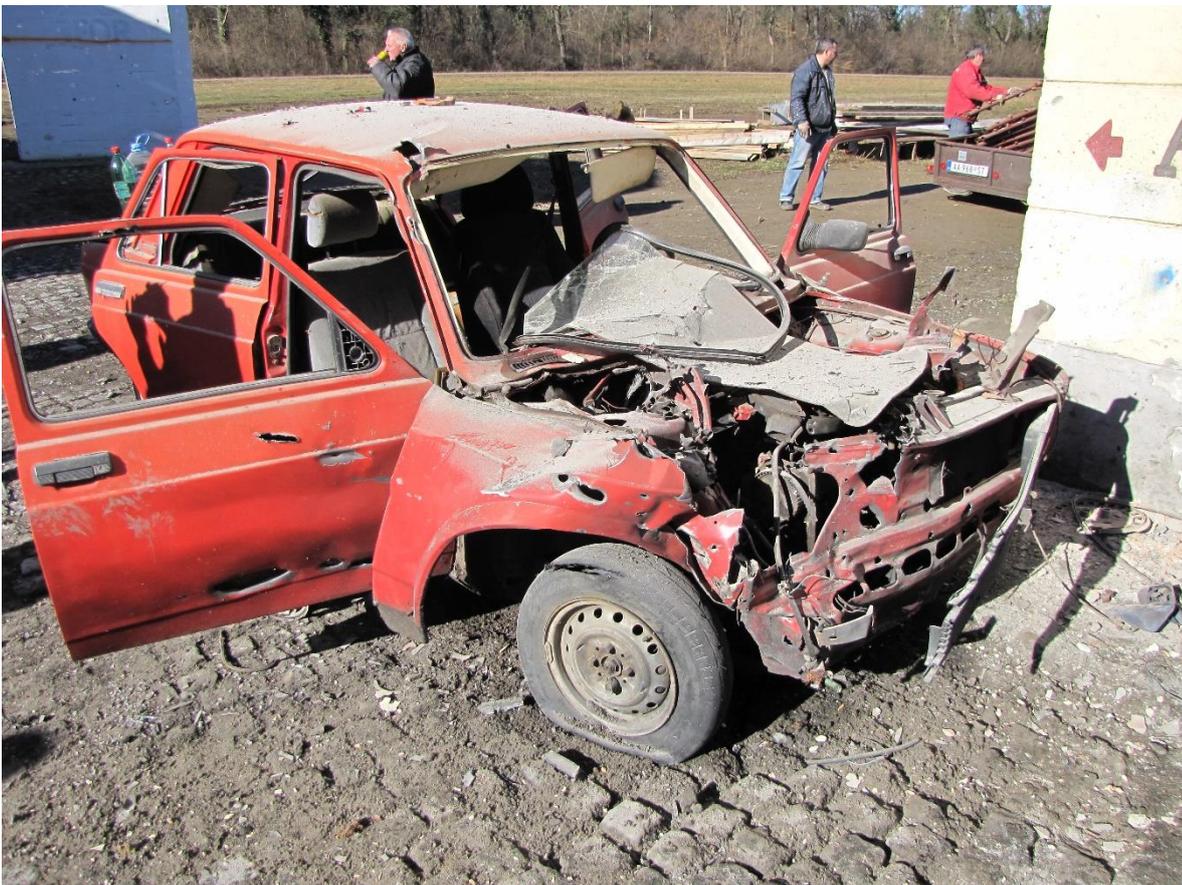
The front of the car on its right side was torn as a result of the explosion pressure. Heavy damage was caused to the vehicle engine, the chassis and to the internal engine components.

Fragmentation penetrated into the passenger compartment and the vehicle roof.

The vehicle was flung towards the wall and found 73 cm from the wall, and was also flung about 1 meter backwards.

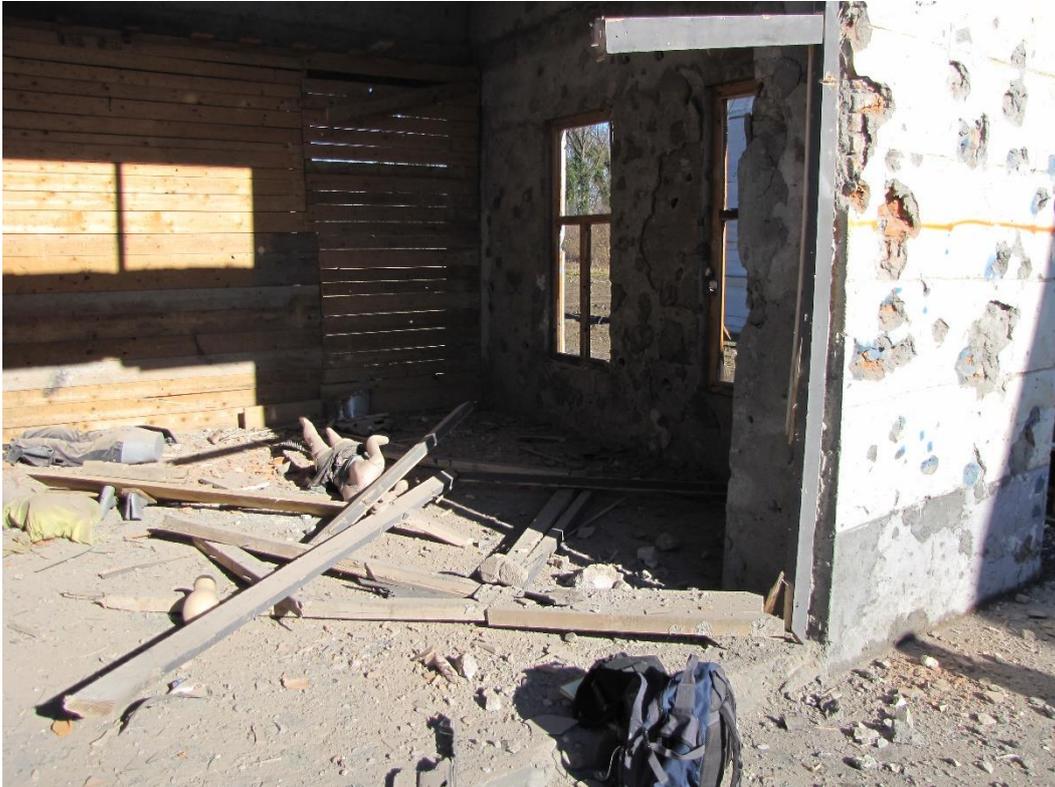
As a result of the explosion the display window of the store was flung into the building and broke. The window mannequins were flung into the store and broke. The store interior was filled with stone fragments, dirt and a great deal of dust. This is contrary to the original Tuzla event as noted above.

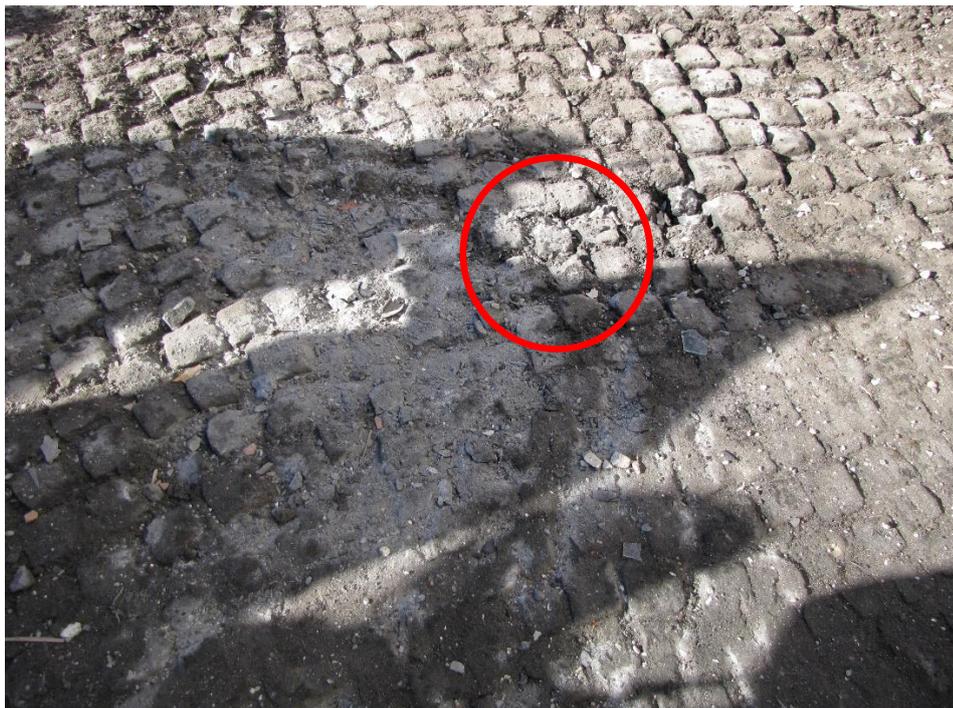
Although the shell fuze was inserted between the granite stones, the explosion crater was shallow.

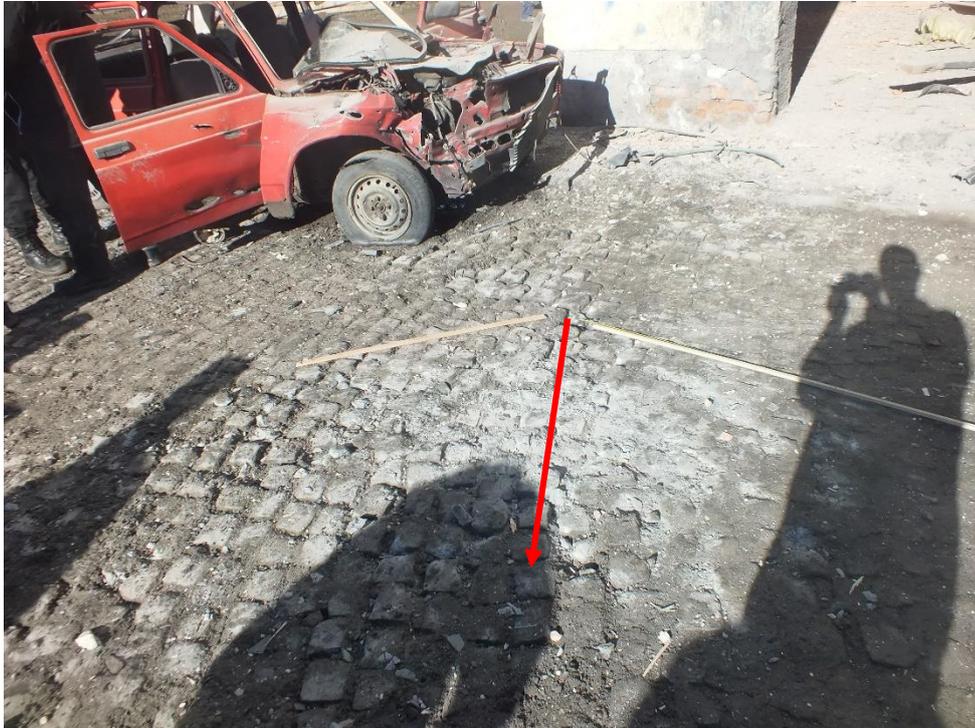
A ground fragmentation spread was created on the granite stones spreading from the explosion crater in the southeast direction – according to the azimuth of the projectile positioning.

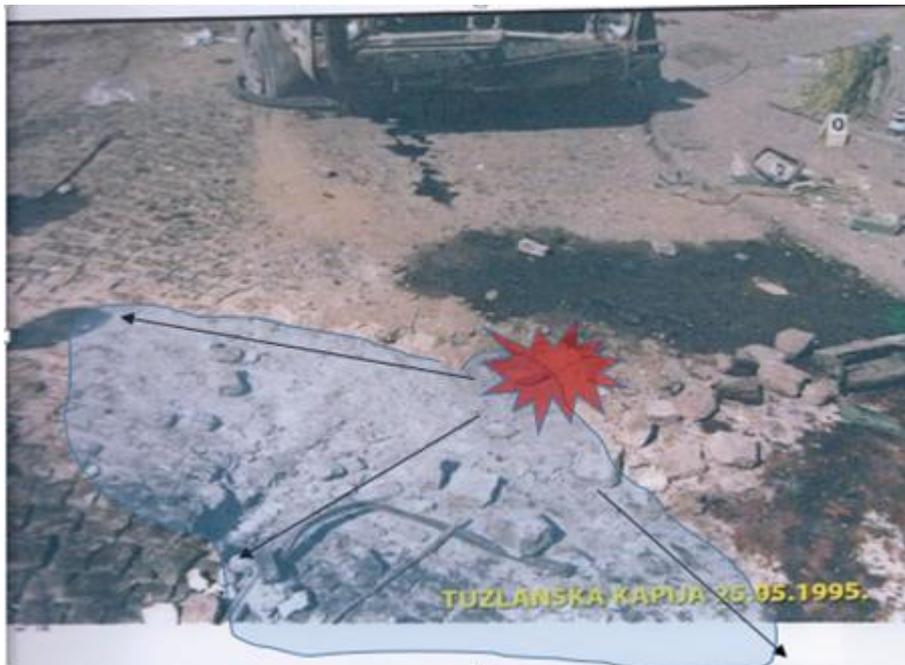
The characteristics of the direction and fragmentation spread are compatible with the characteristics of the fragmentation spread created in the original event at Kapija.

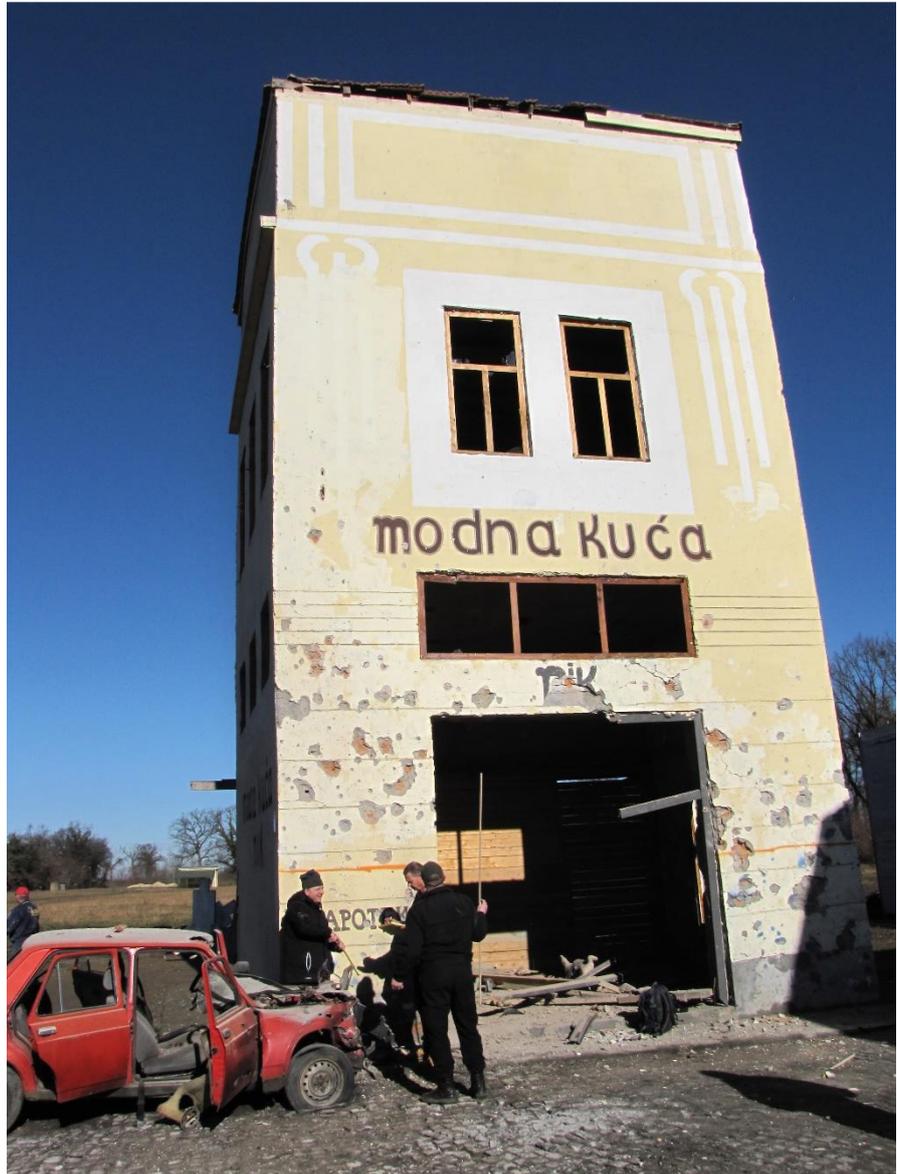
The building façade was damaged as a result of the explosion from a very large number of fragments concentrated on the building walls up to the height of about 3.5 meters. This is contrary to the Kapija event and to results of the aforementioned results of test no. 1.
