1. REPORT DATE April 2016			2. REPORT TYPE Technical report		3. DATES COVERED	
4. TITLE AND SUBTITLE Review of <u>Dr. Zecevic</u> expert opinion report conclusions regarding the causes and results of the explosion occurred at Kapiia square in the city of Tuzla on 25/05/1995					5a. CONTRACT NUMBER	
					5b. GRANT NUMBER	
					5c. PROGRAM ELEMENT NUMBER

6. AUTHOR(S) Sharon Joseph					5e. TASK NUMBER	
					5f. WORK UNIT NUMBER	
					8. PERFORMING ORGANIZATION REPORT NUMBER 32-16	
7. PERFORMING ORGANIZATION NAME(S) AND ADDRESS(ES) <u>Temech-Consultants</u> Tel-el 2516700 Israel					8. PERFORMING ORGANIZATION REPORT NUMBER 32-16

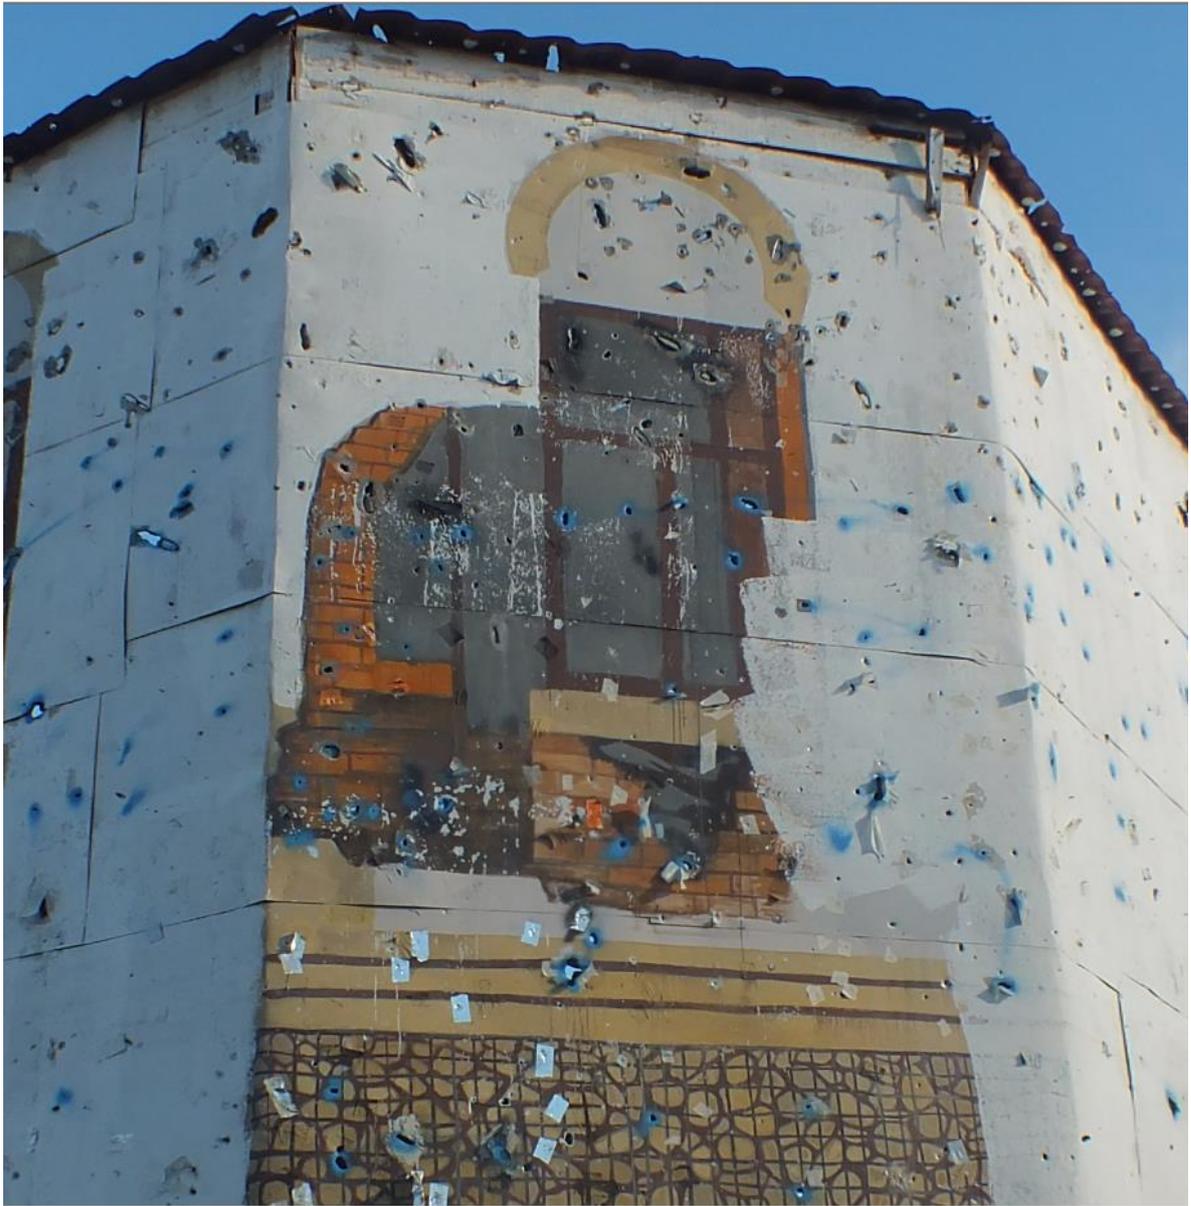
The first – fragmentation was found on the upper part of the area of the West corner of the Samoizbor building, although to a lesser extent than in test no. 1.

In blue – damage from test no. 1 and no. 2 – on the face side of the Samoizbor building

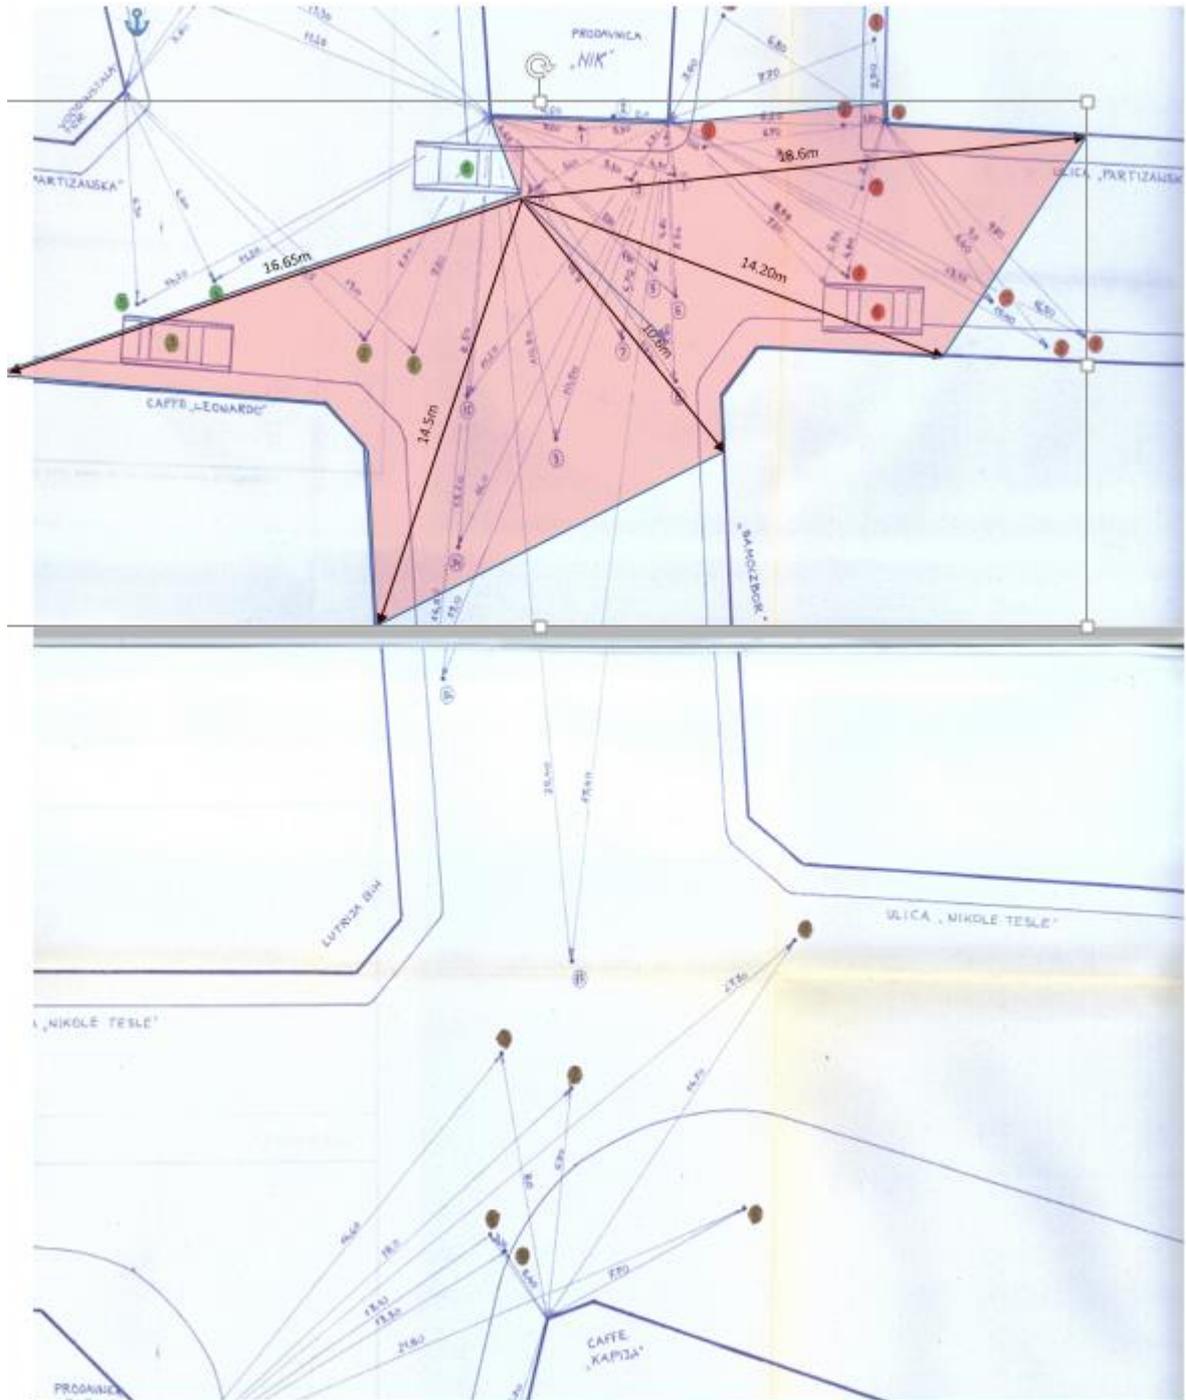
Range of maximum effective fragmentation on buildings – test no. 1 – based on projectile's position of projectile in Dr. Zecevic's opinion

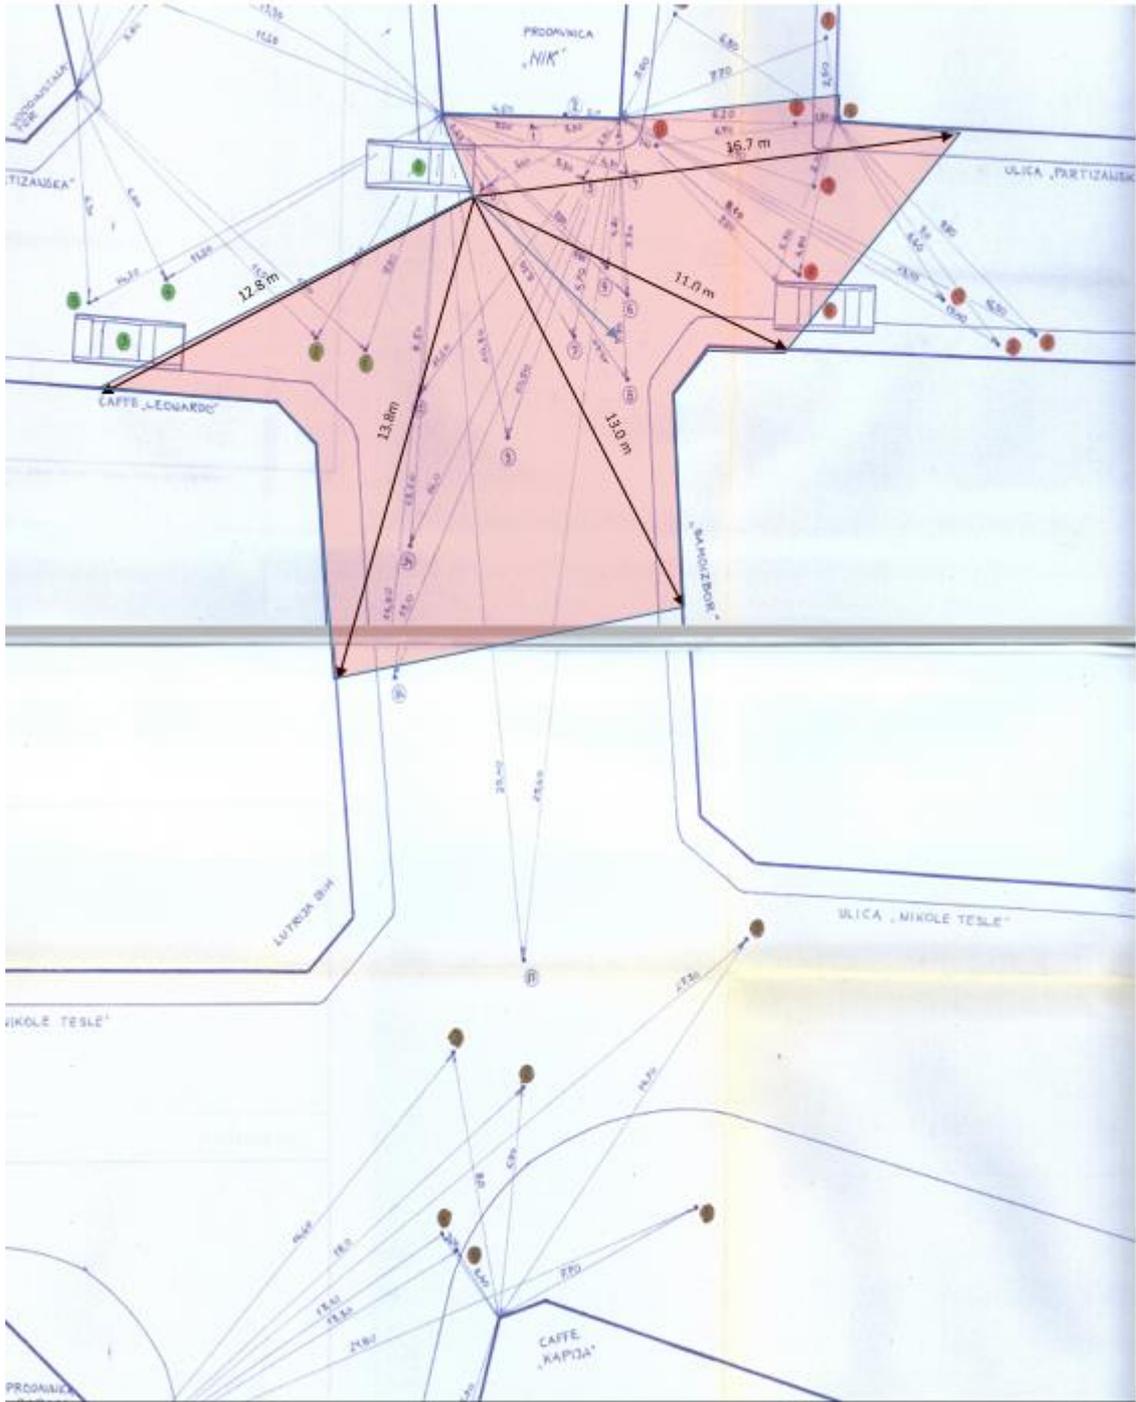
Range of maximum effective fragmentation on buildings – test no. 2

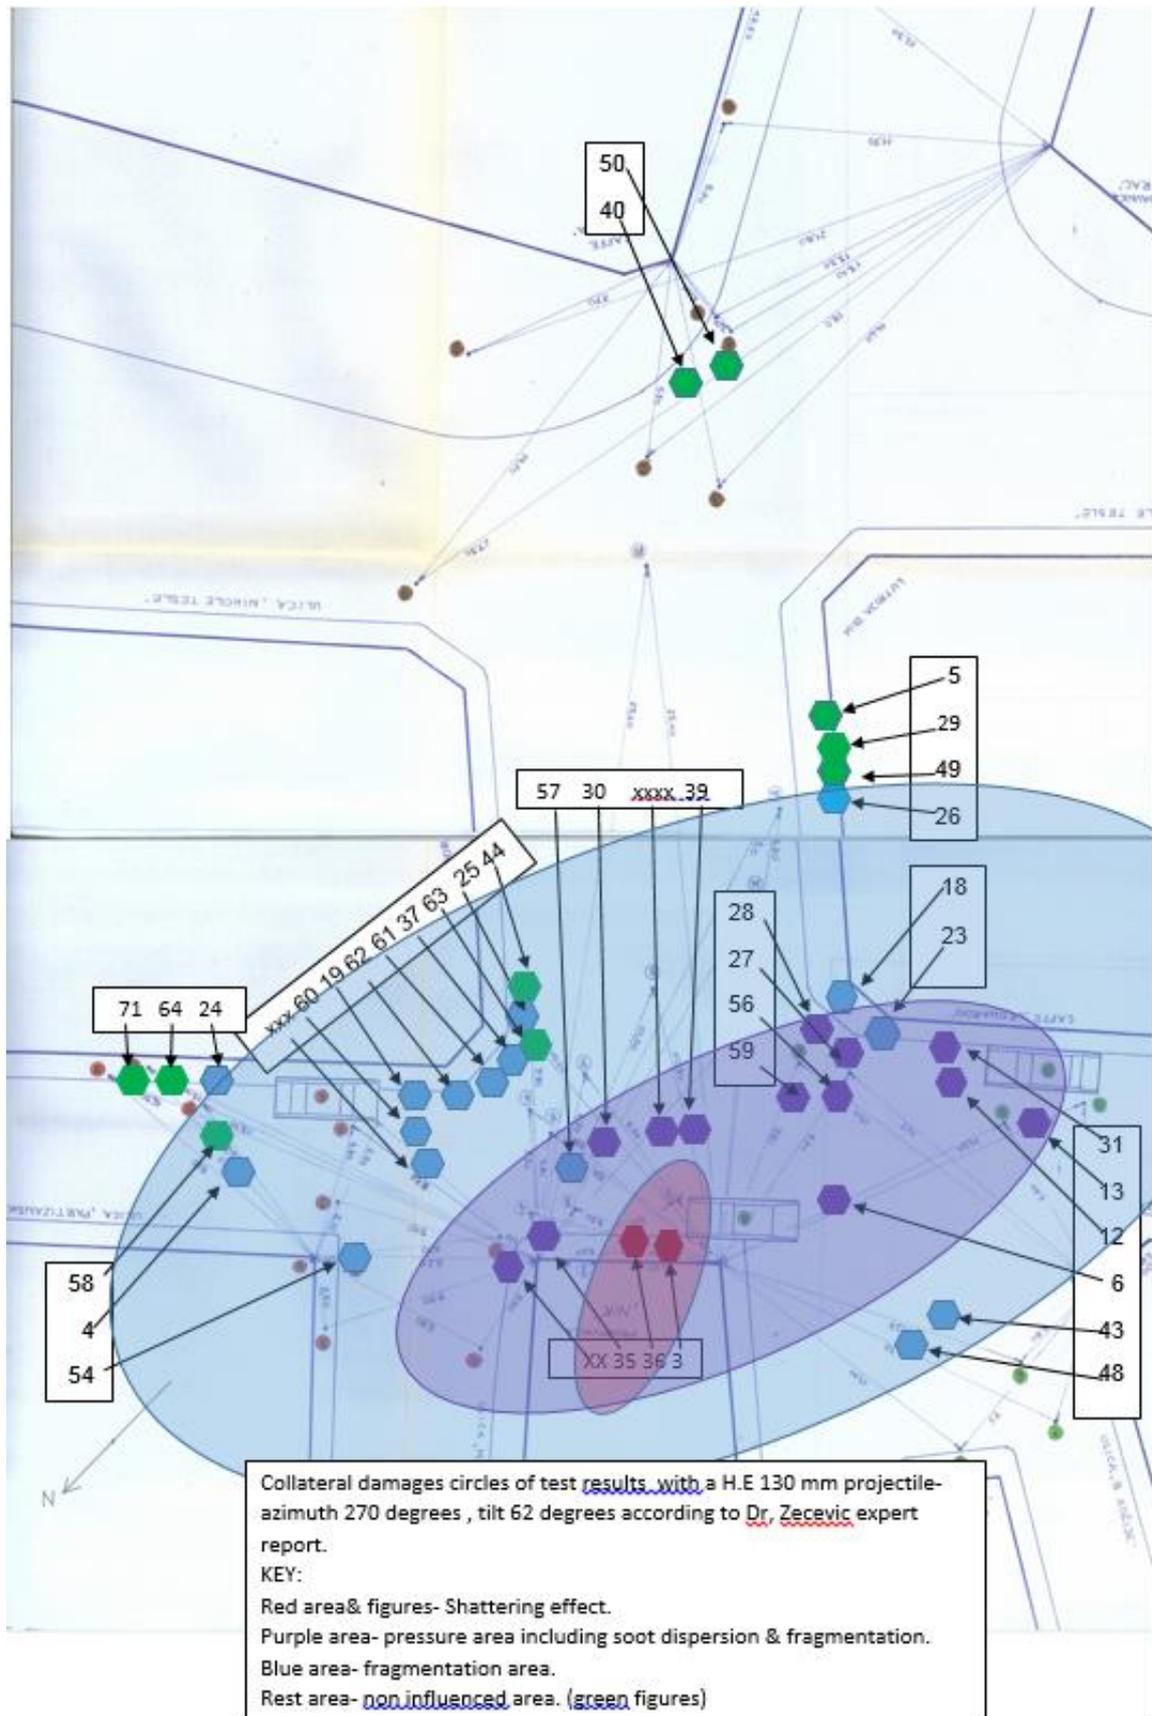
Injuries to Human Figures – Test No 1

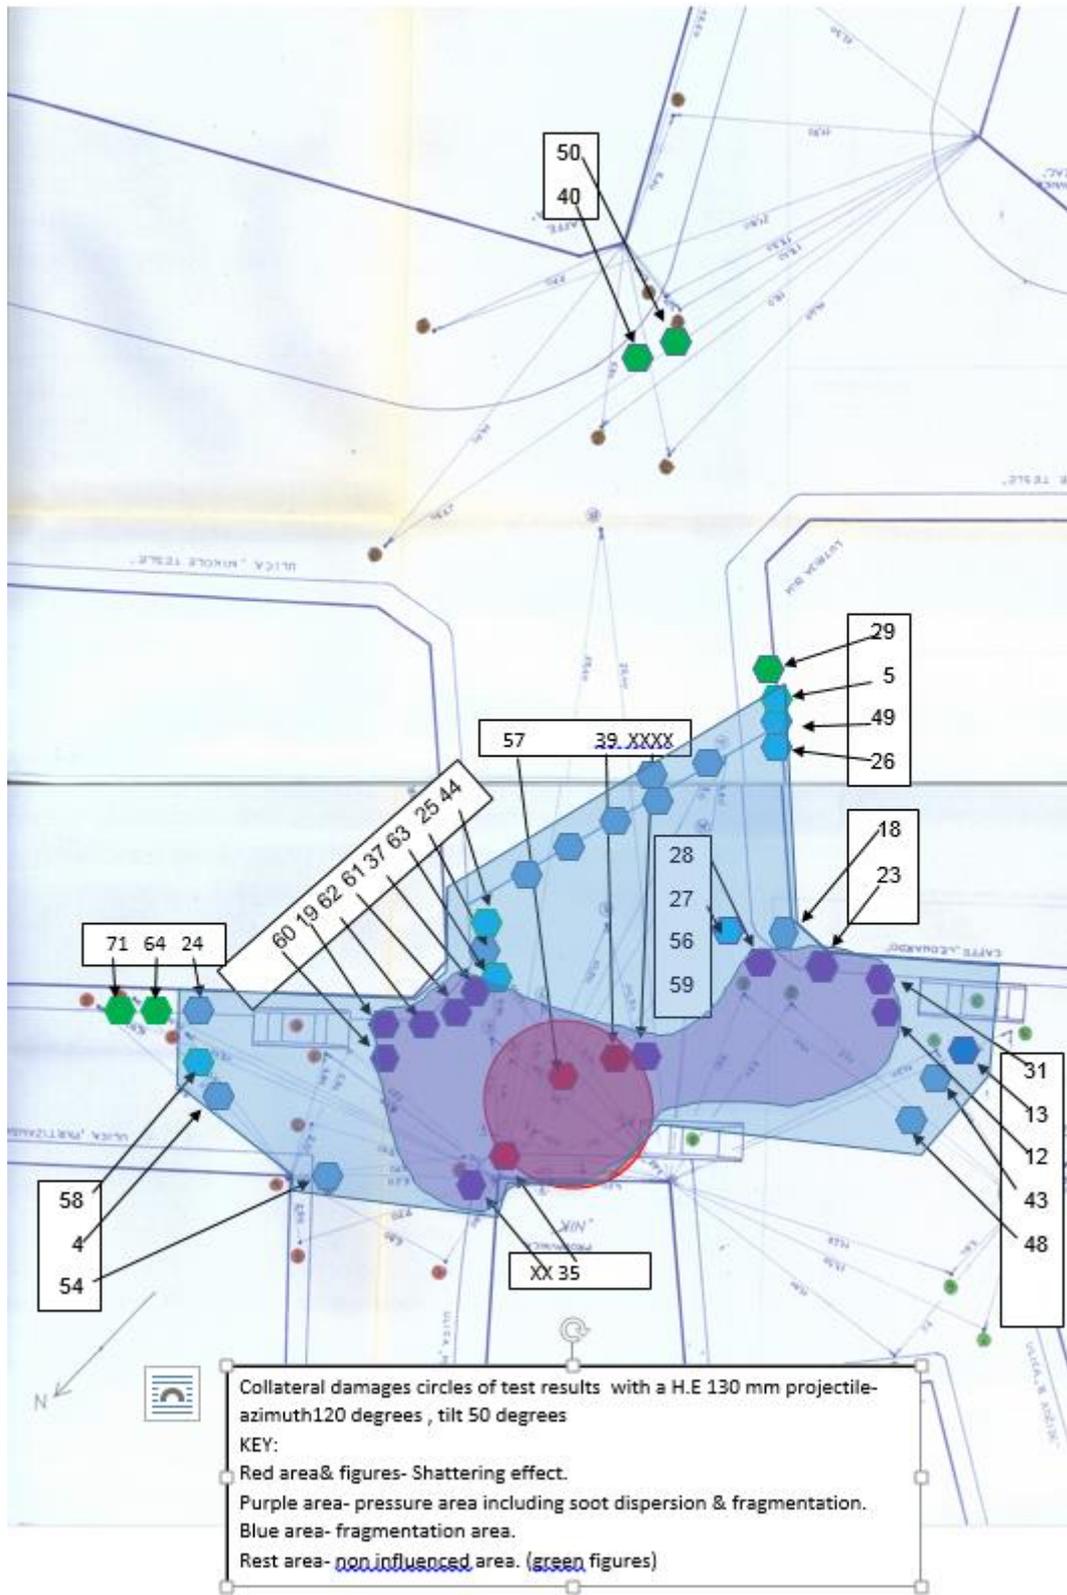
Injuries to Human Figures – Test No 2

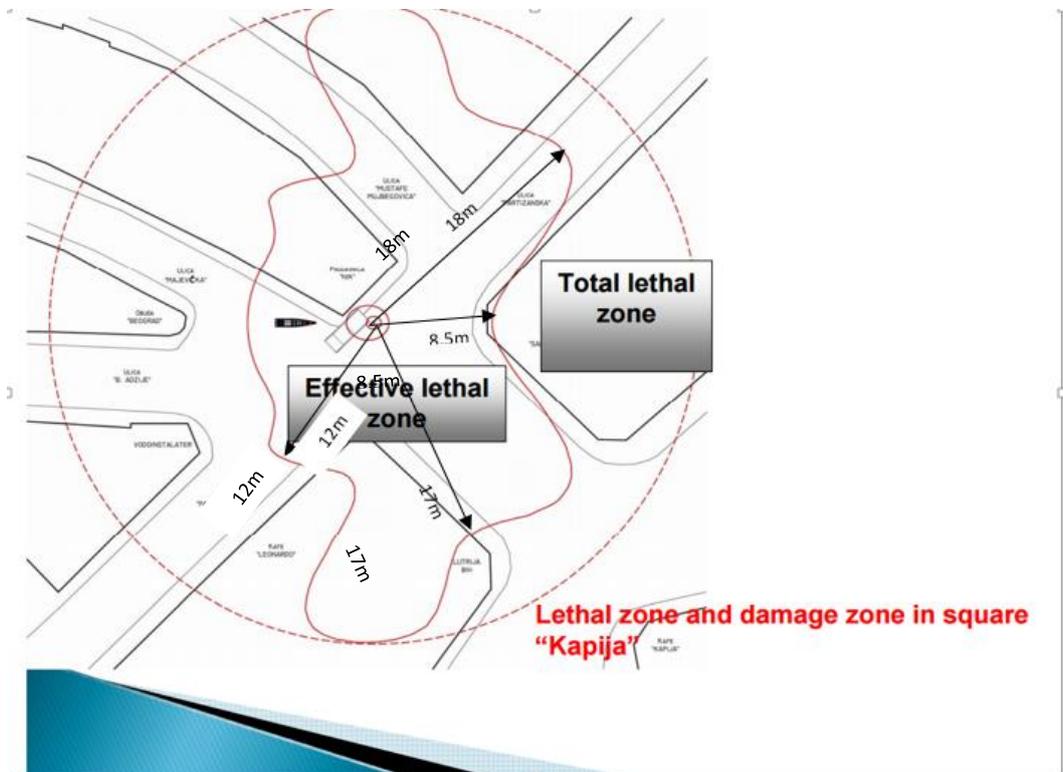
Maximum effective Fragmentation based on Dr. Zecevic's model

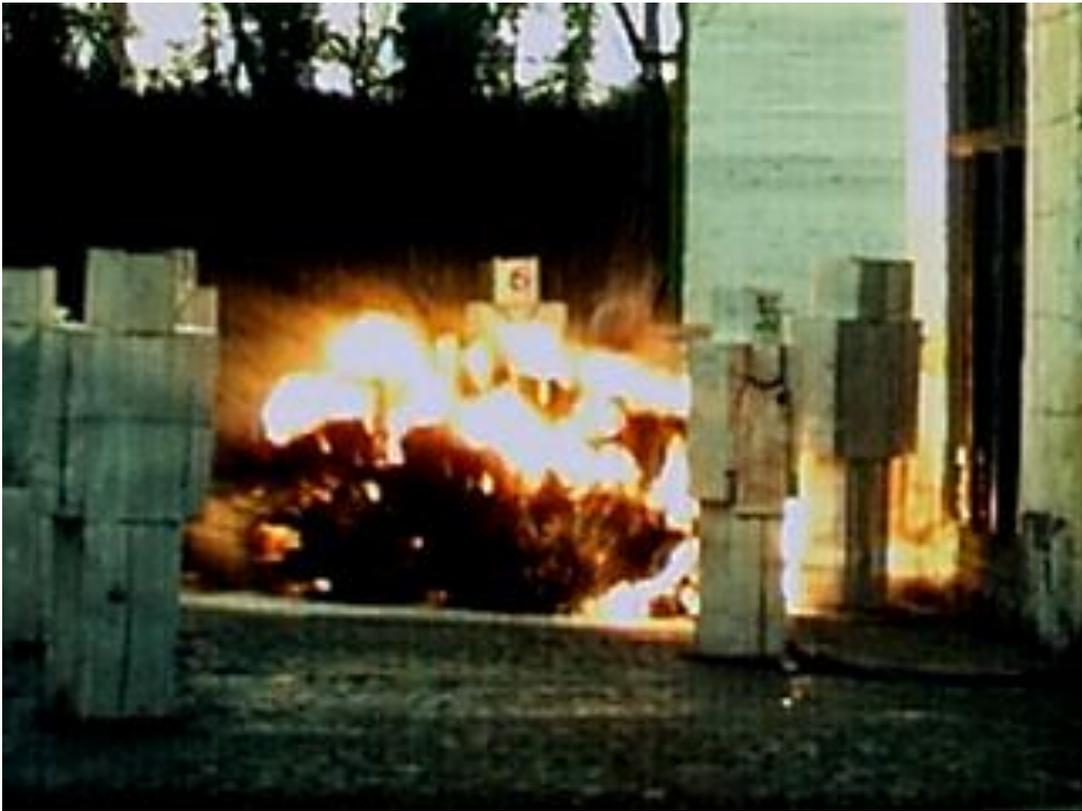
Fireball – test no. 1 – radius of 1.5 meters

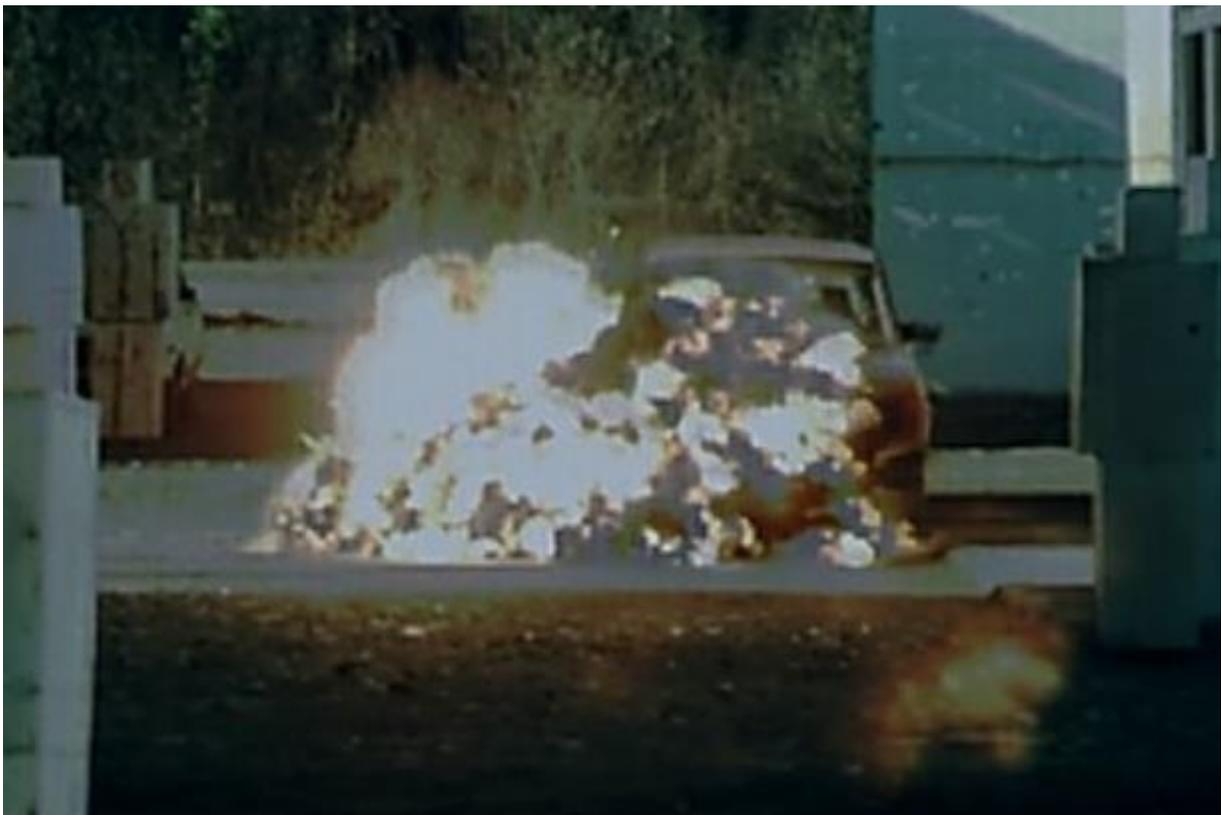
Fireball – test no. 2 – radius of 1.5 meters

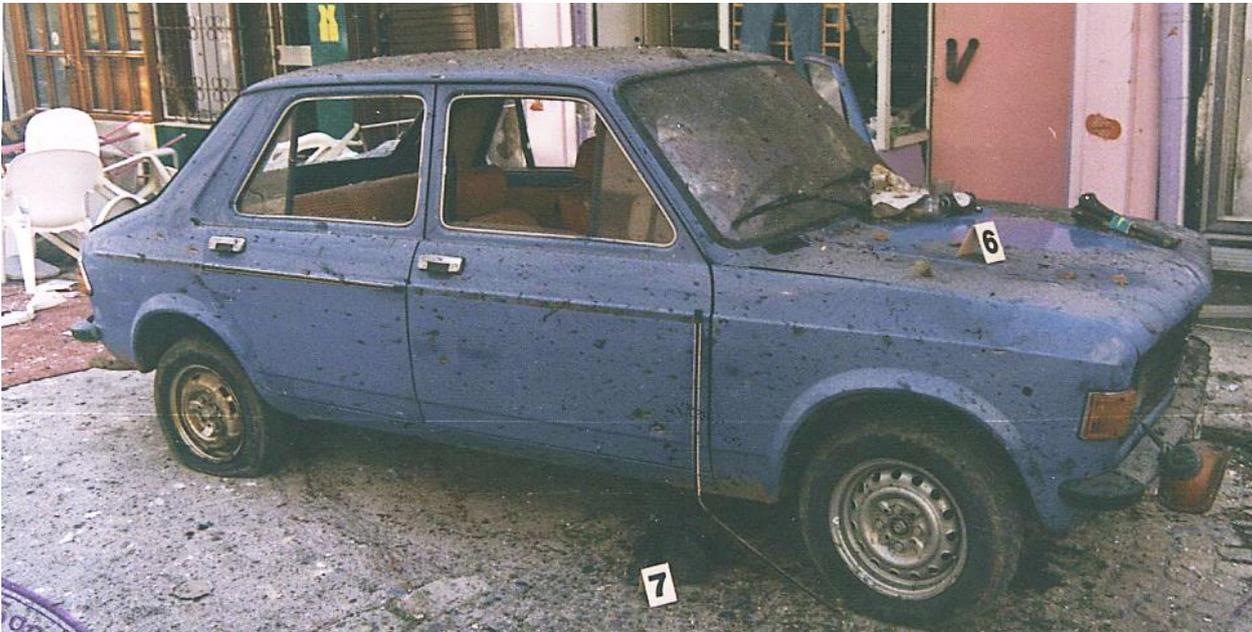
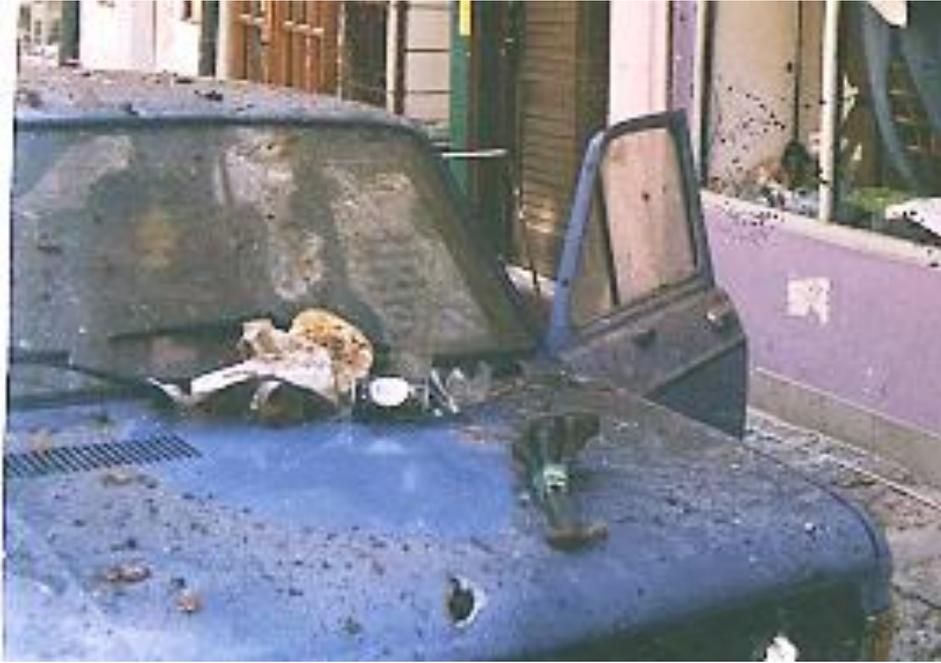
The vehicle itself was covered all along its front- front fender, engine hood, windshield and the roof with remains, most likely from shattered bodies. On the engine hood there was an area clean of remains – perhaps this is where the remains of one of the victims found adjacent to the explosive was flung as a result of the shattering effect of the explosives, or perhaps one of the victims sat on the engine hood and absorbed the remains into his body;

In addition, the vehicle's side and back windows appear to be shattered.

Such a massive dispersion of human body remains requires exposure of the victim's body to the explosion very close to the point of explosion. It is not possible that these remains, in such a large concentration, will arrive from the area of the Golf vehicle, particularly as there is no photographed evidence showing that these remains were found in additional places, except for one place -

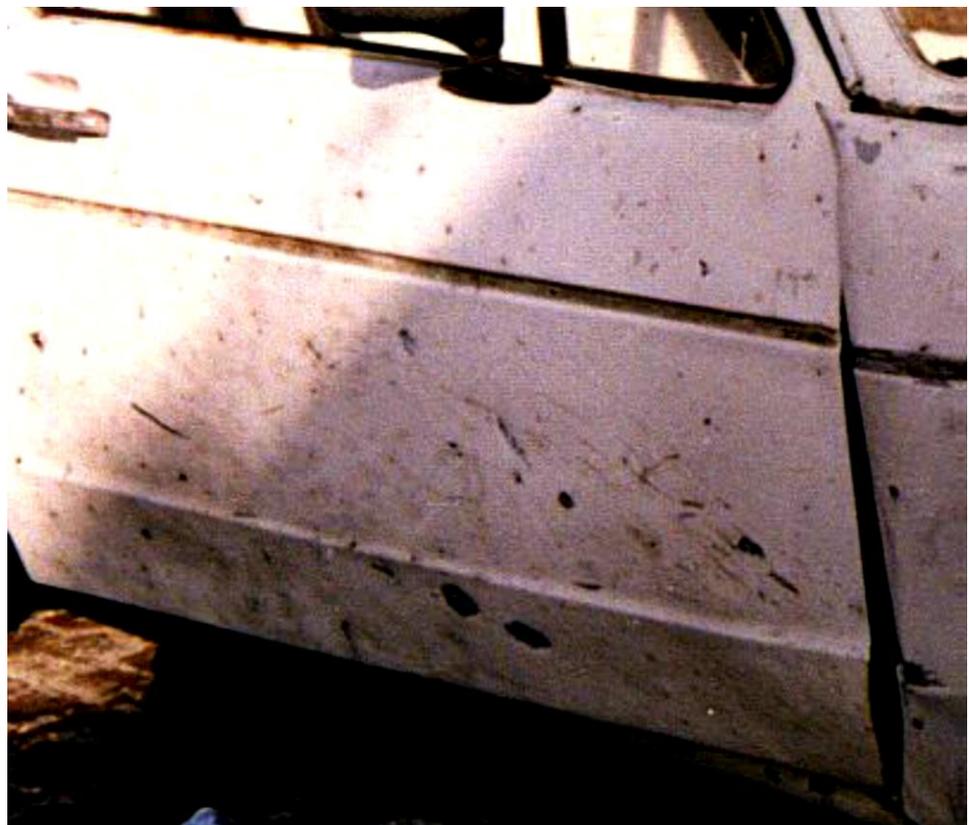
Splashes and smears of blood, human tissue, and penetrations of shrapnel in the right-hand door of the vehicle

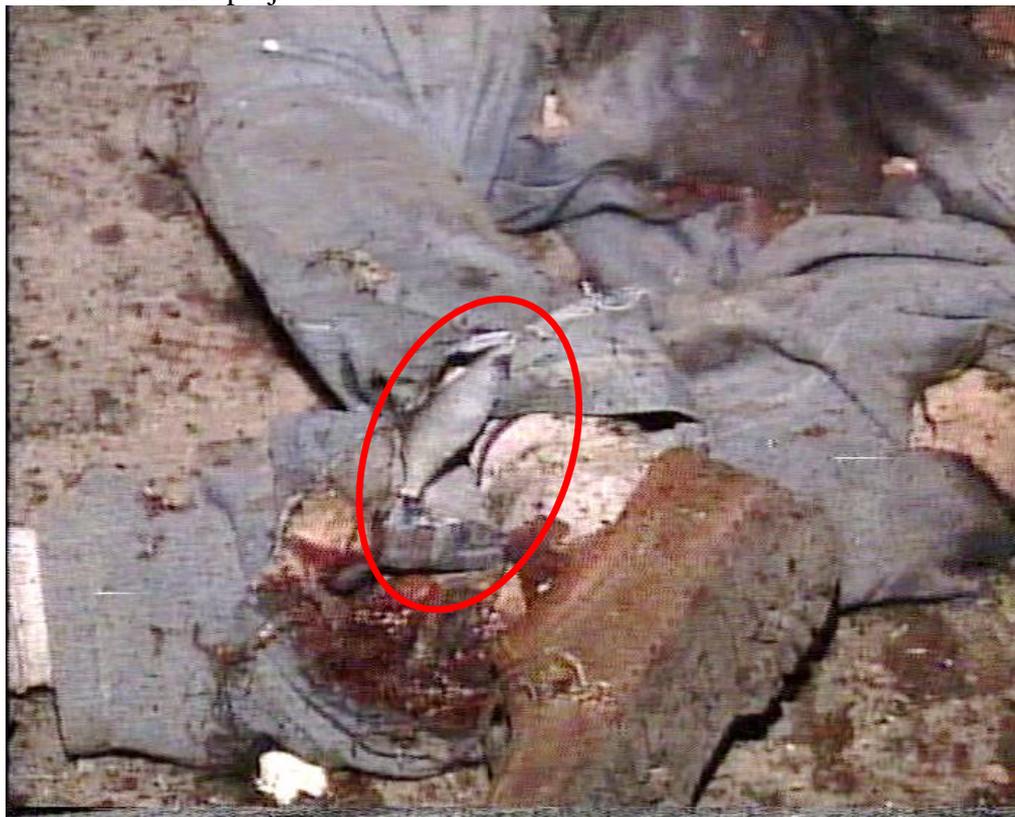
In front of the blue vehicle, located adjacent to the corner of the Samoizbor building lay a human corpse.

An examination of the film from the cameras that documented the event shows that smoke was emitted from the victim's severely shattered leg, a long time after the explosion. These circumstances indicate that the source of the smoke was not the result of metal fragments that touched the victim's legs. What's more, adjacent to the place emitting the smoke an object was found that appeared to be a thin partially round metal object about 10-15 cm long. At this stage the object has not been identified, and the issue should be further examined as it is clearly not from the 130 mm OF 482M projectile.

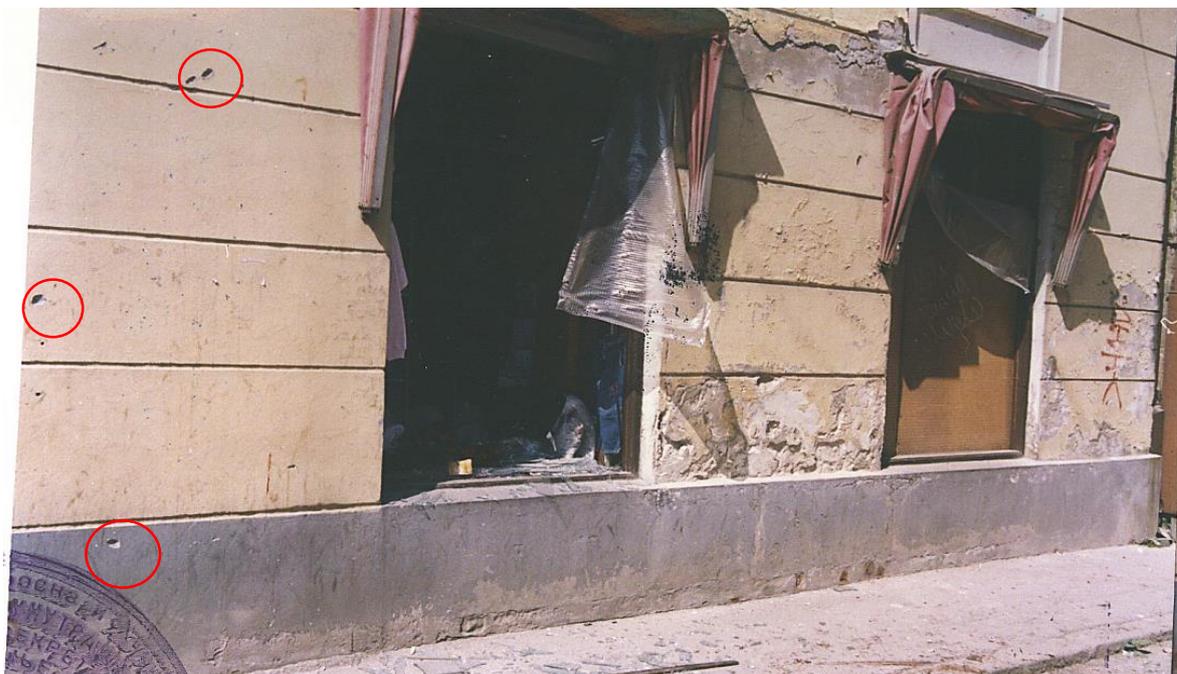
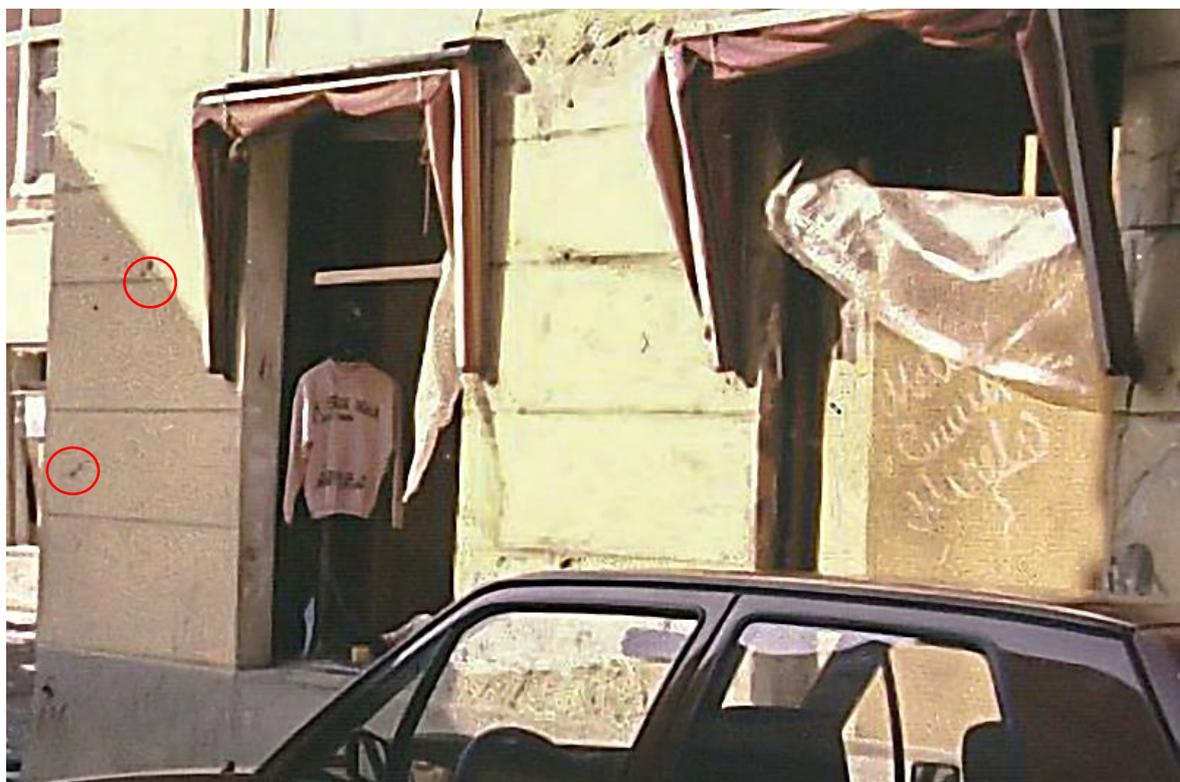
Diagonal fragment damage from the direction of the ground upwards was found in a number of places on the northeast wall of the NIK building, near the corner of the building, in a place completely hidden from the explosion center.

This damage is not unequivocally related to an object that exploded, as claimed, near the Golf vehicle. Furthermore, the finding of this damage undermines the determination regarding what occurred at the event in Kapija.

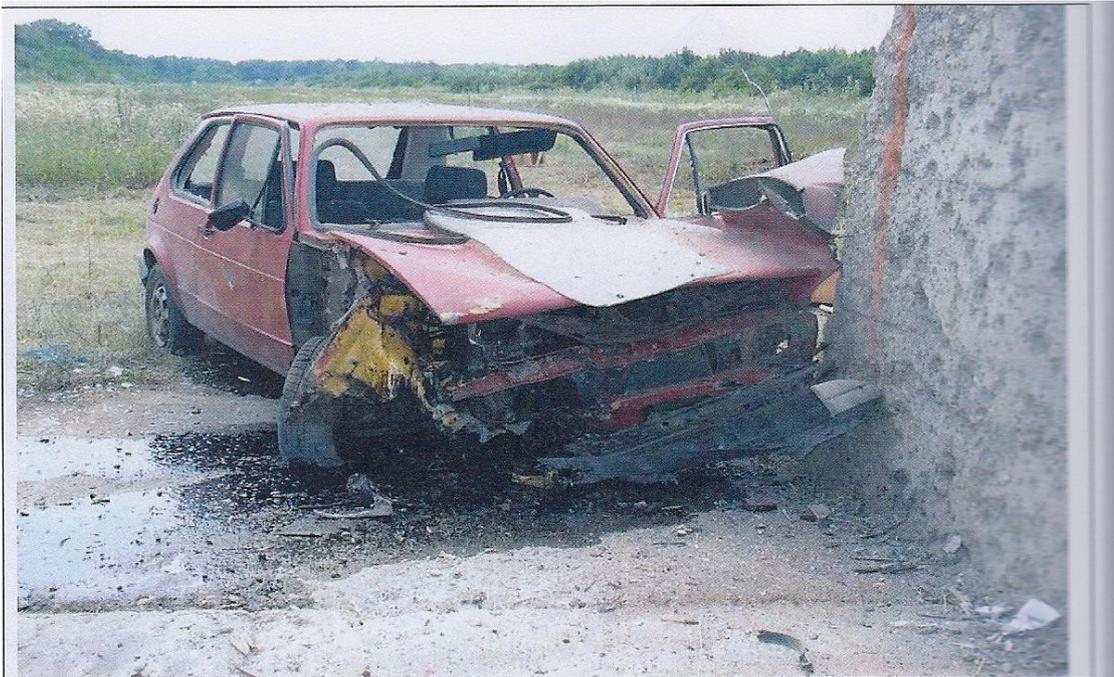
Results of test no. 1

Concrete	Severe damage to the right corner of the vehicle and the wheel of the vehicle	145 cm backwards, 60 cm towards the wall	Shallow, fragmentation spread of about 170 degrees
2	11/08/2014	130mm M79	62	270	Distance of about 40 cm from the right corner of the vehicle

Photograph 20 – The vehicle, type “Golf 1“ after the activation of 130 mm OF482M projectile placed under the 62° angle in relation to the horizon (photograph PICT0754)

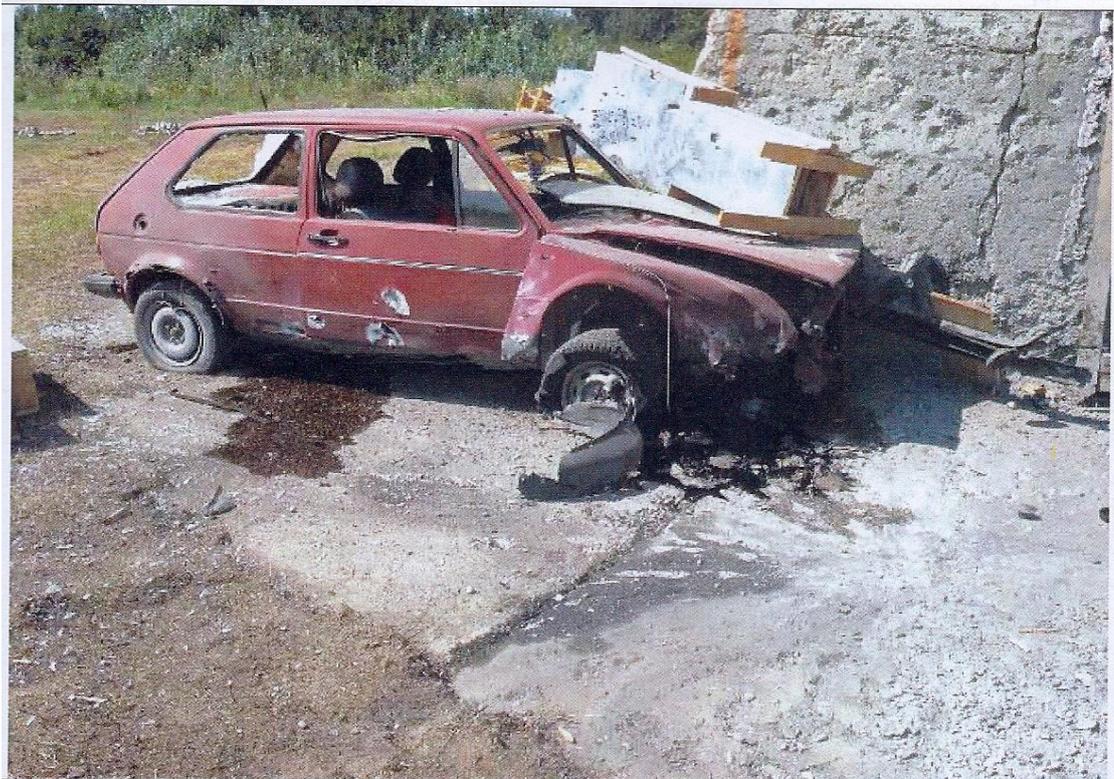
Results of test no. 2

Concrete	Tearing of the right side, damage to the right wheel, penetration of shrapnel into the right door	80 cm backwards, 47 cm towards the wall	
3	05/08/2014	130mm OF 482M	43	90	Distance of about 40 cm from the front of the vehicle close to the center

Photograph 24 – The vehicle, type “Golf 1“ after the activation of 130 mm M79 projectile placed under the 62° angle in relation to the horizon (photograph DSCN5605)

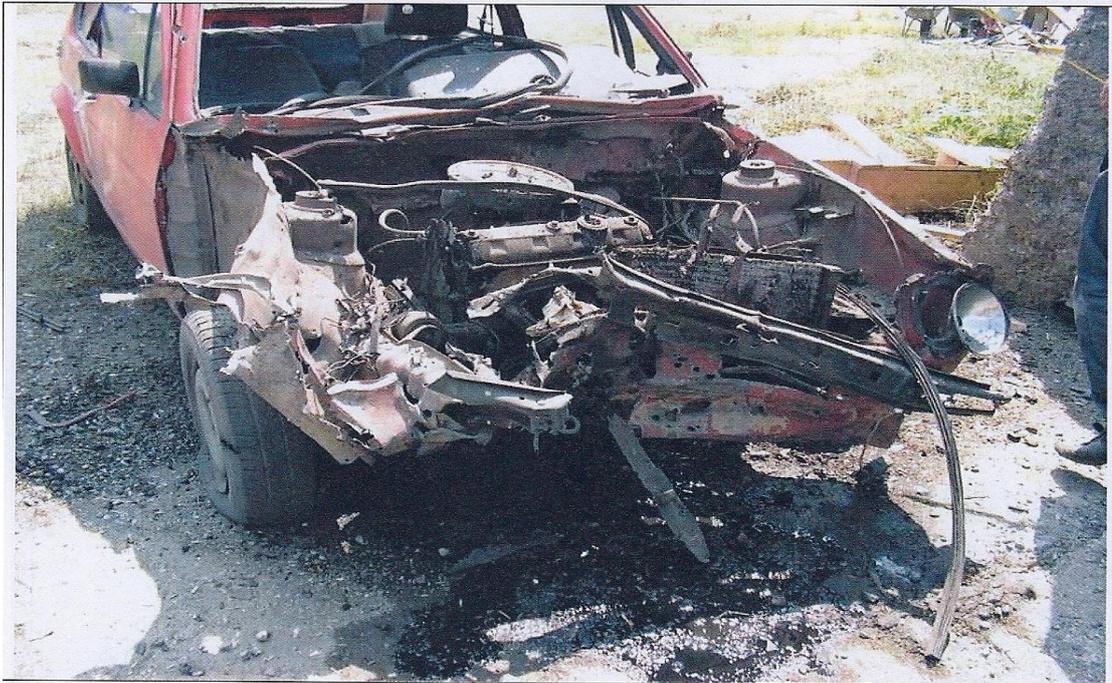
Results of test no. 3

Concrete	Severe damage to the front of the vehicle, engine and right side	80 cm backwards, 47 cm towards the wall

Photograph 28 – The vehicle, type “Golf 1“ after the activation of 130 mm OF 482-M projectile placed under the 43° angle in relation to the horizon (*photograph PICT0910*)

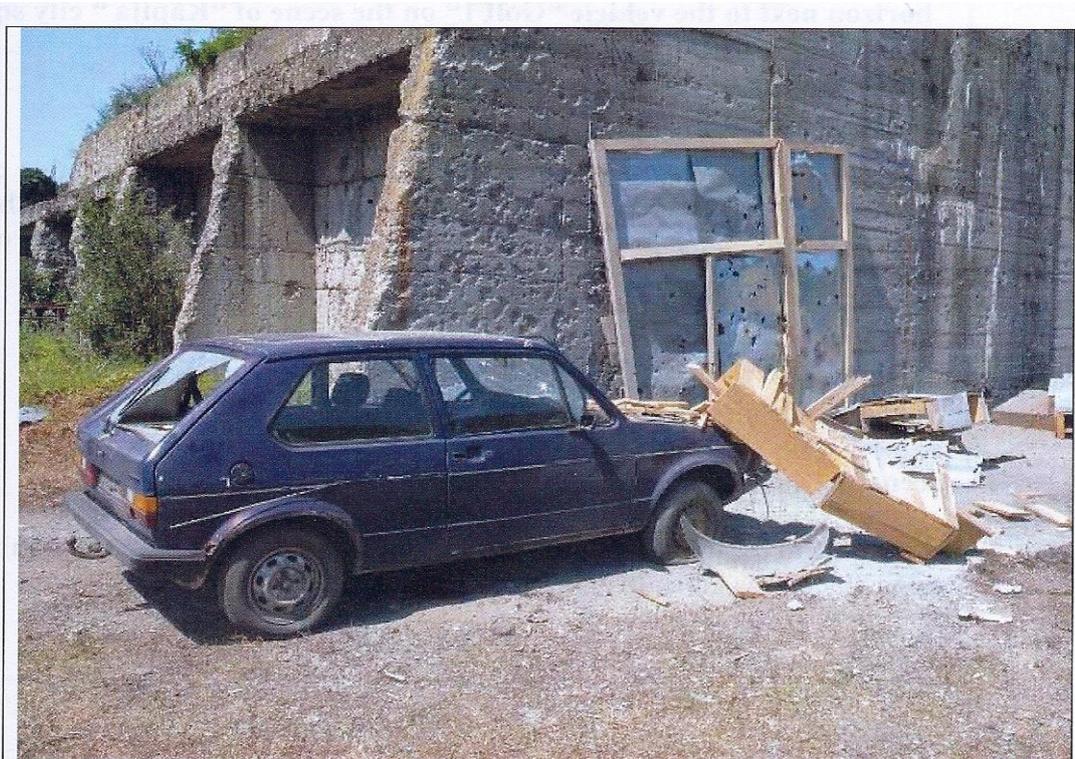
Results of test no. 4

Concrete	Presumably light damage to the vehicle, rear window shattered	20 cm backwards, 10 cm in the direction of the wall	
5	25/08/2014	130mm OF 482M	62	270	Distance of about 40 cm from the right side of the vehicle

Photograph 30 – The vehicle, type “Golf 1“ after the activation of 130 mm OF 482-M projectile placed under the 31° angle in relation to the horizon (*photograph PICT0754*)

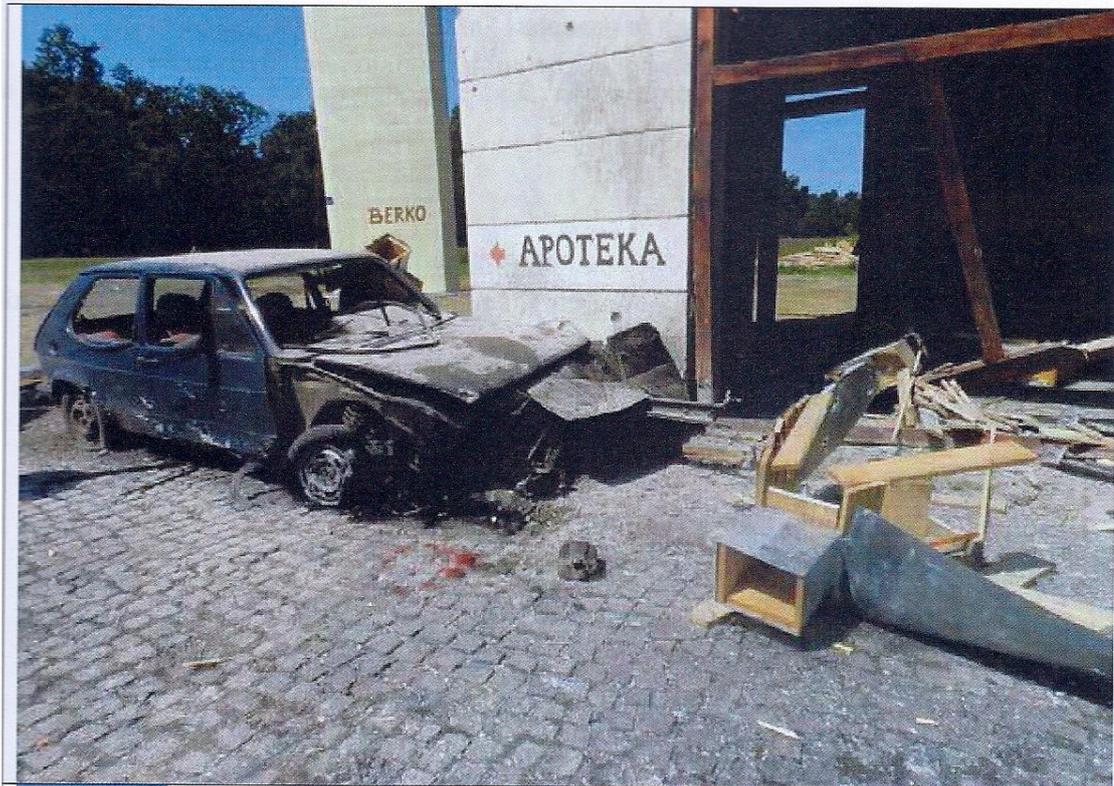
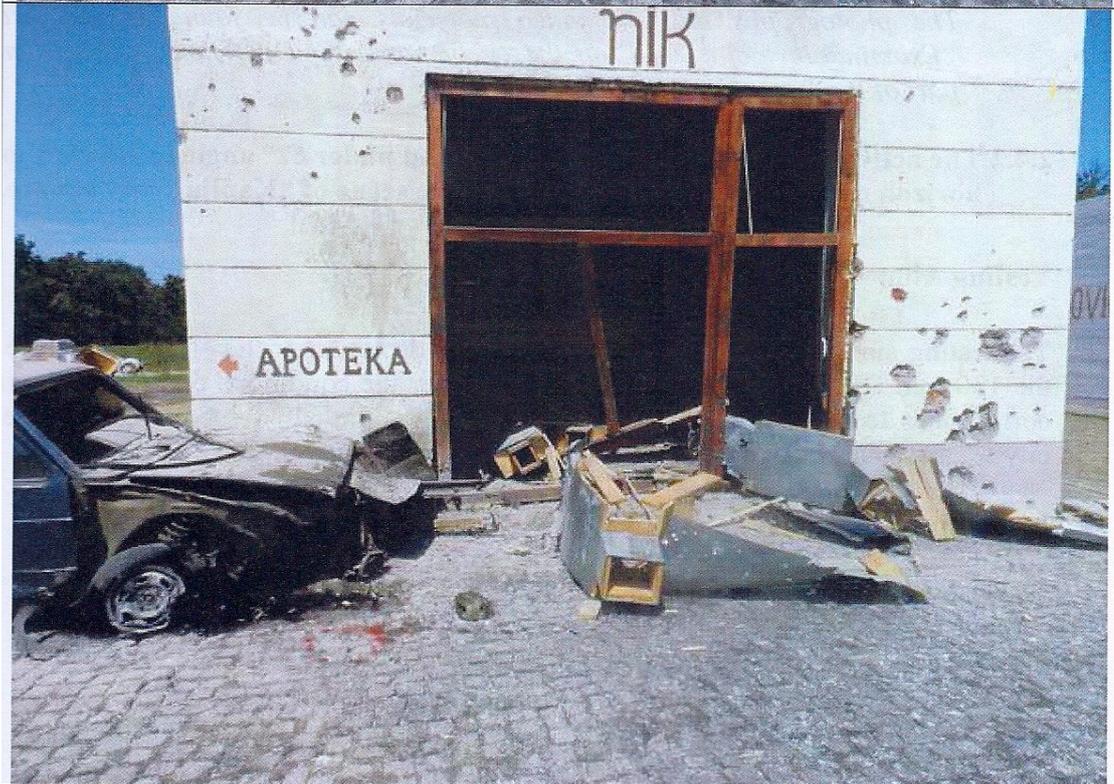
Photograph 33 - The place of explosion of the 130 mm OF-482M. *In the centre of the red circle is the explosion centre.*

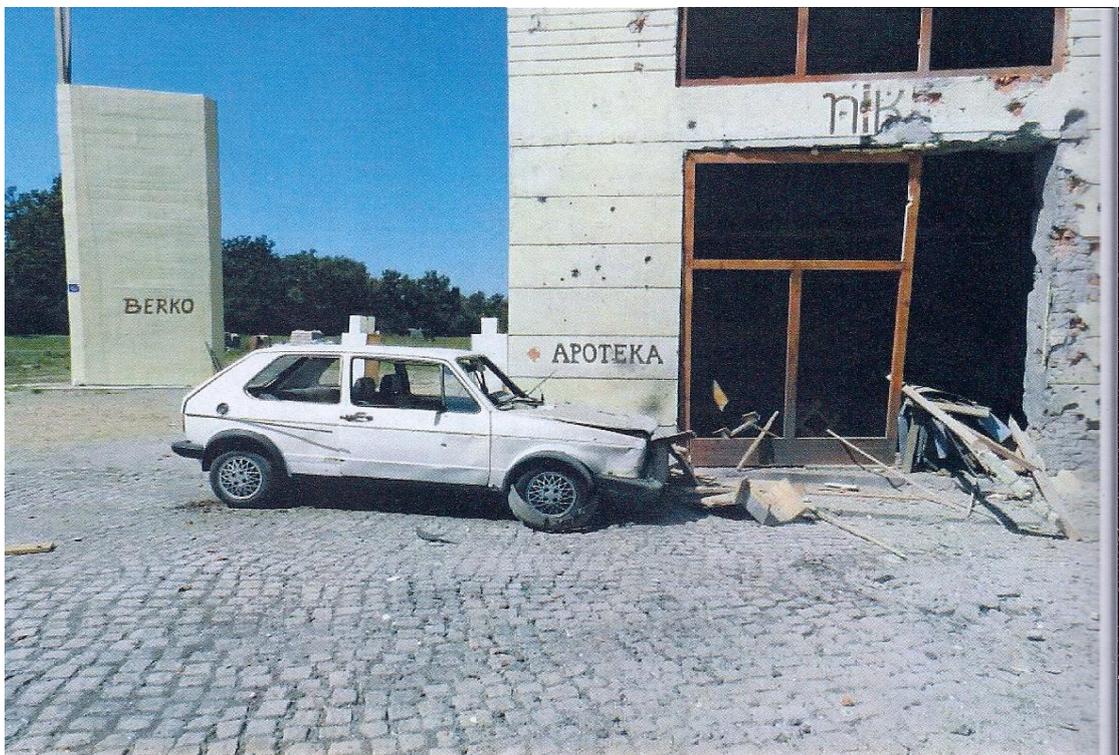
Photograph 40 The place of explosion of the 130 mm OF-482M

Results of test no. 6
