**ADDITIONAL BALLISTIC EXPERTISE ASSOCIATED TO THE
EVENT AND CIRCUMSTANCES IN CASE OF EXPLOSION AT
"KAPIJA" LOCALITY IN TUZLA ON 25 MAY 1995**

REPORT AND OPINION

**Court expert for ballistics, firearms and cold weapons MSc. Vlada Kostić,
B.Sc.M.E., in cooperation with qualified person for ballistics Branka
Luković, B.Sc.M.E.**

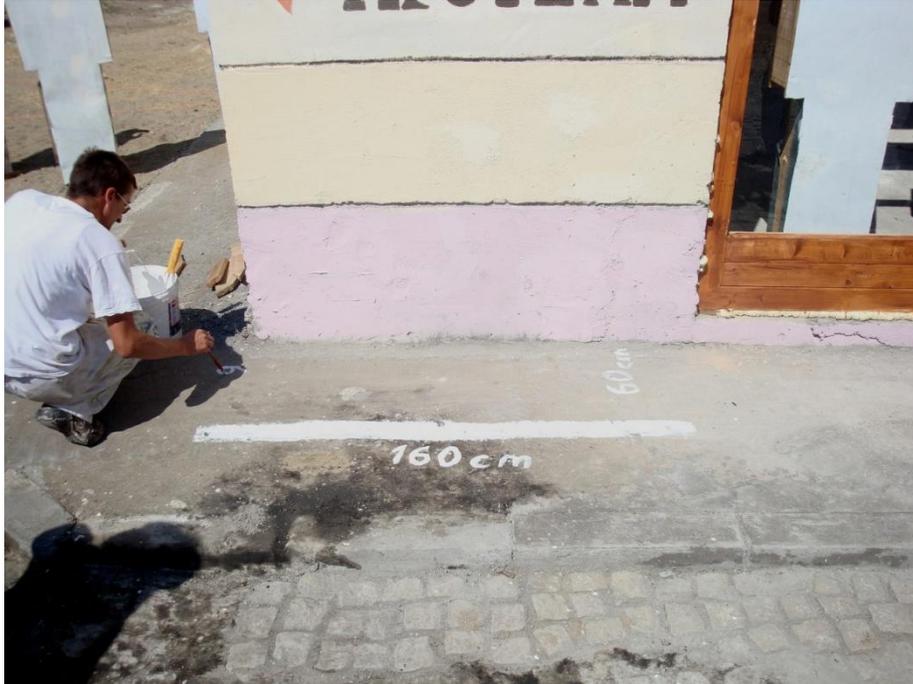
On Figure 1 is shown the defining of position for placing the VW car, model "Golf 1", which closely matches the position of such a car on the RCS, before the activation of explosion on 25 May 1995. Line of 1.6m length defines the position of front end of the car in relation to the left edge of "NIK store" model wall. Distance of left lateral side of the car was defined with a distance of 0.6m in relation to the facade plane of that same model.

Figure 1 – Defining of spatial elements for setting up the “GOLF 1” car in front of “NIK” store object

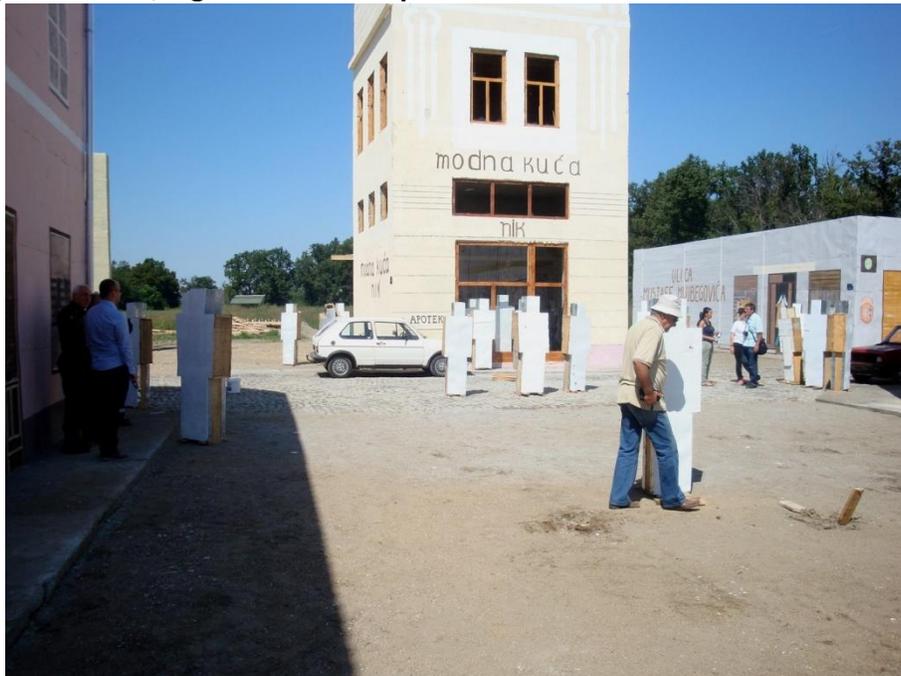
Figure 2 – Wider looks of the site of experiment performing, with the car and dolls in positions as they were before the explosion

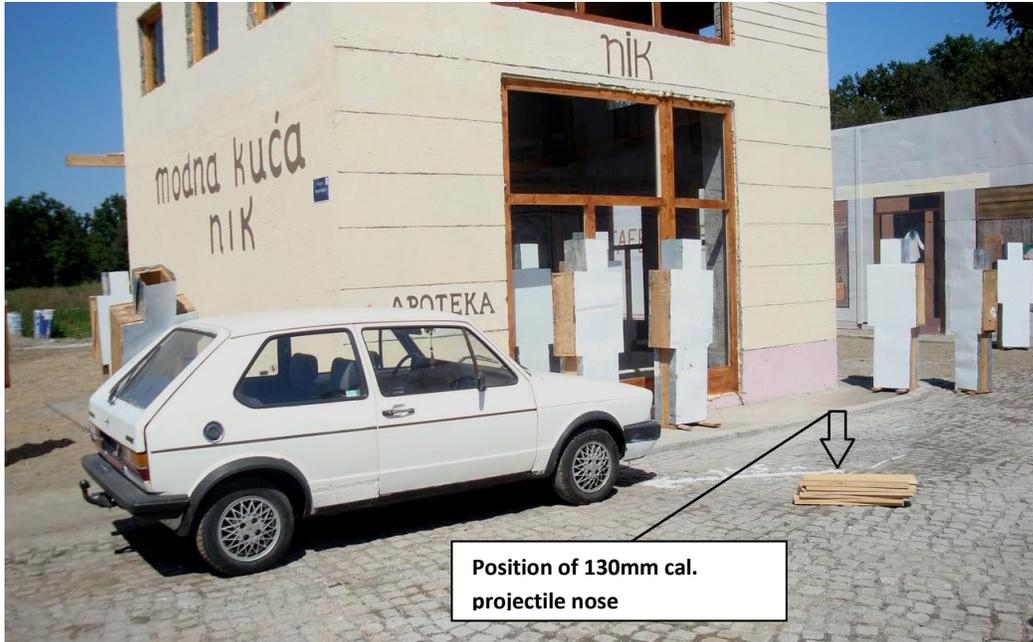
Figure 3 – Appearance of the site with the car and dolls in approximate positions as they were before the explosion, with marked position of projectile nose

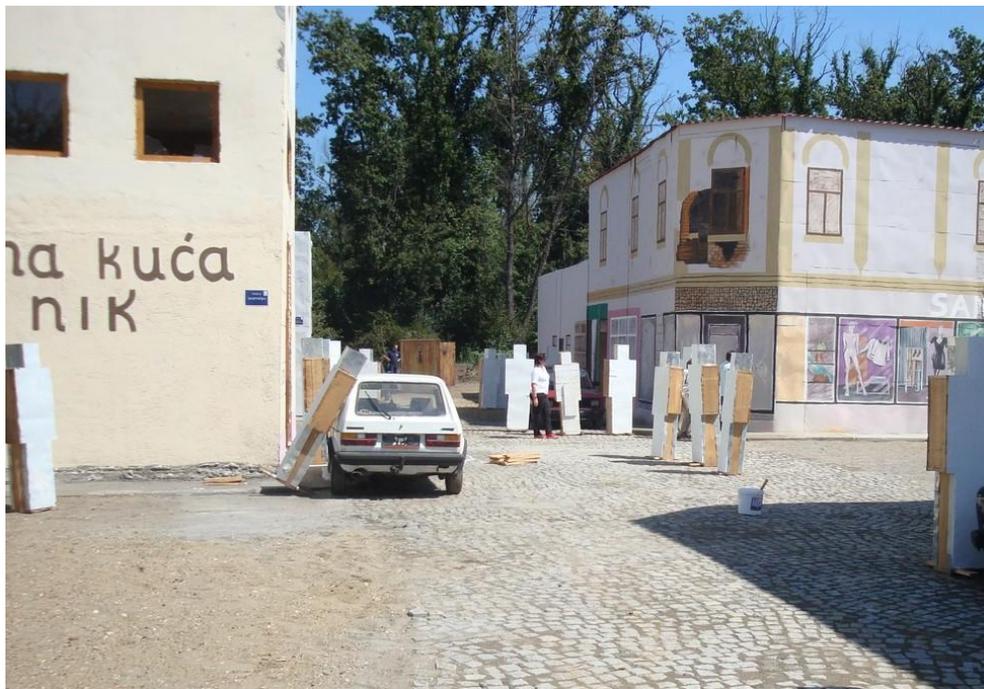
Figure 4 of the Report shows appearance of the site with the car and dolls which simulated present persons, in approximate positions as they were immediately before the moment of explosion on 25 May 1995, view towards "Partizanska Street".

Figure 4 – Appearance of the site with the car and dolls which simulated present persons, in positions as they were before the moment of explosion on 25 May 1995, view through "Partizanska Street"

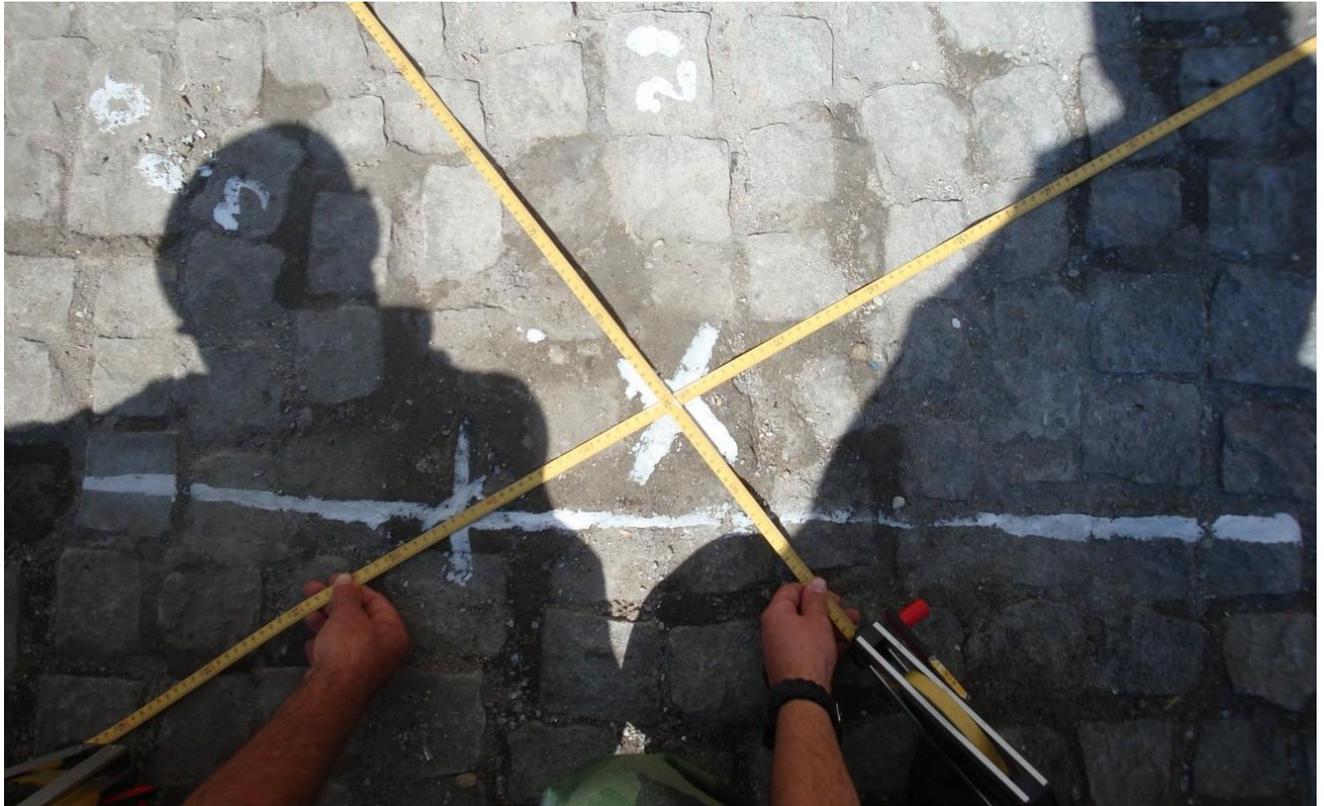
Figure 5 of the Report shows defining of spot, i.e., the position of projectile nose in relation to the model of "NIK store", according to the data from the document titled: "CRTEŽ LICA MJESTA", Subject: Shelling – sketch of the crater, No.: 20-1/02-3-9-7-175/95 from 25/26 May 1995, which was drafted by crim. technician Irfan Džinović during the investigation.

Figure 5 – Defining of spot, i.e., the position of projectile nose in relation to the "NIK" store object, based on the sketch of the crater No.: 20-1/02-3-9-7-175/95

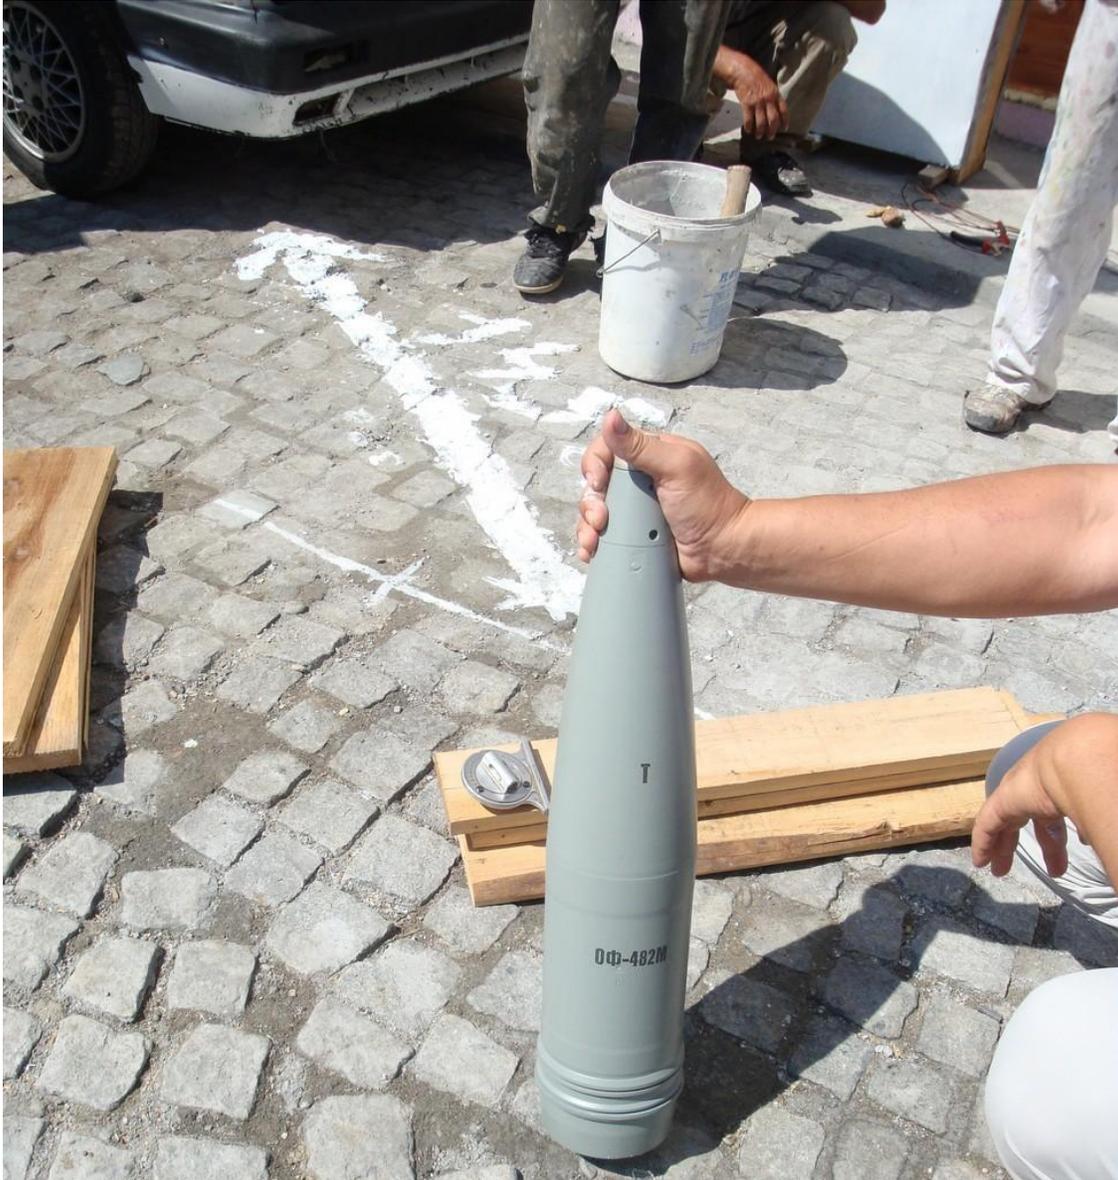
Figure 6 of the Report shows appearance of 130mm caliber projectile OF-482M, which was activated for experimental purposes, taken immediately before setting it up in the position for activating. Thick white line marks direction of projectile towards front right fender of the set-up car "GOLF 1", in accordance to the mutual positions of the crater and the car on the site of subject case.

Figure 6 – Appearance of 130mm caliber projectile OF-482M immediately before setting it up in the position for activating, thick white line marks the direction of the projectile towards the car

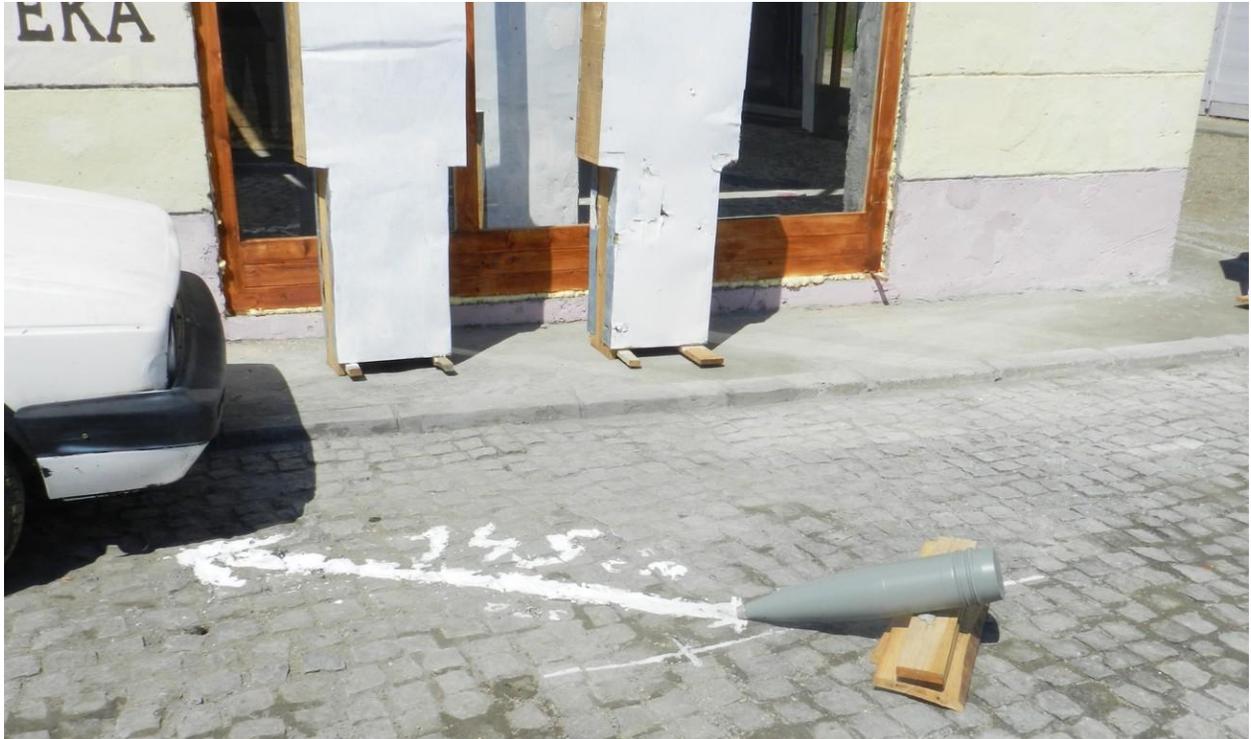
Upon ending the preparations for the experiment, 130mm OF-482M projectile was set up to abovementioned position, under inclination, i.e., under controlled 20° angle, its back part leaning on a board, and fuze immediately on the ground of granite cubes, Figure 7 of the Report.

Figure 7 – Position of the projectile at which activation was performed
